Edenwood Mill (2020/013) – Binder 3

ENGINEERING REPORT 7170

**EDENWOOD MILL
EDENWOOD LANE
OFF BOLTON ROAD NORTH
RAMSBOTTOM
BL0 0EX**

13.03.2020 MP/CH

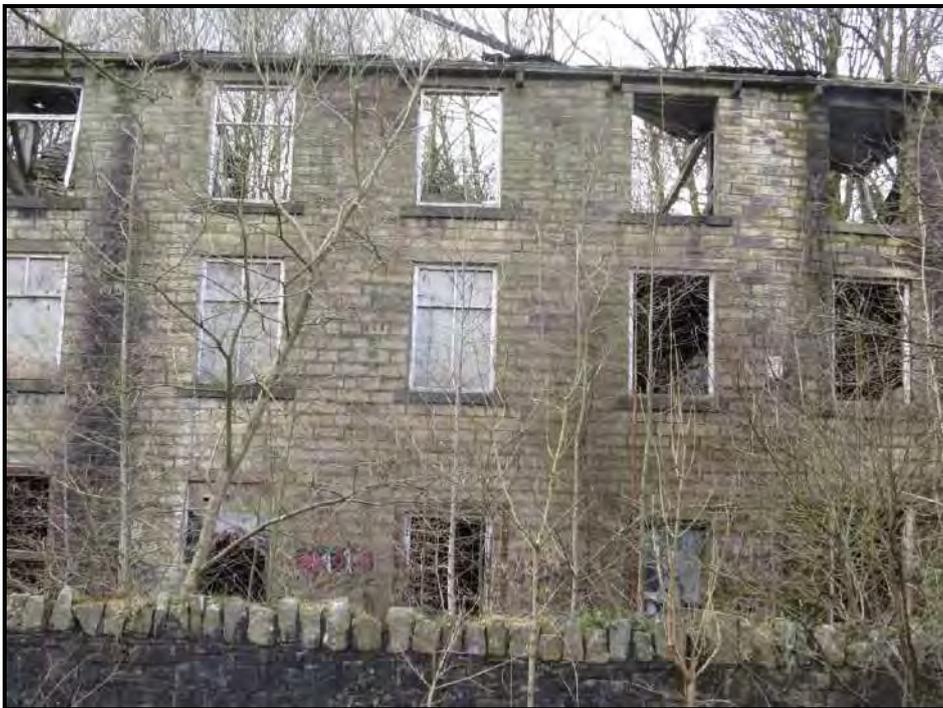
075 Front elevation Bays 11 - 14

- 3.1 The original mill has a back to earth construction in natural stonework of solid wall construction incorporating three storeys to the front riverside elevation, accessed with a 4 metre wide track located at the site of the variable height retaining wall leading to the Southern front corner of the mill. The mill was completed with a blue slated pitched roof. (Photograph 075, 076, 077).

- 3.4 For identification purposes the windows are numbered from left to right, Bays 1 – 8 with exception of a blank Bay between Bays 1 and 2 on a regular pattern. (Photographs 075, 076, 077).

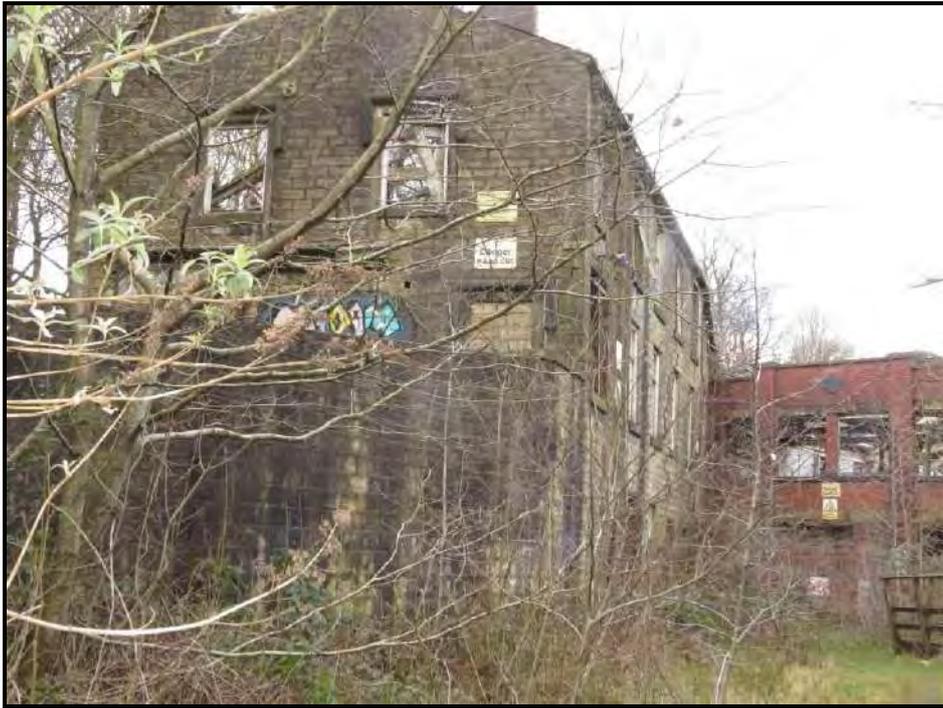
133 Southern gable and front elevation

- 3.6 In the vertical plane loss of vertical alignment is evident in the upper levels the loss of vertical alignment increasing towards the right hand aspect. (Photographs 133, 134, 139, 140).

- 4.1 The two storey gable fronted Southern elevation is accessed at first floor level, the access road retained on a natural stone wall leading from Edenwood Lane up to the Southern corner of the original mill. Maximum wall height on the front elevation in the order of 4 metres. (Photographs 133, 135).

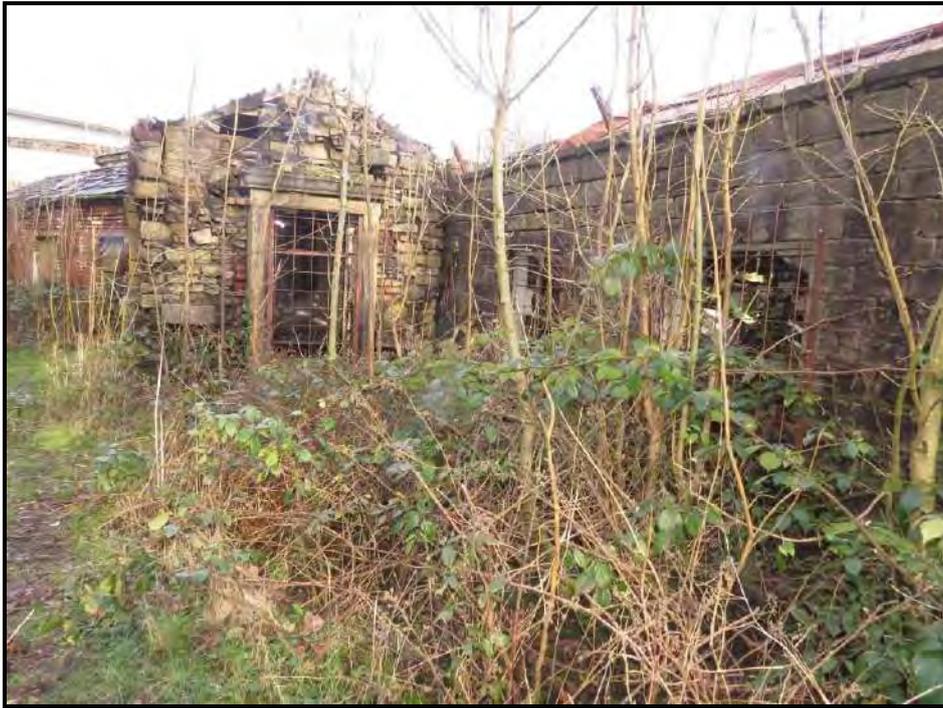
026 Gable door to Unit 5

- 7.1 A 3 metre wide gable doorway leads into the South Western elevation (main unit) located on the left hand rear North Western corner of the complex. (Photograph 026).

- 7.2 The original outer leaf of dressed stone has been removed from the doorway exposing the random inner wall construction. (Photographs 026, 027).
- 7.3 The external rear wall to the entrance of Unit 3 is completed in dressed stone incorporating three rectangular windows. Some of the stonework at wall plate level is missing. (Photograph 030).
- 7.4 From the entrance into the rear wall follows a skew alignment to the larger area of the main Unit towards the North East. (Photographs 028, 029).
- 7.5 The flank wall constructed in Accrington brick, both wall thicknesses circa 300mm, and incorporating 375mm x 100mm wide piers beneath a four course deep corbelled brickwork at eaves level. (Photographs 030, 031, 032).

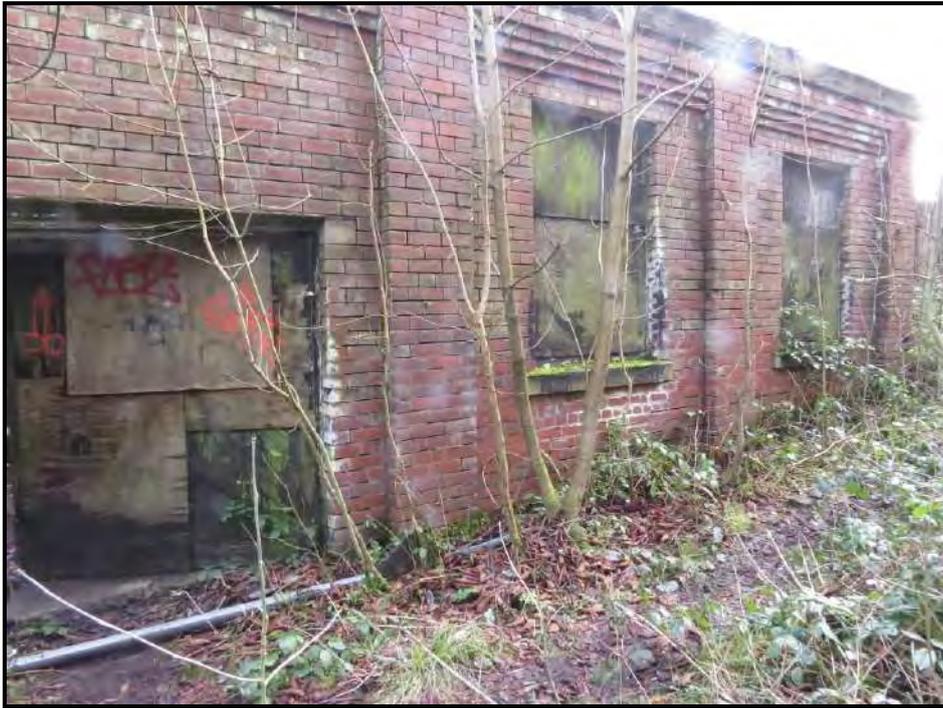
034 Unit 5 main rear wall, panel 1 - 2

- 7.5 The rear North Western wall to Unit 3 extends for a further 30 metres with a 2 metre square opening flanked on the right hand side (South West) by two Bays between brickwork piers incorporating rectangular windows on stone cills beneath a four course deep corbelled brickwork head. (Photographs 034, 035).

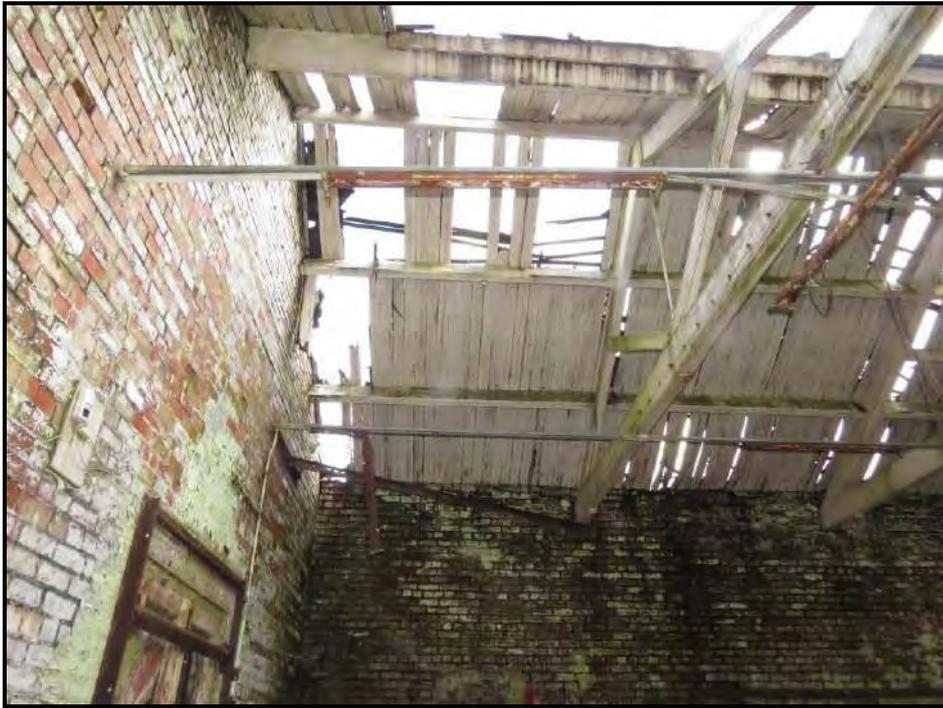
048 Collapsed roof South East slope

- 7.6 The window details are repeated to the left hand (North East) of the opening with four matching windows. (Photograph 036).
- 7.7 Internally the roof construction incorporates king post with a central steel tie on the largest spans whilst the smaller spans towards the entrance are of tied rafter configuration. (Photographs 037, 038, 039).
- 7.8 The roof is over-boarded but all the slates have been removed. (Photographs 179E, 041, 042, 048).

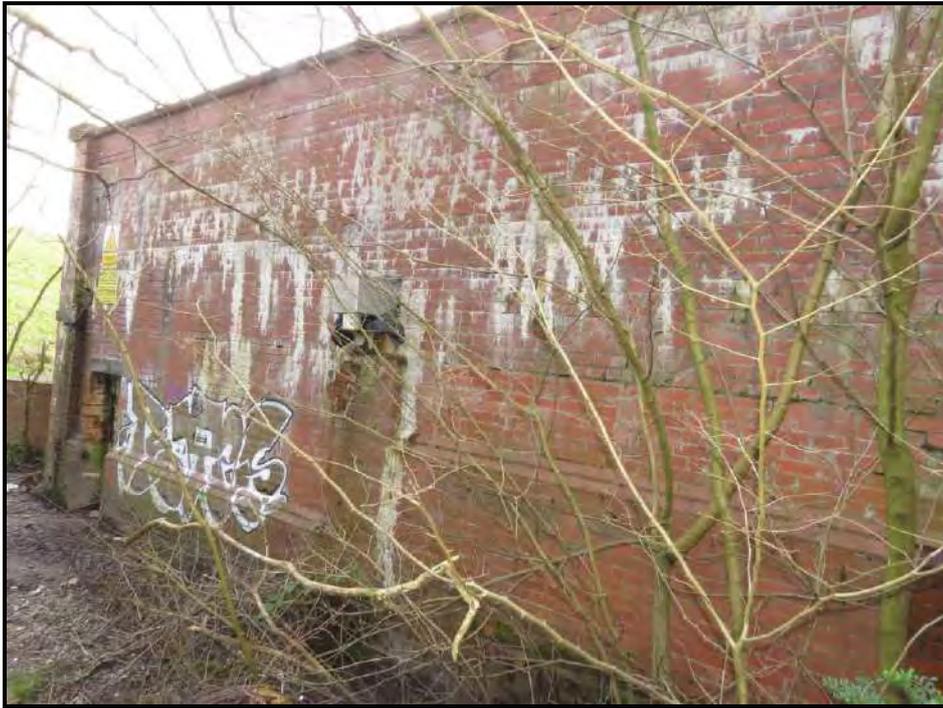
054 Flank wall, Units 9 - 10

- 9.2 Considerable efflorescence is evident to the brickwork but the vertical profile is reasonable. (Photographs 053, 054).

- 9.3 The eroded water channel on the Northern aspect is shown in photograph 055.
- 9.4 The rainwater hopper from the roof valley between Units 9 and 10 still exists against the flank wall, with a personnel door on the left hand North Eastern corner. (Photographs 054, 055).

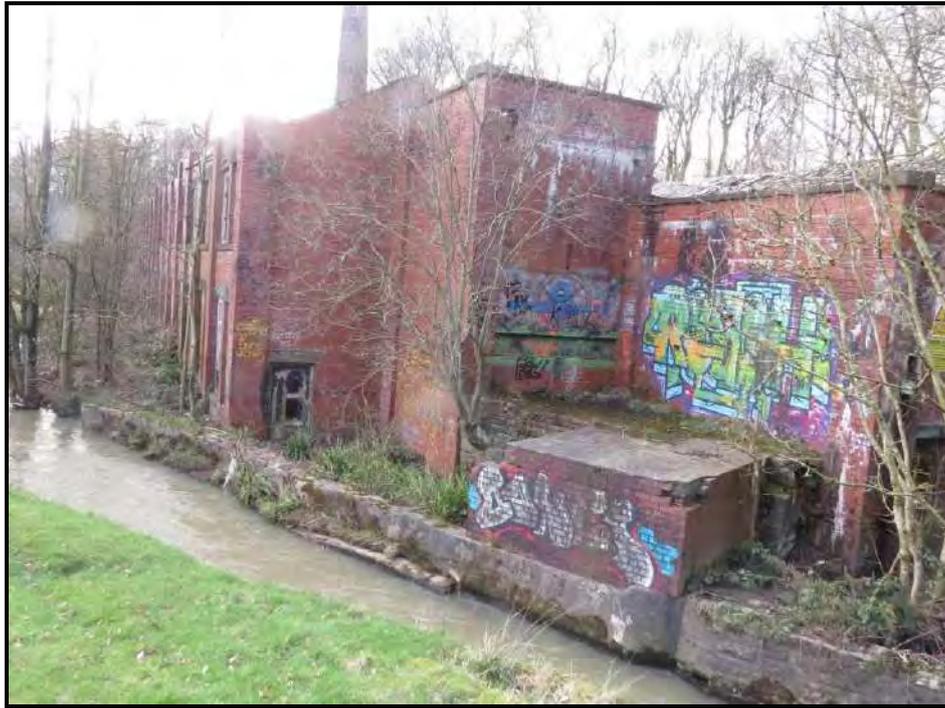
062 River Irwell and North East corner detail

- 10.1 The North Eastern corner of the main mill overlooks the River Irwell incorporating twin culvert discharge pipe diameters approximately 1.5 metres constructed in a head wall overlooking the downstream section. (Photographs 059, 060).
- 10.2 The North Eastern corner incorporates a 10 metre return wall from Unit 10 with a full height rectangular infill construction between the part gable elevation of Unit 8. (Photographs 061, 062, 063).

- 11.9 The North Eastern corner incorporates a rectangular infill structure between the North Eastern gable of Unit 11 and the South of the flank of Unit 10. (Photographs 062, 063).
- 11.10 On the left hand end of the front elevation (South West) there is a single storey brick faced outshoot spanning over the River Irwell extending for a width in the order of 4 metres incorporating 3 number window openings on the two flank walls, with double window openings with adjoining piers on the front South East aspect. (Photographs 0.73, 078, 086).

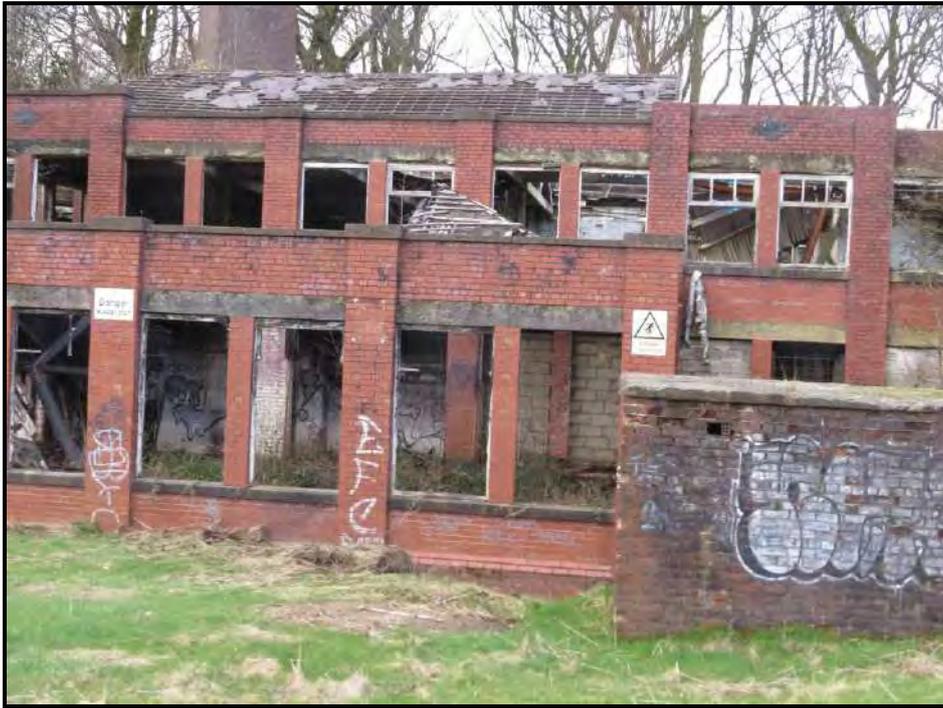
070 Bays 6 – 9, Unit 4

12.1 The window heads to Bay 5 follow a slight hogging profile with settlement towards the right hand and left hand aspect. Spalling to the concrete lintels is evident with exposure of the reinforcement, copings are missing at eaves level with spalling to the concrete window heads at first floor level. (Photographs 070, 072, 087, 088 089, 090, 091, 092).

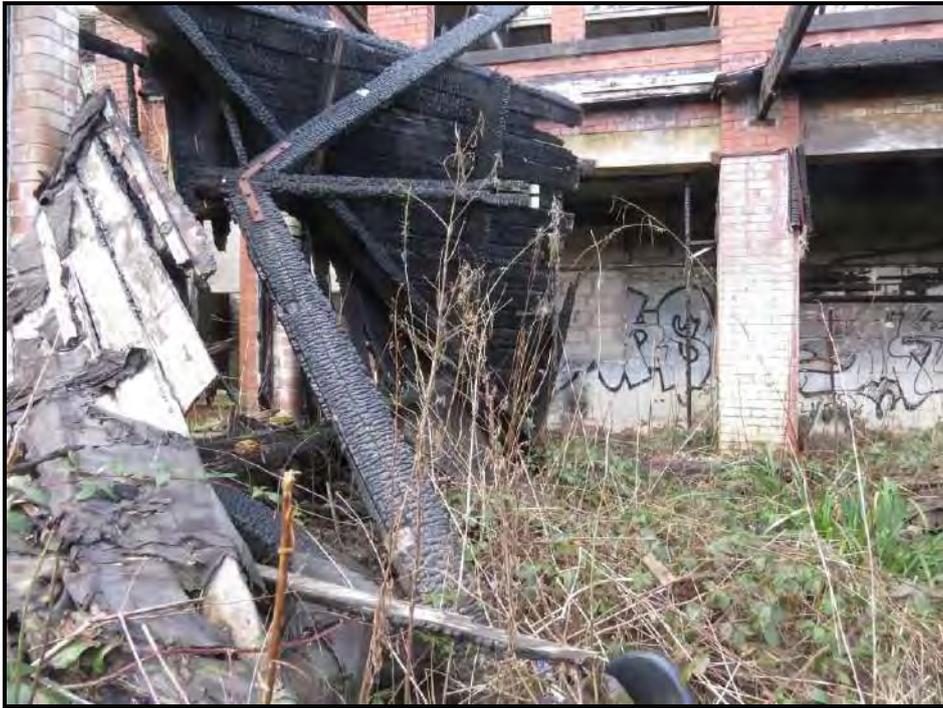
079 Interior River outshoot, Bays 2 - 3

- 11.11 Internally, the outshoot is overgrown with the remains of a fire damaged hip on the North Eastern side. (Photographs 078, 079, 080, 081, 082, 084, 085).

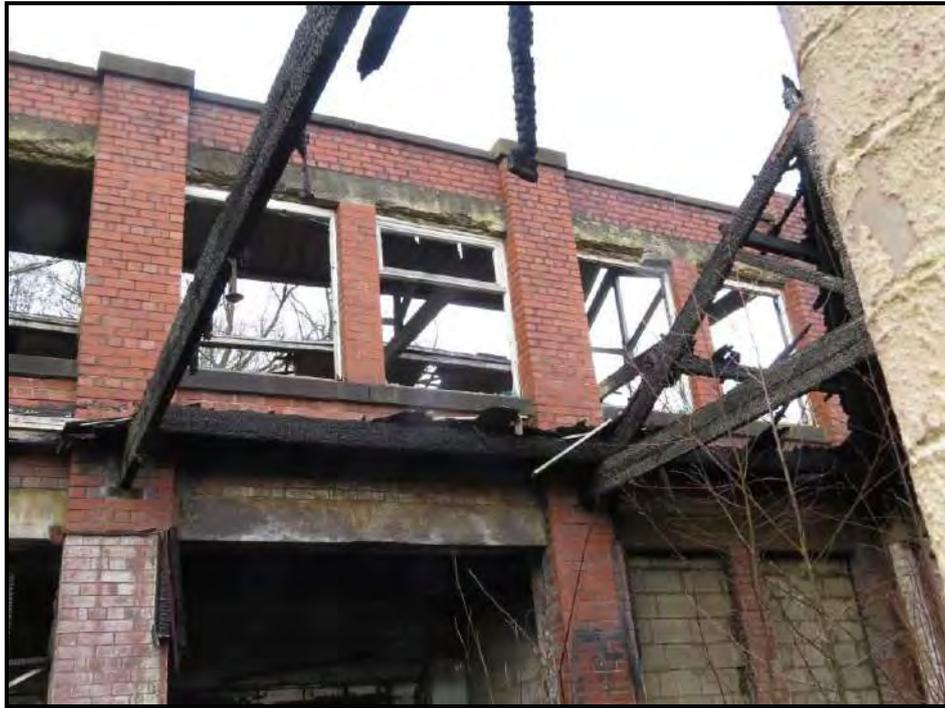
081 First floor main mill, Bays 3 – 4, Unit 4

- 11.12 At first floor level on the main unit (Unit 4) severe spalling is evident to all the concrete lintels at first floor level to Bays 1 – 4 with spalling of the concrete and exposure of the main reinforcement. (Photographs 081, 082, 083 – close up).

- 11.13 On the river frontage the first floor lintels to Bays 1 – 9 (18 number) are constructed in reinforced concrete and severe spalling is evident exposing the reinforcement and this will involve the replacement of the eighteen windows including wall replacement above the windows.

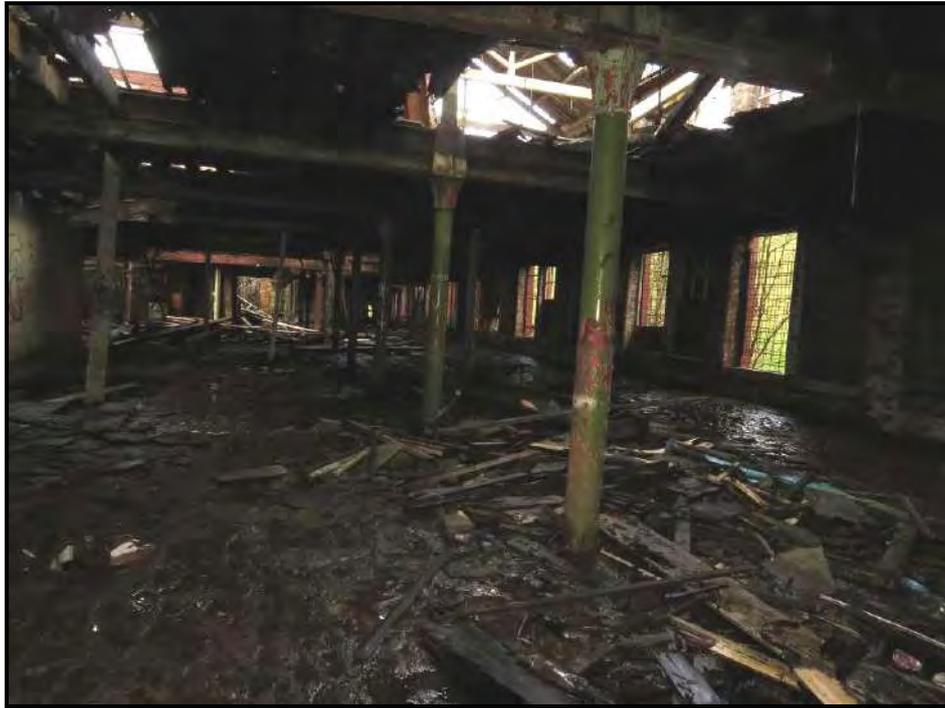
152 Unit 3, Bays 5 - 8

- 16.1 A limited inspection of the ground floor of Units 3 – 4 was made adjoining the windows to the river elevation around Bay 5 (outshoot) to Bay 9.
- 16.2 The section was one of the earlier constructions incorporating 150mm cast iron columns with additional steelwork column supports, and a mixture of timber and steel beams and timber floor joists.
- 16.3 Collapse of the upper floor and roof has occurred to several locations with the remains of the timber debris on the floor. (Photographs 148, 149, 150, 151, 152).

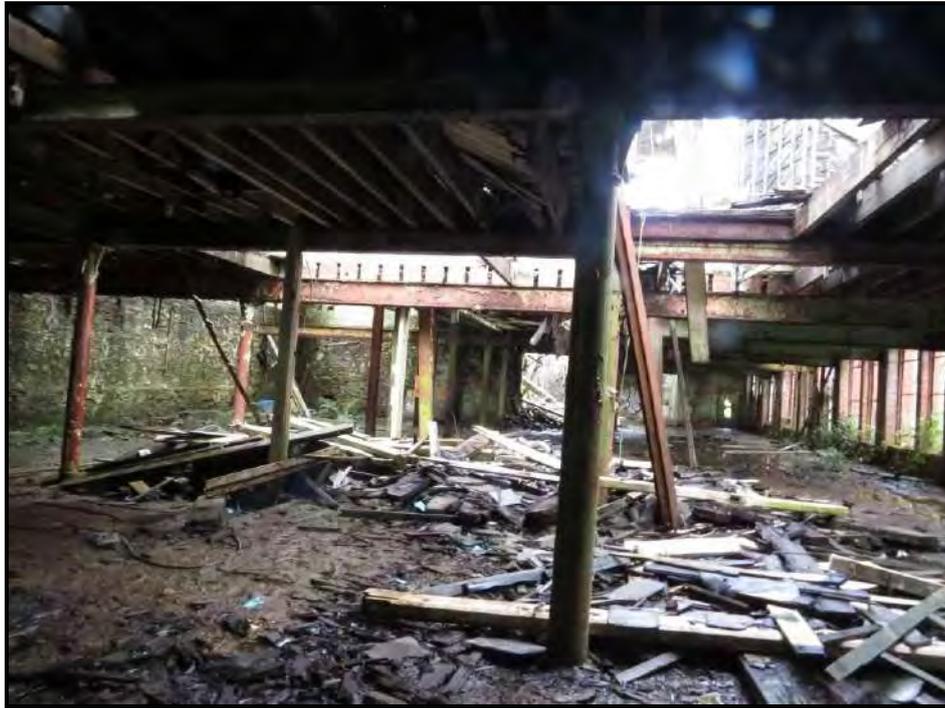
156 Centre floor and roof collapse

- 16.4 Towards the centre of the area more significant losses to the upper floor level are evident. (Photographs 156, 158, 159, 248, 249).
- 16.5 Access to the base of the chimney confirmed a satisfactory construction. (Photographs 242, 243).
- 16.6 On the cross wall between Units 3 – 2 is a 6 metre high wall extending to the roof valley level, the upper first floor level to Unit 2 supported on the lower retaining wall section and the remains of steelwork cross beams at first floor and lower roof level. (Photograph 252).

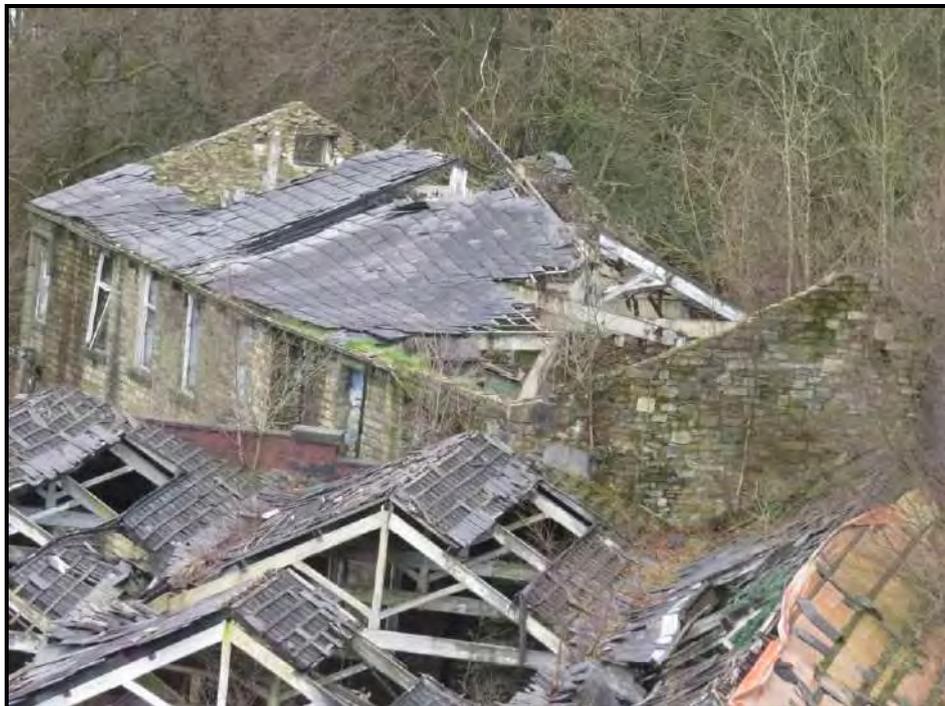
168 Units 1, 2, 3, and 4 damaged roof

- 5.3 The profile of the upper pike stonework to the original canopy is still present although the roof trusses and purlins have collapsed.
- 5.4 The central wall section incorporates 3 number windows at second floor level with a partial cover window to the first floor level. (Photographs 003, 004).
- 5.5 Internally the roof incorporates king post trusses approximately 3 metre centres. Collapse of the main roof slope has occurred over the majority of the roof area. (Photograph 168).

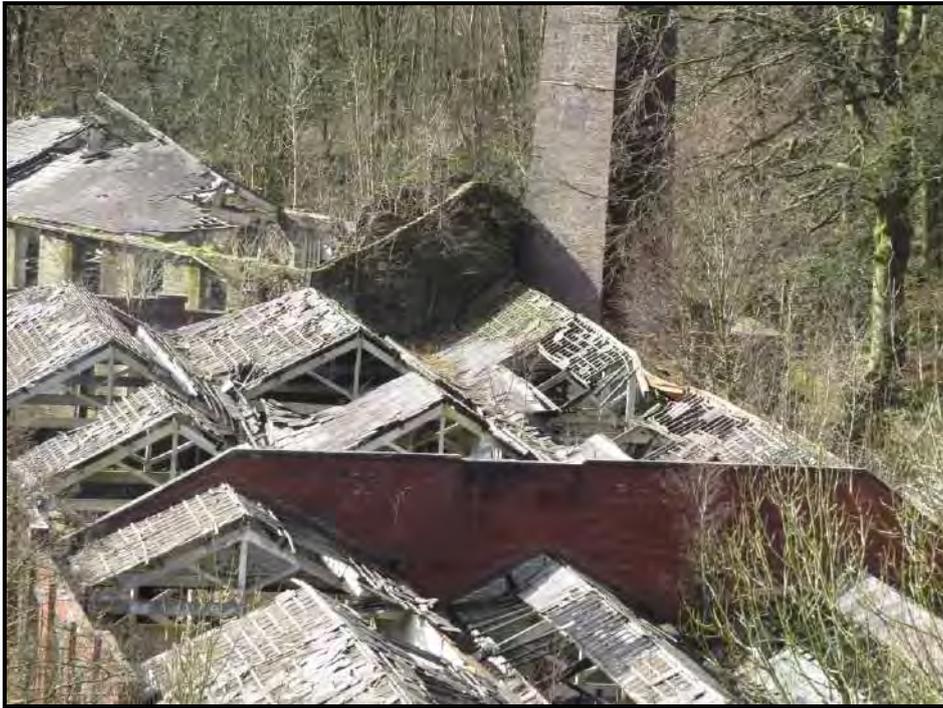
175 Central and North Eastern roofs

- 6.2 The horizontal and vertical profile of the wall is reasonable. (Photographs 019, 020, 021).
- 6.3 From the open windows the interior of Unit 2 can be observed with significant loss of roof structure and slating. (Photographs 022, 023, 175).

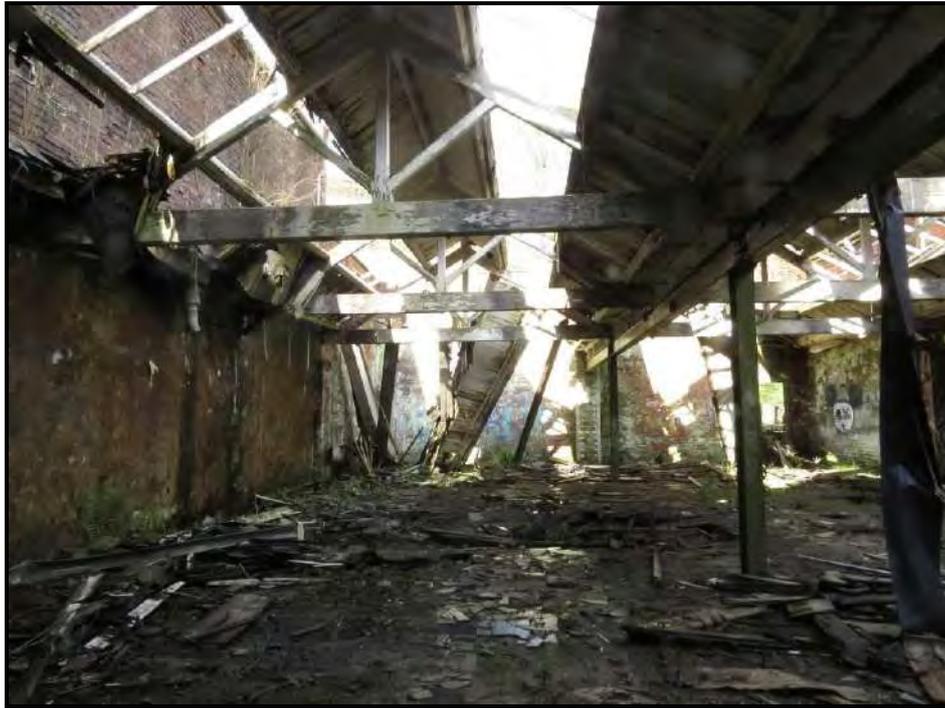
261 Units 3 – 7 roof collapse

- 16.7 Remains of the of the suspended timber floor joist construction are evident towards the East of Unit 3 and part Unit 4. (Photographs 253, 254, 255).
- 16.8 At ground floor level by the external (river wall) partial remains of the upper floor construction are present. (Photographs 256, 258).
- 16.9 Upper floor and roof collapse has occurred towards the North East end of Units 3 and 4. (Photographs 259, 260, 261, 262, 263, 264, 265, 266, 267, 268).

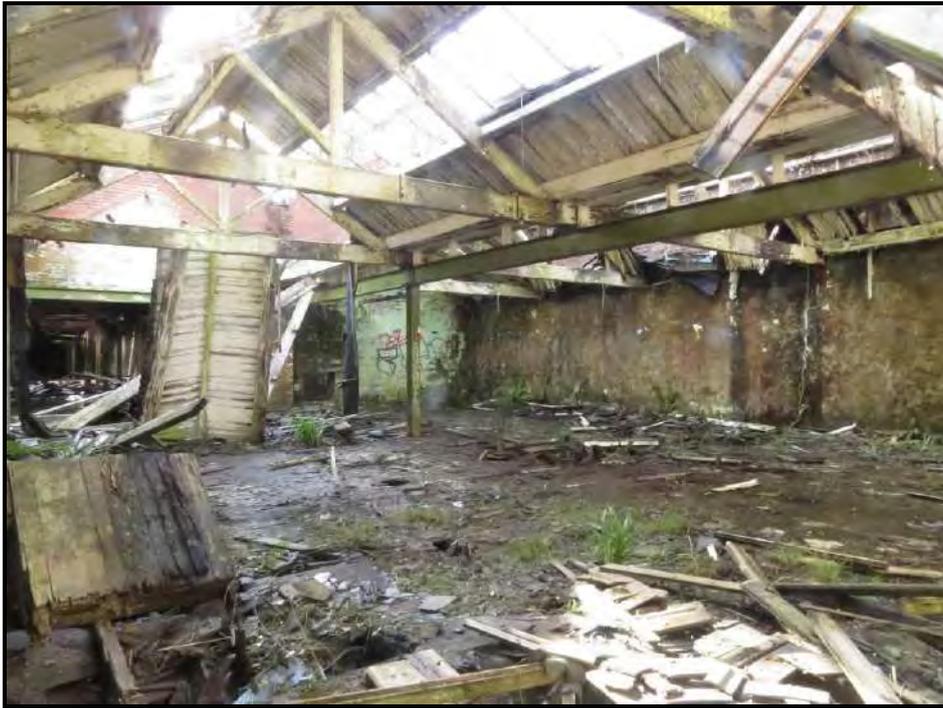
271 Units 8 – 10 North West external wall

- 16.10 In the central section Units 7 – 10 roof debris is evident. (Photographs 271, 272, 273).
- 16.11 Photograph 179 shows the general poor condition of the roof structures to the whole of the mill complex.
