**Action 19.4: Appendix 5 – WML Consulting Preliminary Land
Stability Assessment Clod Lane, Haslingden (Appendices 5 to 7)**

APPENDIX 05
Coal Authority Report

Archive Reports

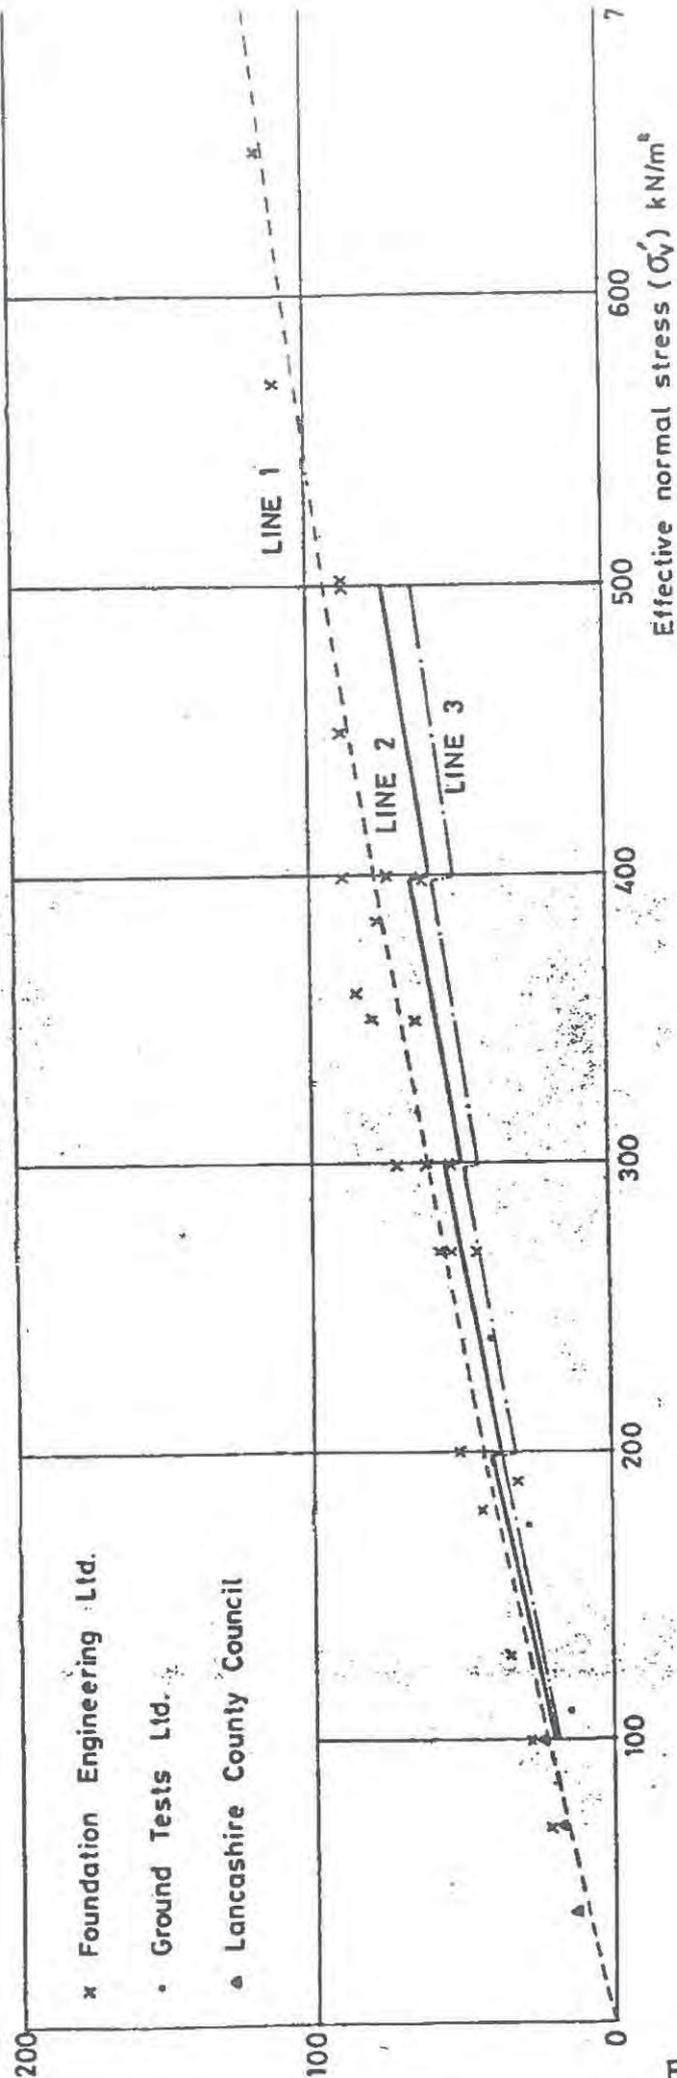
FIG. 2

SUMMARY OF RESIDUAL SHEAR BOX TEST RESULTS FOR HIGH PLASTICITY MATERIALS.

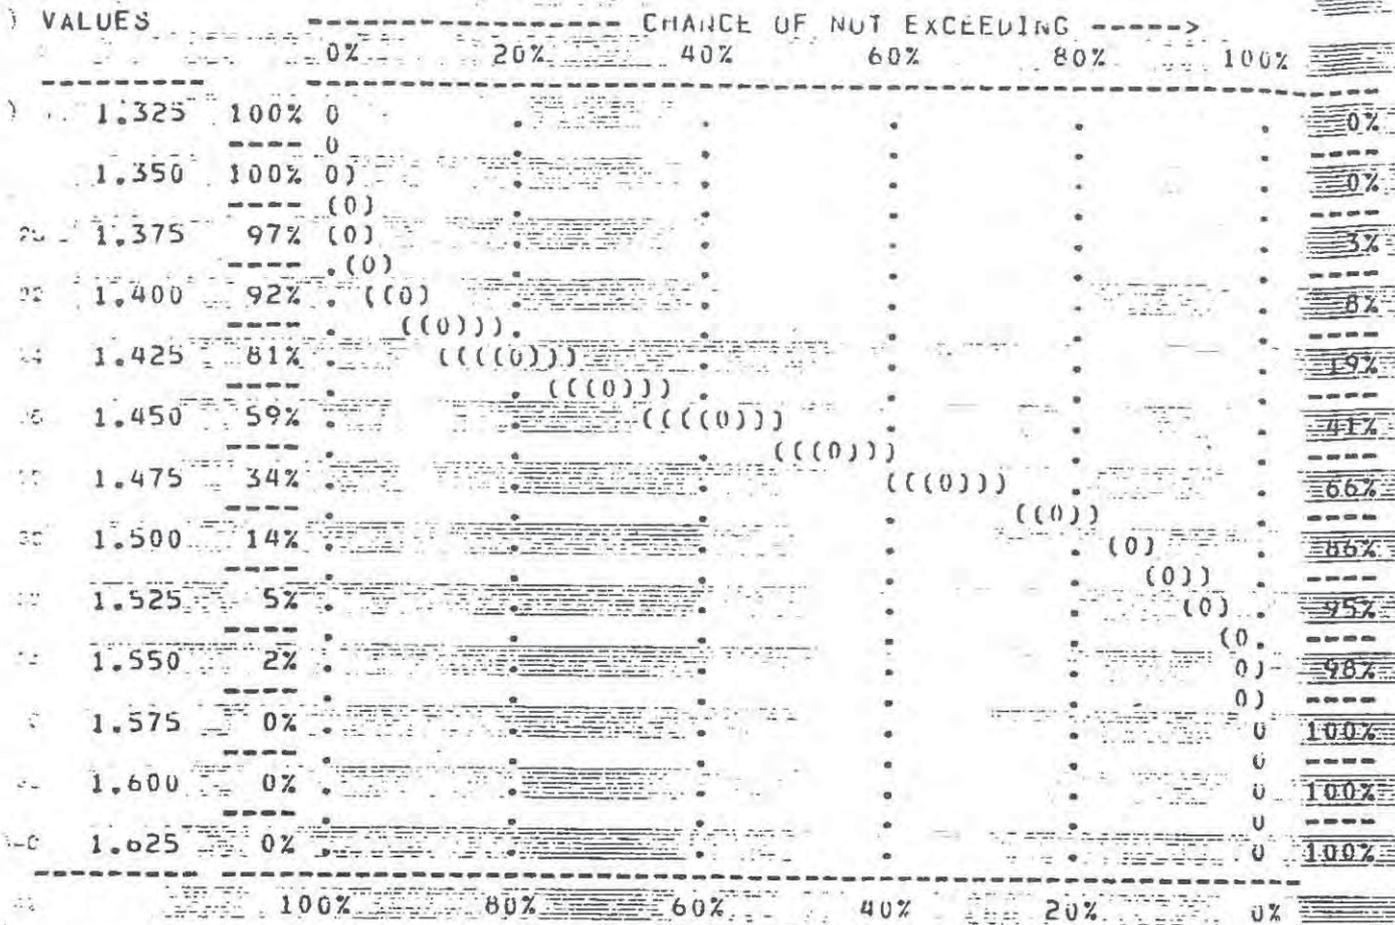
FIG. 6a

PROBABILITY DISTRIBUTION DERIVED FROM 500 SIMULATIONS

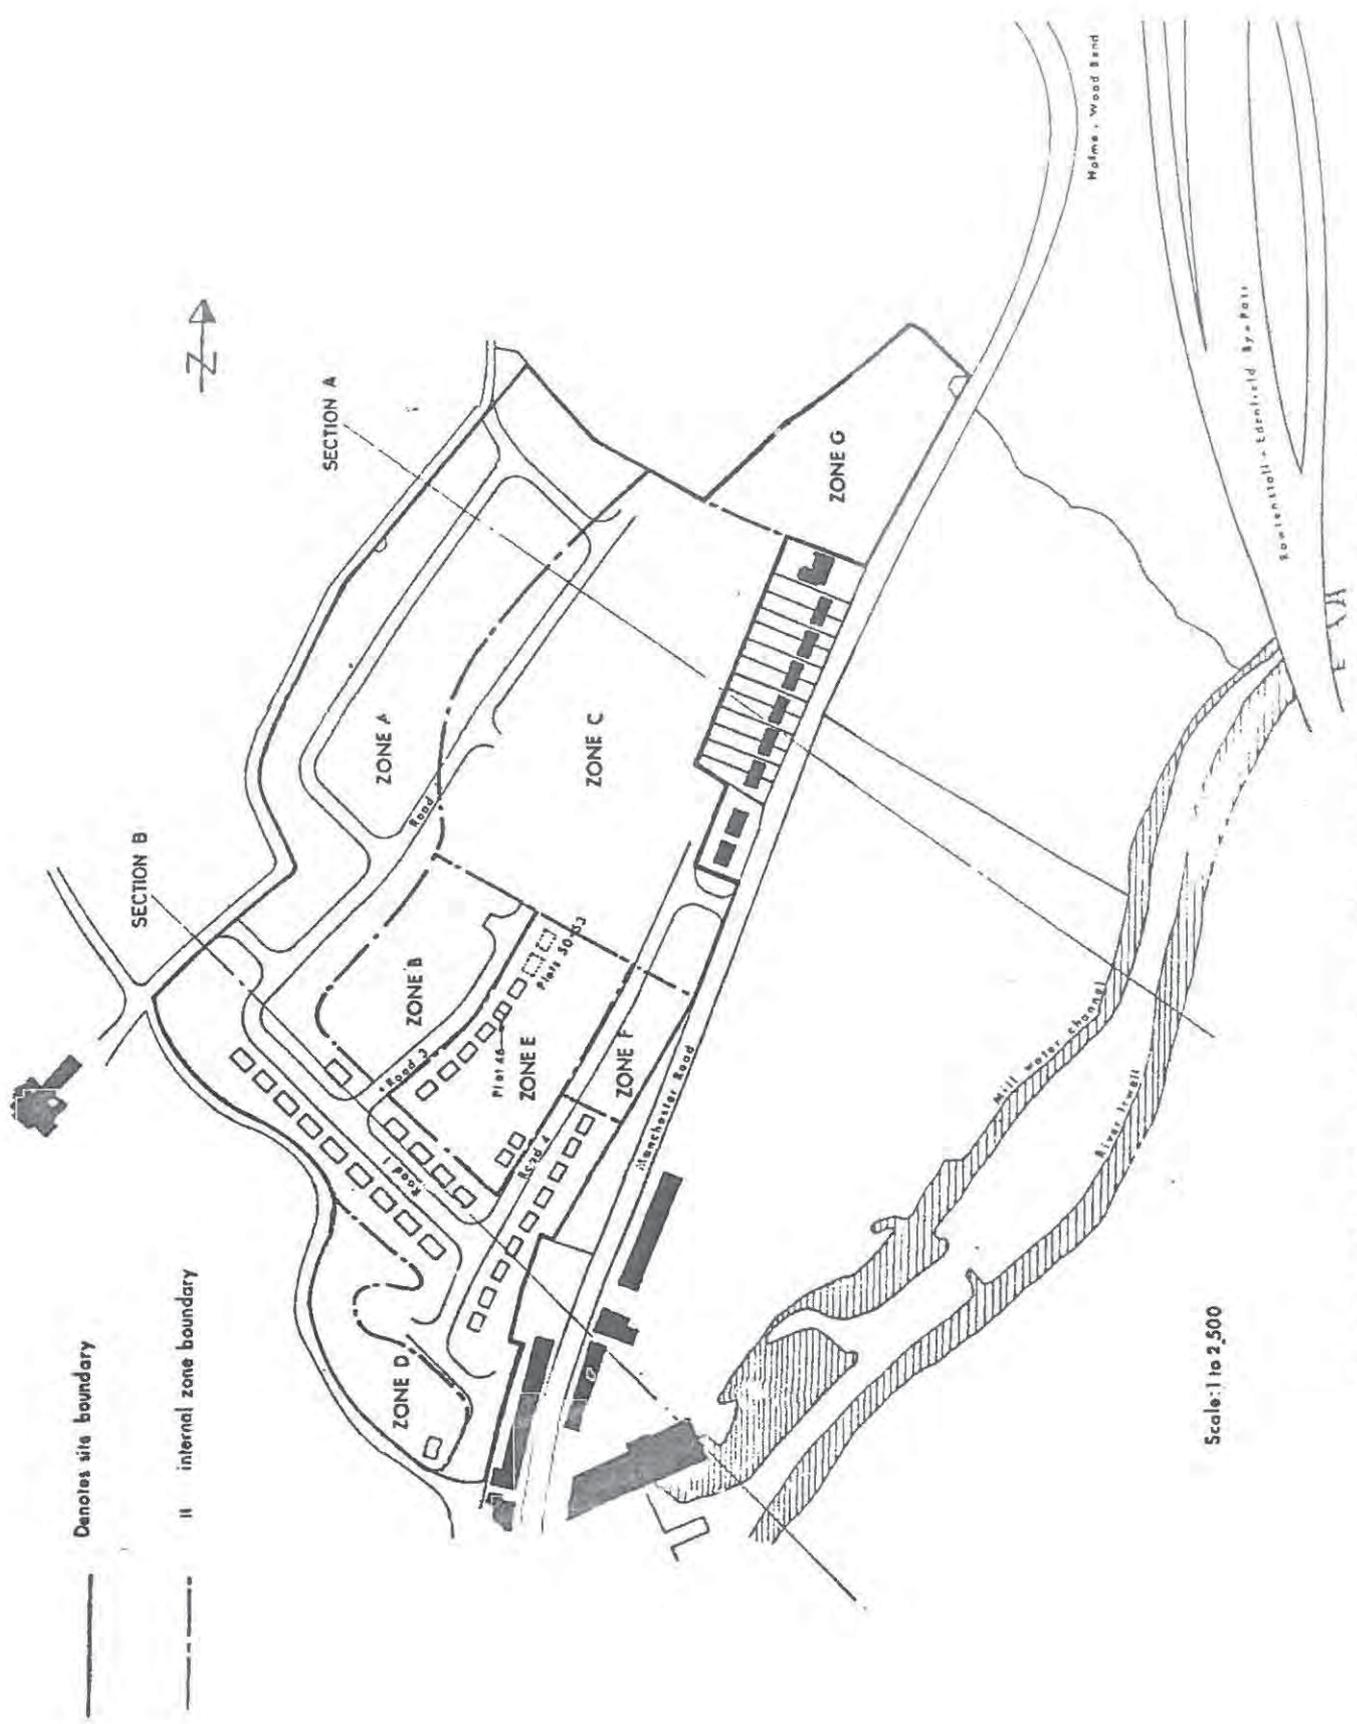
FIG.7

ZONING OF SITE FOR DEVELOPMENT (AFTER 1978 REPORT - FIG.18)

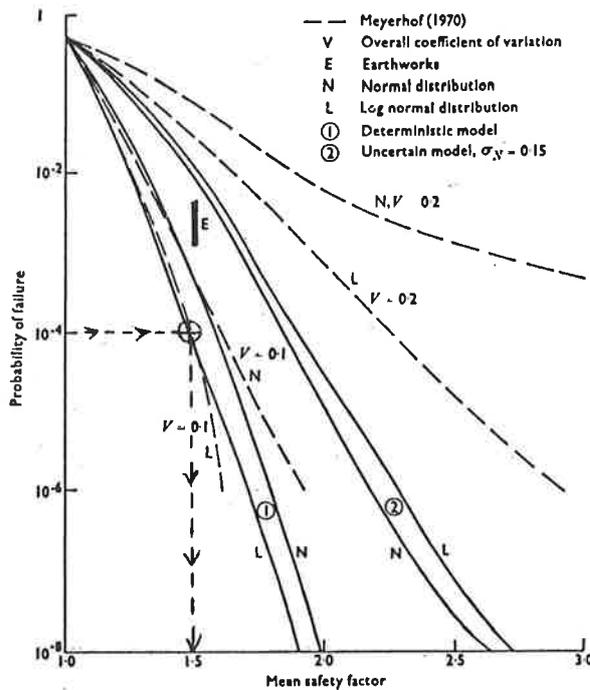
Fig. 16. Relationship between safety factor and probability of failure

It is interesting to note that a recent analysis of this kind has related the mechanistic value of factor of safety to risk (Meyerhoff 1970) and (Alonso 1976). See Fig.16 below

From this it can be seen that for the level of risk quoted by Allott and Lomax (i.e. $< 10^{-4}$) the mean value of the factor of safety is 1.5.
