Fallbarn

Conservation Area Appraisal

March 2008

Rossendale *aliye*
BOROUGH COUNCIL

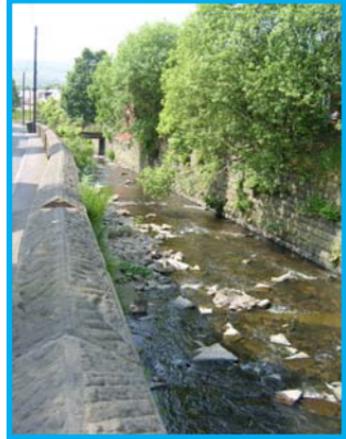
Figure 3: River and River Walls

Views of the group are fairly open from the riverside and there are also glimpses from Rawtenstall and up and down the valley. The two terraces form a gateway to the inner/upper part of the group. The bridge across the river runs close to this entrance. The river and the river wall (*Fig 3*) are an important part of the setting of the buildings, and the

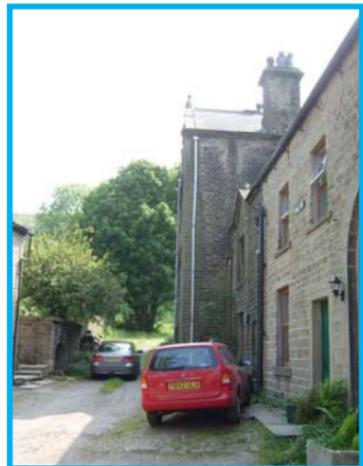
Figure 4: Cherry Tree House & Fall Barn

These stand as two building groups, Rose Cottage and the former barn being earlier than Cherry Tree House. There is a tight track leading into the group and up to the main house. Cherry Tree House is the tallest building in the group and sits at the top of the track. It dominates the settlement (*Figs 4 and 5*). Behind and around are fields of scrubby pasture which form enclosure through the steep hillside but which also bring shadow in winter.

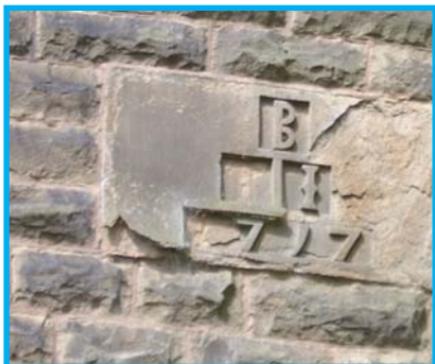
Figure 6: Date stone on Cherry Tree House

Only parts now remain of the Dam Top/Fallbarn village. Cherry Tree House/3 and 5 Dam Top remain and are vacant. At the time of its building the house was attached to the barn (ie Fall Barn, datestone 1846) and Cherry Tree House incorporates a date stone

1717 (*Fig 6*), which may have been from the farmhouse (or possibly a copy of the original date stone) it may have replaced.

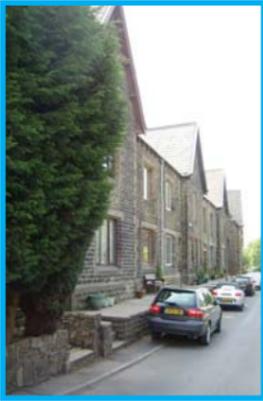
Figure 7: Back to back housing on Fallbarn Road

It is known that Richard Williams also designed Alma Villas, 1851, referred to as a group of picturesque workers houses off Fallbarn Road. These are shown on the 19th century maps as a long back-to-back terrace curving along Fallbarn Road, and appear to be of the same scale as Albert Terrace (*Fig 7*), but were demolished during the first half of the 20th century.

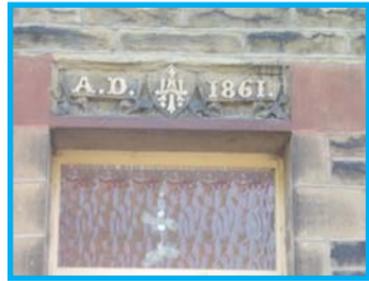
Figure 8: 1861 date stone

The front elevation of Albert Terrace has a date stone 1861 (*Fig 8*) and initials either IAH or IHA, linked to either the Hardman or Ashworth families. It could be speculated that these terraces were part of Hardman's village designed by Williams but no direct evidence of this has so far been found.

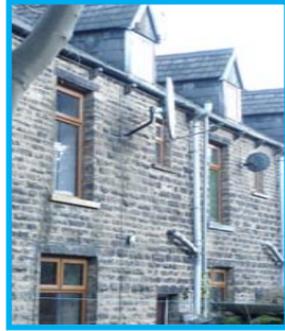
Figure 9: Albert Terrace

The area is a very tight group of buildings centred at the meeting of Fallbarn Road and the track leading down from Cherry Tree House. Merry Trees and Albert Terrace form the main public view of the group standing tall each side of the entrance track and facing the River Irwell in its stone walled cutting. Both are 2/3 storey bold Victorian properties built in roughly faced stone with tall and decorated slate covered roofs. Each has a stone plinth and railings to set them above road level. Merry Trees is finer in detail and decoration than Albert Terrace but the latter is much deeper in its footprint and is visually strong (*Fig 9*). Merry Trees has good stone detailing around windows and doors, tall chimneys, and has the remains of ornamental gothic window frames.

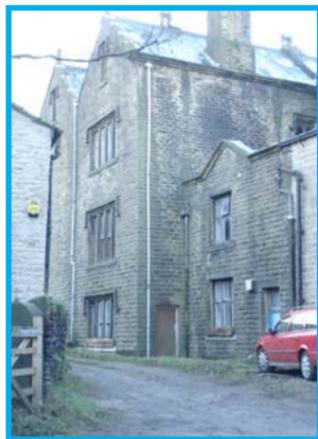
Figure 13: Cherry Tree House

However, it is Cherry Tree House which is the dominant force in the group (*Figs 13 and 14*). It stands high above the barn, ranging from two to four storeys. It is built from pitched faced coursed stone with a steeply pitched slate roof. It is an austere copy of a 17th century mansion, built to a design common in the local area at that time.

stone detailing is from the 17th century; including hood mouldings, stone window tracery, arches and lintels, cornices and verges; but being from the mid 19th century it is still sharp and not eroded. The Dam Top cottages provide the building bridge between the height of Cherry Tree House and the two storey Fall Barn.

2. That efforts should be made to save and use Cherry Tree House and 3 to 5 Dam Top, ideally through working with the current owner, but also through all means open to the Council. It is probable that this may only be achieved through the subdivision of the property and possibly supported by the residential development of the land associated with the house.

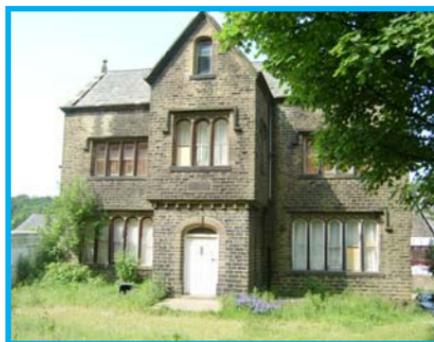
Figure 14: Cherry Tree House Front Elevation

Parts of the house are of mixed heights, detailing, and jumbled rooflines. The front is symmetrical with a central 3 storey porch and mullioned windows to each side. The

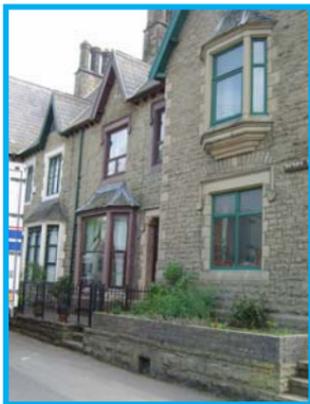
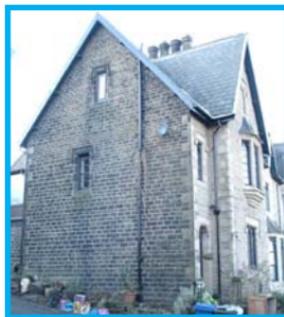
Figure 15: Merry Trees

Merry Trees is a terrace of two and three storeys built in coursed pitched faced stone with a steeply sloping decorated slate roof (Figs 15 and 16). The terrace stands on a stone platform raised above road level and topped by large stone flags (Fig 17).

platform. The railings on part of the platform may not be original. The three storey elements project at each end on the front elevation and have tall lateral gables and top floor windows.

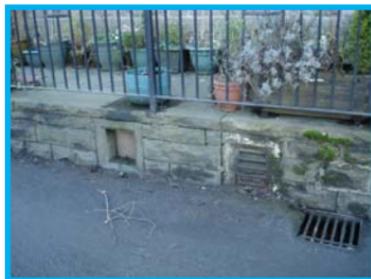
Figure 17: Stone Platform

This has been constructed to take up the change in levels and appears to accommodate cellars in the front part. There are small stone framed doors/coal holes in the front of the

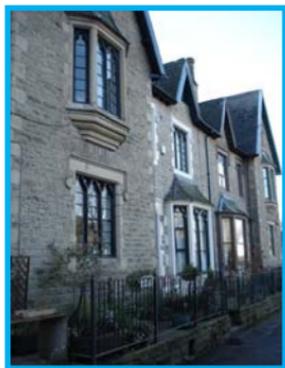
Figure 18: Numbers 53 and 55 Merry Trees

There are dressed stone details at openings and corners with splayed edges and reveals. Openings have stone decoration and hood moulds with plain shield labels. There are splendid bay and oriel windows with canopies in slate and lead. The bay windows have rough stone arches visible. Numbers 53 and 55 (*Fig 18*) have largely retained the fine window frames, which have deep mouldings and triple

arched tops. There is a slightly projecting plinth at the base of the main walls.

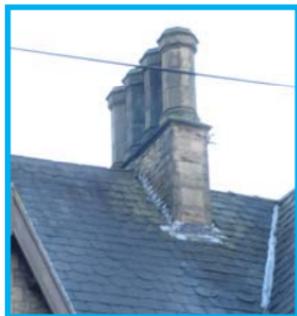
Figure 19: Chimney pots on Merry Trees

There are single, 4 pot (*Fig 19*), and double, 8 pot, chimney stacks in dressed stone with coursed moulded stone pots and drip moulds. Timber barge boards remain but some original window styles have been altered to much plainer and simpler replacements, which have an odd and unfortunate appearance. This is the main alteration from the original design. None are currently in uPVC. The quality of the stone detailing is maintained on the gable elevations.

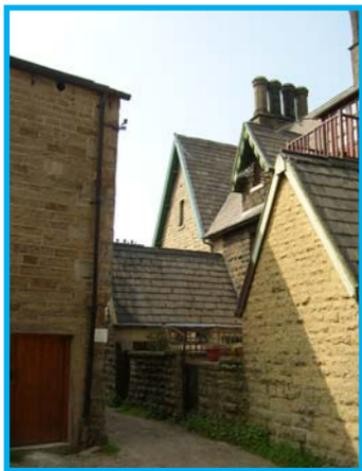
Figure 20: Rear of Merry Trees

The back of the terrace is the product of a higher quality of design than is normally the case with rear elevations. Again there are big lateral gables and tall roof pitches with strong tallish outshots at ground level with double pitched roofs (Fig 20). Window openings are generally plainer. There is a modern timber dormer with French windows and a balustrade above the main eaves level, and an upper level conservatory at one end.

This is a significant and high quality architect designed terrace worthy of protection and restoration.

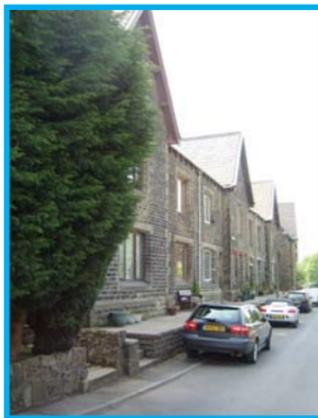
Figure 21: Albert Terrace

(incorporating 57 to 69 Fall Barn Road) (Fig 21) is a two and three storey high stone terrace built in a robust and substantial style and longer than Merry Trees, having an additional central lateral bay and gable.

It is also of pitched face coursed stone with some dressed stone details, and sitting on an uncluttered stone raised platform, but is

in a much plainer and utilitarian style than Merry Trees. This suggests a later copy by a different designer. It has much of the form and scale of its neighbour though has greater depth (*Fig 22*), giving space for true back-to-back accommodation,

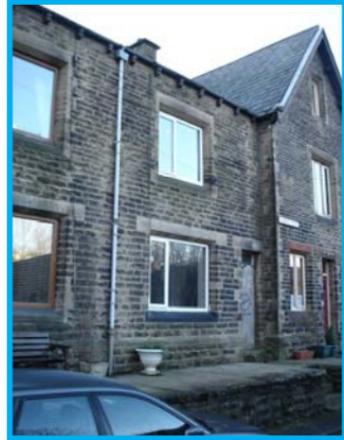
Figure 23: Window frames and
doors in Albert Terrace

Window frames and doors are much altered and are of design and materials out of character with the original design of the building (*Fig 23*).

The Council should provide design guidance to assist residents with the existing and any additional controls, and the need to use traditional details and materials.

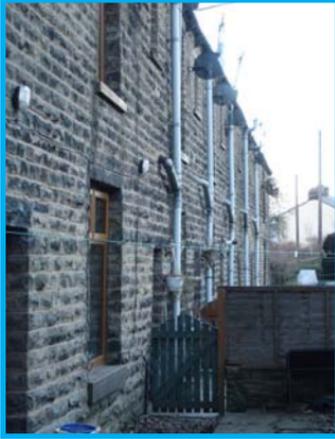
Figure 24: Rear of Albert Terrace

The rear elevation is much plainer with dressed stone only for the lintels and window sills. Each property has a simple dormer window in the roof giving three-storey accommodation. The rear is a busy elevation and has a regular pattern of windows, doors, pipework, aerials and satellite dishes (*Fig 24*).

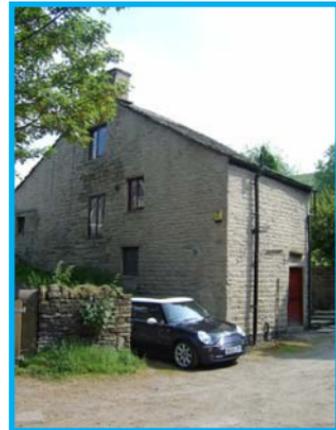
Figure 25: Rose Cottage

Rose Cottage (*Fig 25*) is a detached stone building with a stone flag roof and a chimney stack with no pots. Some external walls are altered and all have been painted. The walls are partially in narrow watershot coursing, common in the 18th and early 19th century, and some parts appear to be earlier and others altered.

The building is set into the hillside. It is a slightly odd shape in being deep at right-angles to the roof ridge, and therefore with large gables. The gables have plain cement roof verges and there are simple small windows, though they are set in an unusual pattern. All this suggests that Rose Cottage was, some time ago, a different shape or part of a larger structure.

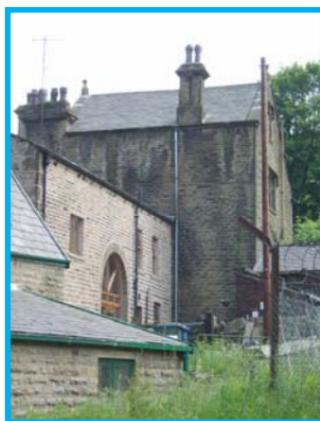
Figure 27: Fall Barn

The barn and number 1 are also built in watershot coursed stone with a slate roof containing rooflights and a new slender chimney stack.

The building is a simple rectangle of two storeys with the barn door openings remaining each with a semi-circular arch top and large cornerstones at the returns. The elevation facing Rose Cottage also has two stone framed doorways and three window openings each with stone lintels and sills. The elevation to the riding school is the same but for an additional window, which has a central stone mullion, a feature common towards the end of the 18th or early 19th century. Timber effect uPVC frames now sit in the openings. In front of the building is the remains of a stone flag hardstanding with a small cobbled road.

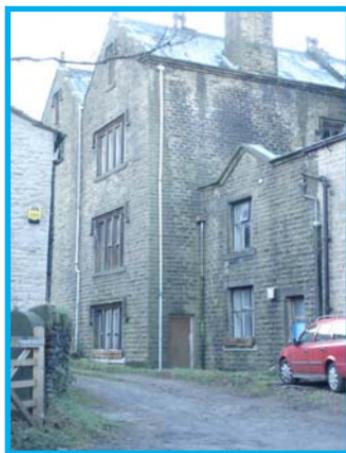
Figure 28: 3 to 5 Dam Top

Cherry Tree House and 3 to 5 Dam Top (Figs 28 and 29) are the most imposing structures in the group. In 2002 they were considered for statutory protection through the list of buildings of special architectural or

The complex is built of regularly coursed local sandstone with ashlar dressings and a slated roof.

Its steeply-pitched roof and full height gabled porch have stone copings and ball finials, and the multi-light stone mullioned windows, those to the ground floor with segmental arches to the lights, and all mouldings with hood moulds with label stops.

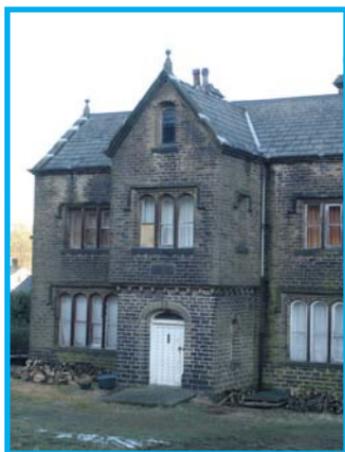
Figure 29: Cherry Tree House

The window openings have sash frames without glazing bars, and the main doorway, set below a slightly jettied upper floor of the projecting porch, has a planked and studied door. The house is of double pile form, both parts

of two storeys with attics, together with a lower range of two storeys. This robustly-detailed building is a good example of its type. This example is a competent but not exceptional design. The building is clearly an important component of its locality, and of local historic interest.

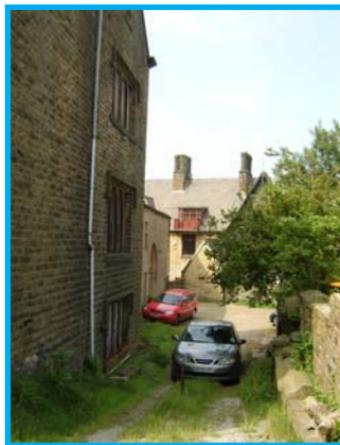
Figure 30: Numbers 3 and 5 Dam Top

Looking up from between Albert Terrace and Merry trees the four storey gables dominate the view, with Rose Cottage more in the foreground. Numbers 3 and 5 (*Fig 30*) are less imposing, being the same height as Fall Barn and with a strong coping line, with parapet and pediment. Beyond the buildings is a largish area of open ground recently (as seen in December 2007) cleared of trees and shrubs. The land rises away from the buildings and gives an open setting to the main front elevation of the house. The boundaries are marked by squared stone random coursed walls with strong stone copings and post and rail fences. The wall has failed in a number of locations. The land rises again beyond the furthest boundary fence and the setting is formed by a group of trees and the hillside (*Fig 31*).

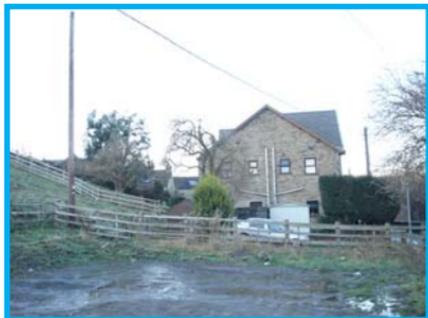
Figure 32: Riding School Car Park

immediately to the east of the buildings, and the riding school is to the west (*Fig 32*).

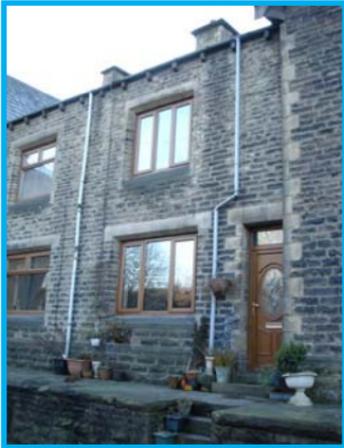
Figure 36: Examples of Window Alteration

4. The nature of some detailed alterations and changes to all occupied properties that have removed original features or used out of character replacements. The most severe of these is the result of window alteration (*Fig.36*).

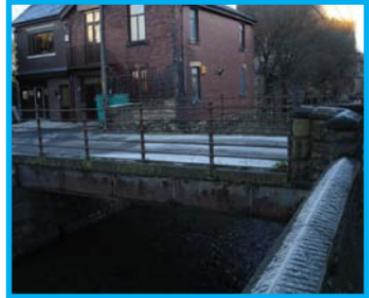
Figure 37: Pedestrian Bridge

5. The poor appearance of the pedestrian bridge over the river (*Fig. 37*).

5. The river bridge requires refurbishment and the cast iron balustrade repainting. It may be necessary for a health and safety check to be undertaken. Ownership and responsibilities will need to be investigated.

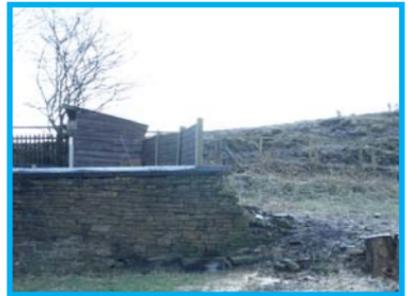
Figure 38: Poor condition of boundary wall

6. The condition of some boundary walls (*Fig.38*).

8. Stone walls, gateposts and features are important to the area's character. They should not be removed or demolished and if in poor condition should be repaired.

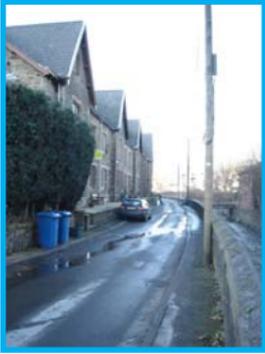
Figure 39: Impact of street lighting

7. The impact of street lighting and BT poles on the appearance of the street (*Fig.39*).

6. When the repair or renewal of street lighting is to be undertaken consideration should be given to a more appropriate design of new column for the area.

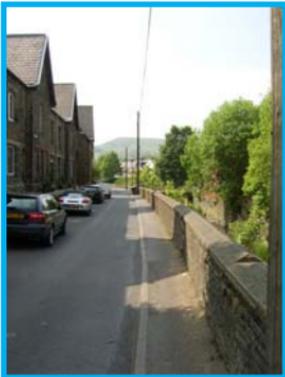
Figure 40: Difficulty in finding parking space for residents

8. Apparent difficulty in finding parking space for residents (*Fig.40*).

4. There appears to be a lack of parking space in the area, together with a lack of bin storage. These are both practical issues which impact on the area's character. Opportunities for resolving these two issues need investigation, possibly in the context of land adjacent to Fallbarn Road to the east.

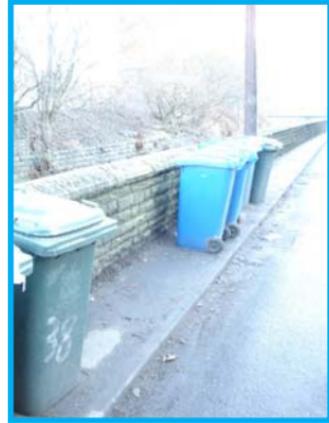
Figure 41: Lack of Storage for residents bins

9. The lack of storage for the resident's bins (*Fig.41*).
