GOODSHAWFOLD CONSERVATION AREA

CHARACTER APPRAISAL AND MANAGEMENT PROPOSALS PLAN

ADOPTED FOR DEVELOPMENT CONTROL PURPOSES FROM 1st SEPTEMBER 2011

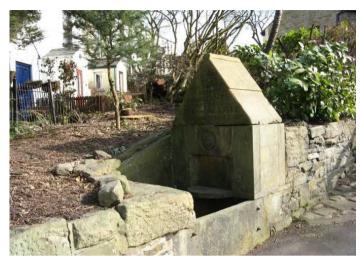
The former village water supply once emerged (it is now dry) from a carved head in a stone plinth erected in 1855. The triangular-shaped coping is elegantly carved: "Erected by Subscription by the Inhabitants and the Exors of the LATE John Hargreaves Esq. A D 1855".

Beneath the coping is the carved head with a stone shelf below for buckets. The well was reset and repaired in 1978, as recorded by further lettering below.

Detail of the Spewing Duck spring

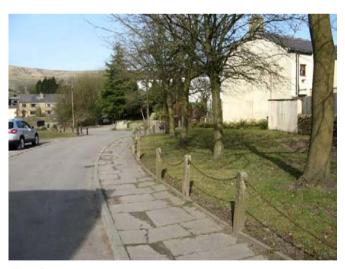
The Green

- The Green the existing boundary is in poor condition and is made up from short concrete bollards connected by chains;
- The setting of the Spewing Duck and the spring itself both need improvement;
- The poor condition of the historic bridge over the Limy Water:

The removal of the existing concrete bollards on The Green and their replacement with wrought iron railings, or perhaps cast iron bollards, would be a suitable enhancement, although care needs to be taken due to potential lorry over-run. Improved litter bin provision would be welcome.

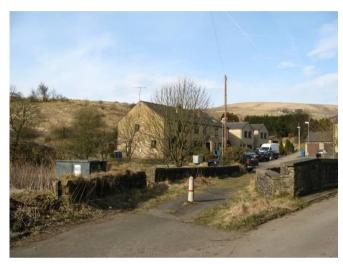
The historic bridge over the Limy Water is also in need of some repairs, including re-pointing using the correct lime mortar. Rubbish on the adjoining river banks should also be cleared away, and the trees and other planting maintained. The bollard on the bridge could be replaced with a traditional cast iron bollard, which would be more appropriate, and the bridge could be repaved using recycled sandstone setts. The modern substation or telemetry unit next to the river, although not much more than a cupboard, would benefit from repositioning in a less conspicuous location.

Bridge over the Limy Water

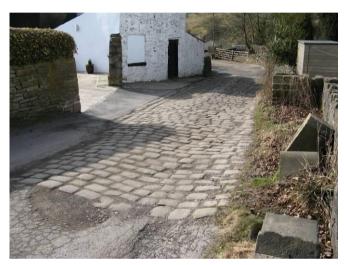
It has been noted that areas of sandstone flags and setts remain in the Conservation Area and these will have to be carefully maintained and protected from damage. This will generally be the responsibility of the County Council. If trenching is required, the statutory undertakers must reinstate the paving to its exact appearance upon completion of the work. In the long term, the installation of further areas of traditional paving would be advantageous, including the replacement of the concrete kerbs to the stone pavement next to The Green with sandstone or granite kerbing.

Traditional paving in Goodshawfold
