FALLBARN CONSERVATION AREA

CHARACTER APPRAISAL AND MANAGEMENT PROPOSALS PLAN

ADOPTED FOR DEVELOPMENT CONTROL PURPOSES FROM 27thTH OCTOBER 2011

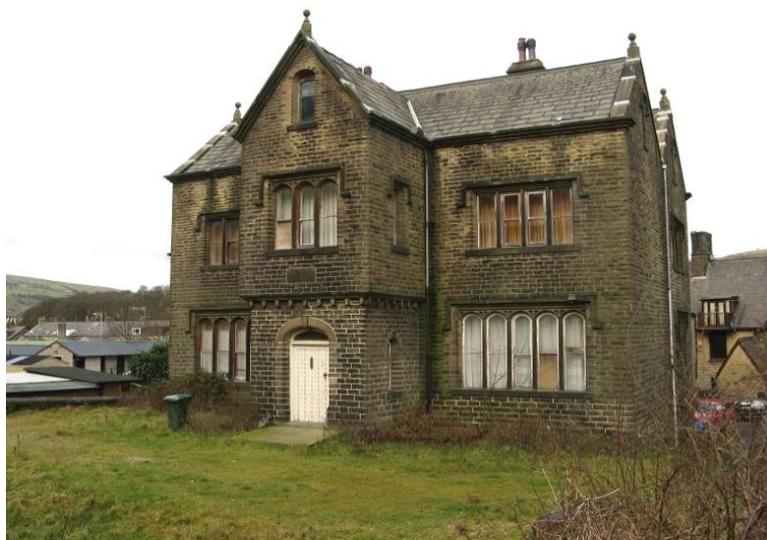
A narrow track leads into the group and up to Cherry Tree House. This is the tallest building in the group and sits at the top of this track, dominating the settlement. Behind and around are fields of scrubby pasture on the rising hillside which provide a sense of enclosure though they also bring shadow in winter. Post and rail fences and copses of trees and shrubs are also typical in the area.

Cherry Tree House is the dominant building in the group. It stands high above the barn, ranging from two to four storeys, and constructed from pitched faced coursed stone with a steeply pitched slate roof. Nos. 3 and 5 Dam Top provide the building bridge between the height of Cherry Tree House and the two storey Fallbarn Barn, and have similar though less striking details as Cherry Tree House. All of these buildings – Cherry Tree House and Nos. 3 and 5 Dam Top appear to be vacant and are in very poor condition.

The 2007 Character Appraisal for the Conservation Area noted that Nos. 3 and 5 Dam Top and Cherry Tree House, which are in the same ownership, are all vacant and in poor condition. Since then, the buildings have been left to deteriorate further and no acceptable proposals for their preservation or for redeveloping the site have been received by the Borough Council. The poor condition of these buildings not only (potentially) affects the fabric of the buildings, but is causing blight on the surrounding properties and generally has a negative effect on the character and appearance of the Fallbarn Conservation Area.

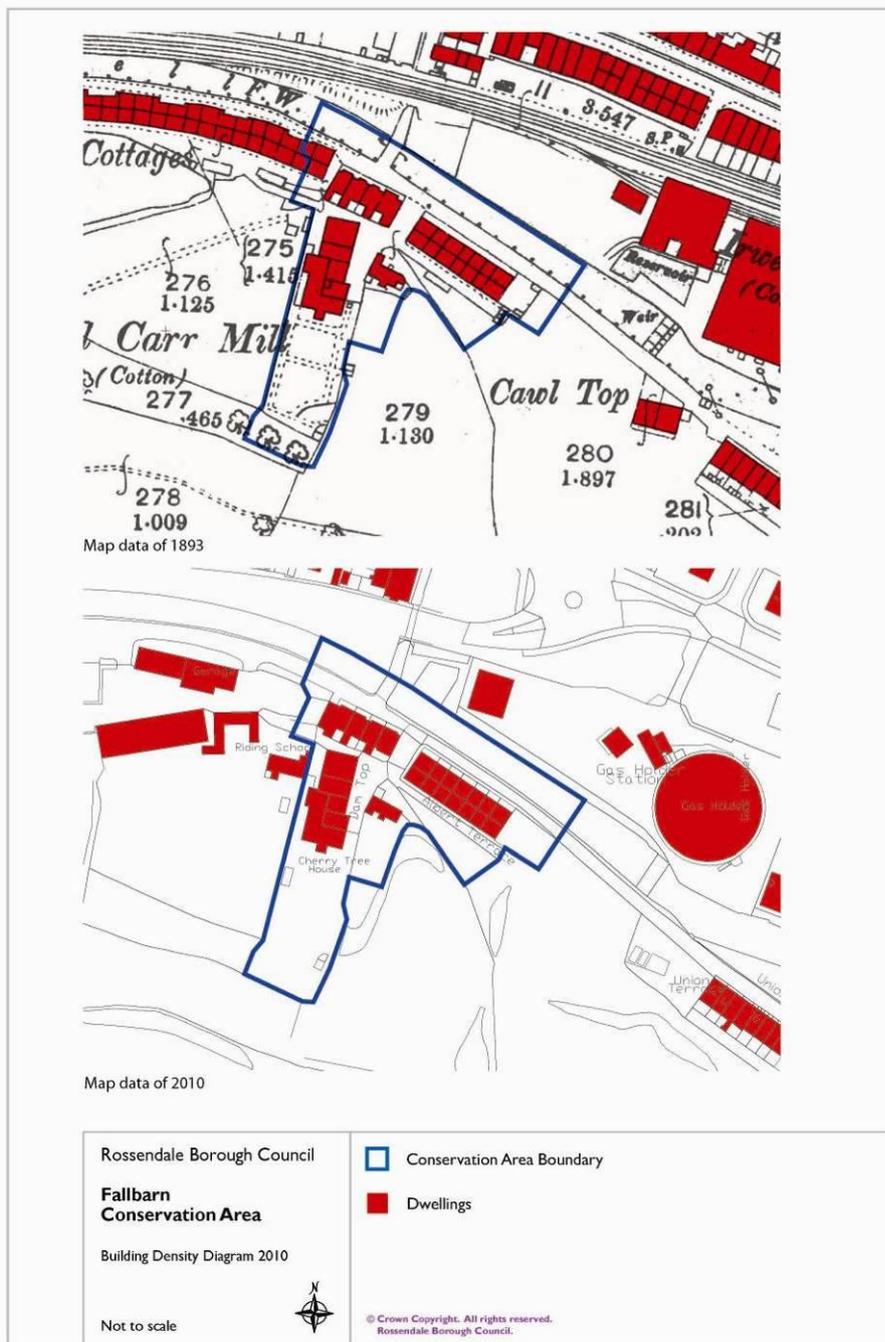
Looking up from between Albert Terrace and Merry Trees the four storey gables dominate the view, with Rose Cottage more in the foreground. Nos. 3 and 5 Dam Top are less imposing, being the same height as Fallbarn Barn and with a strong coping line, with a parapet and pediment. Beyond the buildings is a largish area of open ground which was cleared of trees and shrubs in 2007 and does not appear to have been touched since. The land rises away from the buildings and gives an open setting to the main front elevation of the house. The boundaries are marked by squared stone random coursed walls with strong stone copings and post and rail fences. The wall has failed in a number of locations. The land rises again beyond the furthest boundary fence and the setting is formed by a group of trees and the hillside.

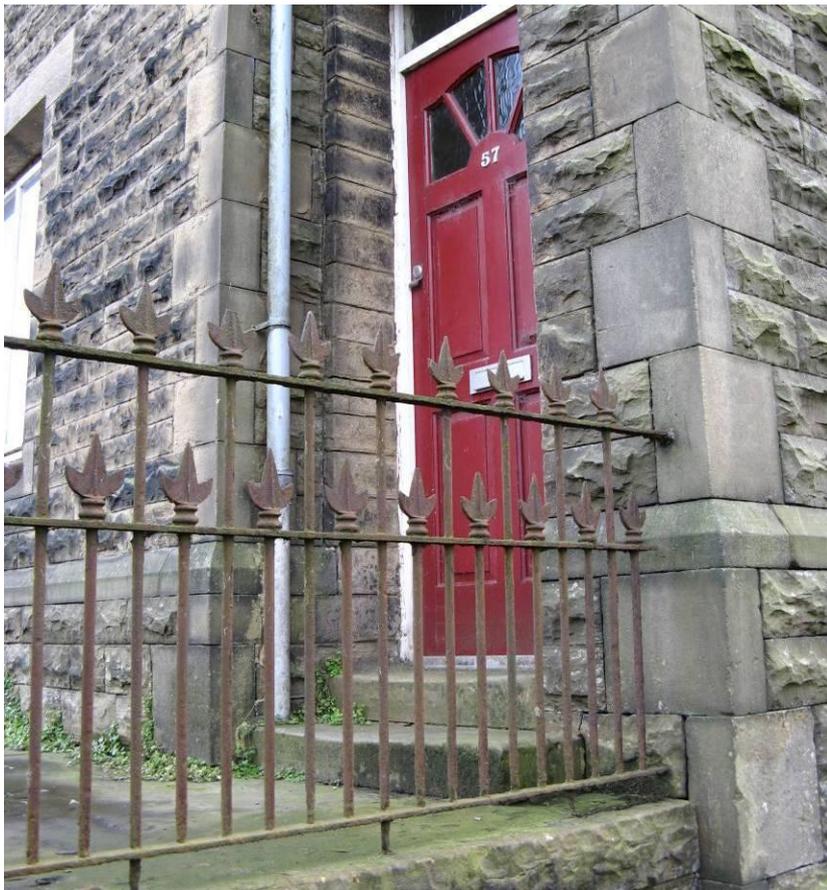
The front areas to Merry Trees and Albert Terrace appear to have had cast iron railings with spear heads – a small section remains in front of No. 57 Albert Terrace and another, possibly original example, remain to one side of No. 49, part of Merry Trees. Most of the original examples have been replaced with modern spiked railings which do not copy these original designs. There are simple modern metal railings to the bridge and the adjoining public area on the north side of the bridge towards Bacup Road, which are in keeping.

Railings in front of Albert Terrace

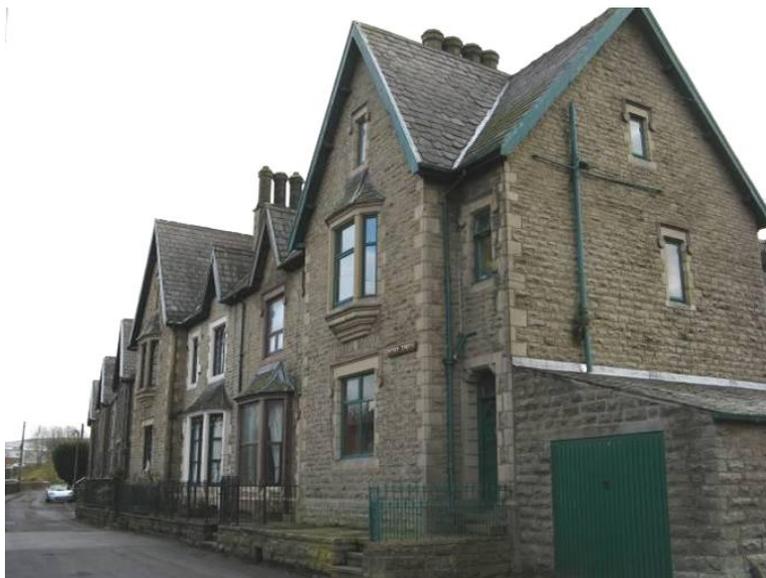
Modern tarmacadam is used for all of the pavements and street surfaces in Fallbarn, although the road surface along Fallbarn Road is full of potholes. There are traditional sandstone setts on the pedestrian link to Lever Street, but these are just outside the Conservation Area. A small area of disturbed historic paving (sandstone setts and paving slabs) can be seen on private land around the back of the terrace blocks which face Fallbarn Road, and sandstone paving slabs can also be seen in front of these blocks, which they sit up about 0.9 metres (Albert Terrace) or about 0.45 metres (Merry Trees) above the road level, creating a raised plinth. The original sandstone steps also remain in front of these two blocks.

Merry Trees sits on a sandstone plinth above Fallbarn Road

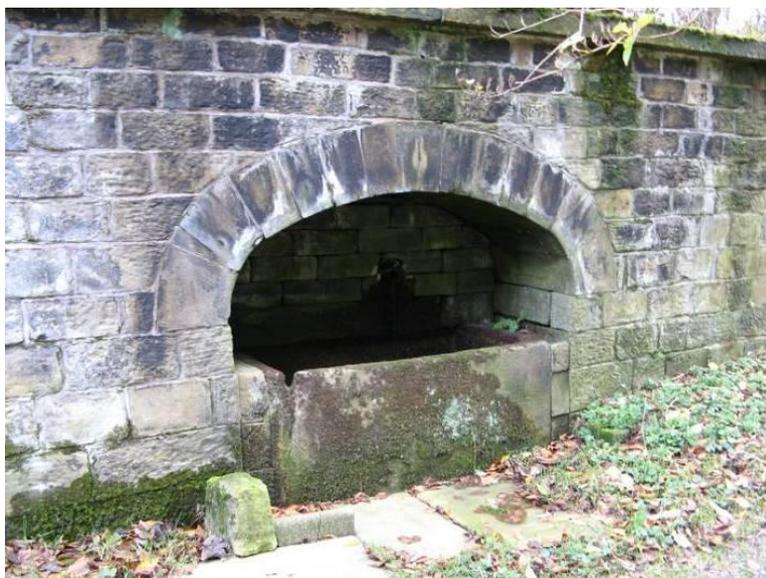
There is virtually no street furniture or other features apart from an old black and white cast iron name plate on Merry Trees, which should be retained. The more modern 'Albert Terrace' sign on the flank wall of No. 57 is in need of cleaning. Next to Rose Cottage is a spring and water trough set in a stone wall and arch, the whole appearing to date to the 19th century.

The spring and water through next to Rose Cottage

It has been noted that many of the stone walls, gate piers and other stone features in the Conservation Area are in poor condition, and that the private track to Cherry Tree House is also poorly maintained. The former village spring and its stone surround must also be preserved by careful maintenance, but it is not clear who is responsible for this.

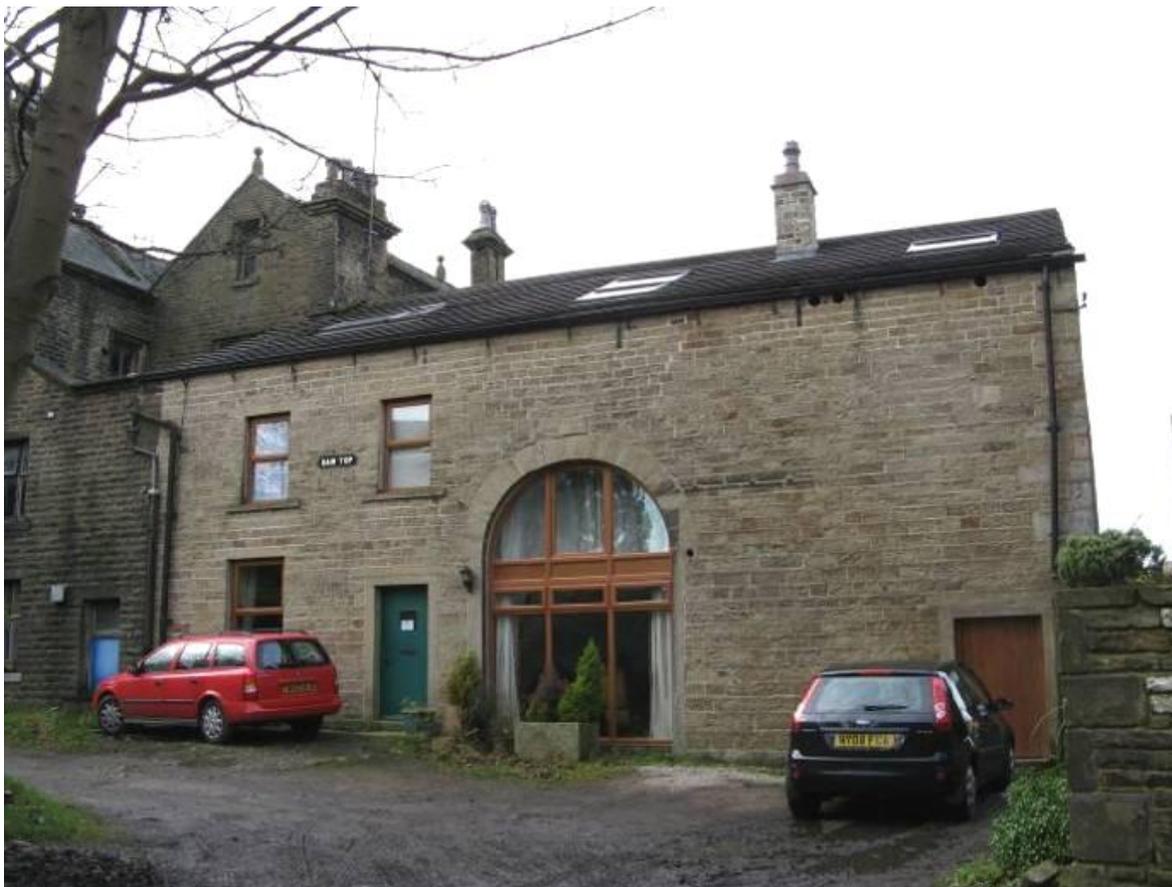
Fallbarn Barn is now two houses

Fallbarn Barn appears to be c1800 and possibly altered at the building of Cherry Tree House – it bears a datestone 'Rebuilt 1846'. It is a good plain building constructed in coursed stone with a slate roof. On the opposite side of the track is a small stone house (Rose Cottage) which is built into raised ground and which, from parts of its walling, suggests a similar date

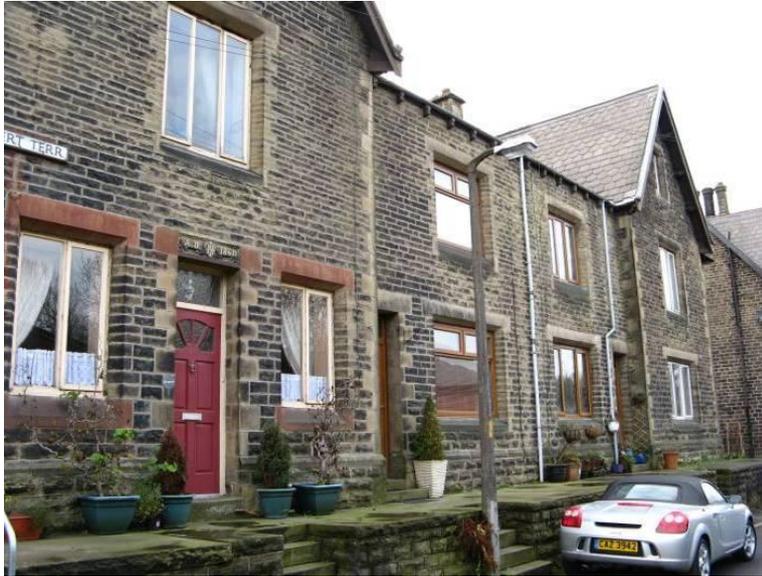
Detail of Albert Terrace

The front elevation has plainer windows and simpler stone surrounds, with smaller window openings in the gables. Overall, the window frames and doors are much altered and due to their design and materials are out of character with the original design of the building. The rear elevation is much plainer with dressed stone only for the lintels and window sills. Each property has a simple dormer window in the roof giving three storey accommodation. Both end elevations of the block are spoiled by modern external pipework. The rear elevation has a regular pattern of windows, doors, pipework, aerials and satellite dishes.

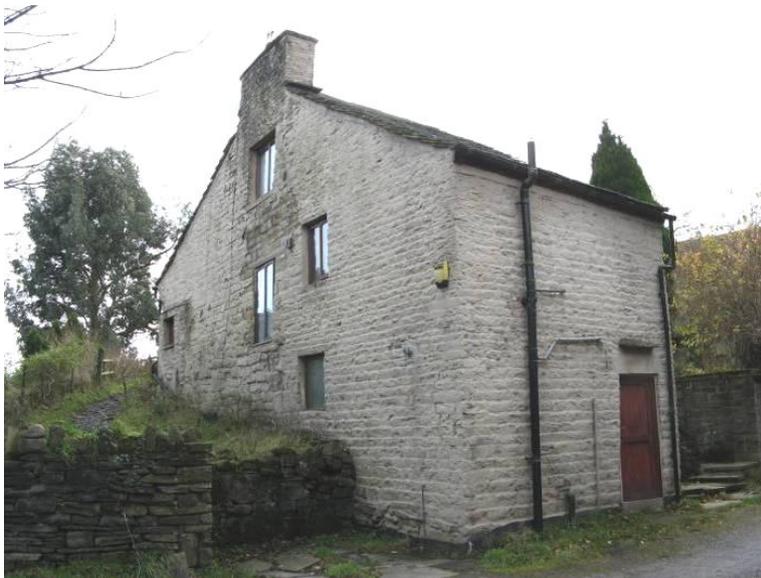
Rose Cottage

Rose Cottage is a detached stone building set into the hillside with a stone slate roof and a chimney stack with no pots. Some external walls are altered and all have been painted. The walls are partially built using narrow watershot coursing, common in the 18th and early 19th century, and some parts appear to be earlier and others altered. It is a slightly odd shape in being deep at right angles to the roof ridge, and therefore with large gables. The gables have plain cement roof verges and there are simple small windows, though they are set in an unusual pattern. All this suggests that Rose Cottage was, some time ago, a different shape or part of a larger structure. The doorway by the track has a deep lintel with a simple dripstone above, and a modern conservatory/entrance porch is located to one side.

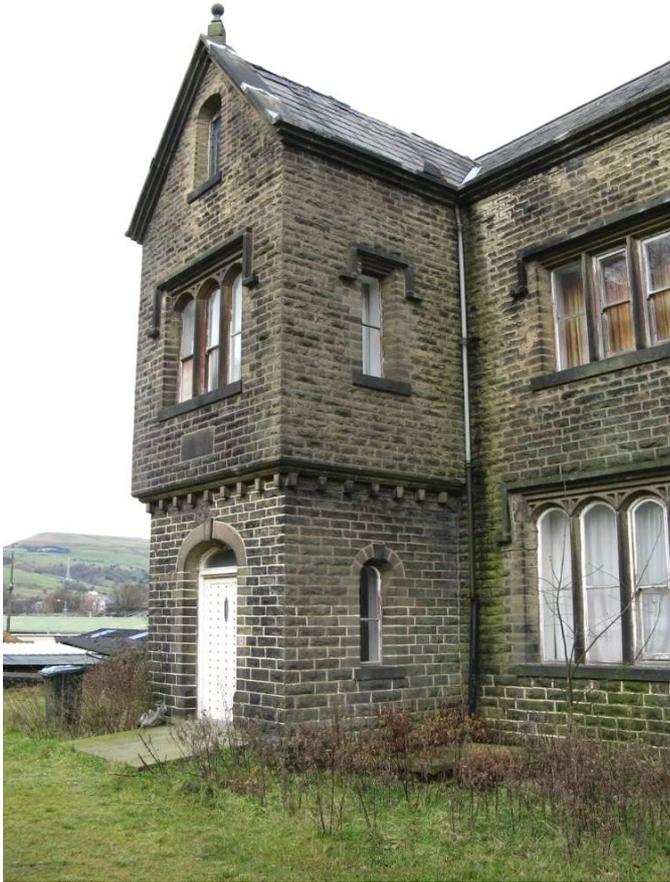
Cherry Tree House

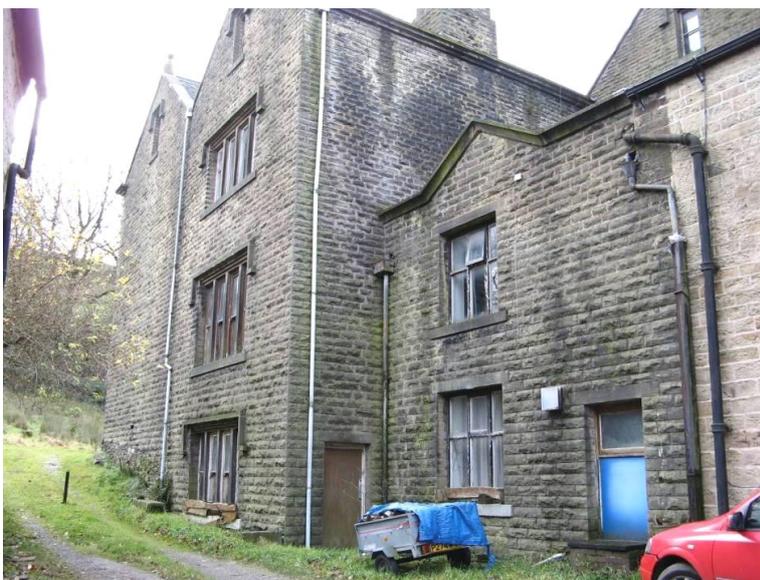
Nos. 3 and 5 Dam Top

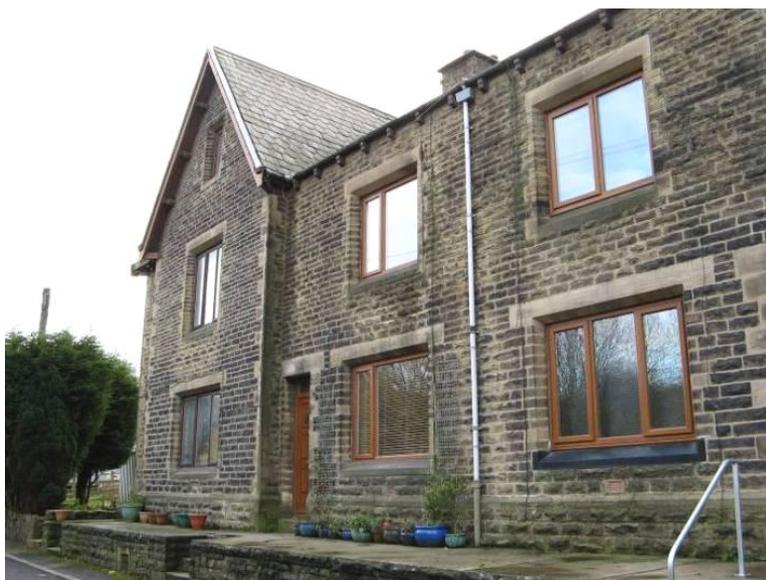
It has been noted that nearly all of the properties in the Conservation Area have to a degree been adversely affected by the alterations to the roofs, chimneys, windows and front doors. These changes are 'permitted development' which can be controlled by the Council through the imposition of an Article 4 Direction. Article 4 Directions are made under the *General Permitted Development Order 1995*, and can be served by a local planning authority to remove permitted development rights where there is a real threat to a particular residential building or area due to unsuitable alterations or additions.

Modern alterations to Albert Terrace

Whilst an Article 4 Direction cannot be retrospective, the serving of one would incrementally improve the character and appearance of the conservation area. An Article 4 Direction can also be focused on groups of buildings, rather than the whole conservation area, such as unlisted buildings of particular local significance and all 'positive' buildings. Any Direction will require an up to date photographic survey to record the present condition of the buildings concerned, and written guidance will need to be provided to householders. Where resources allow, the provision of grants to help with the additional costs associated with traditional materials or the reinstatement of lost architectural features (such as the replacement of uPVC windows with windows to a traditional design) can be helpful.

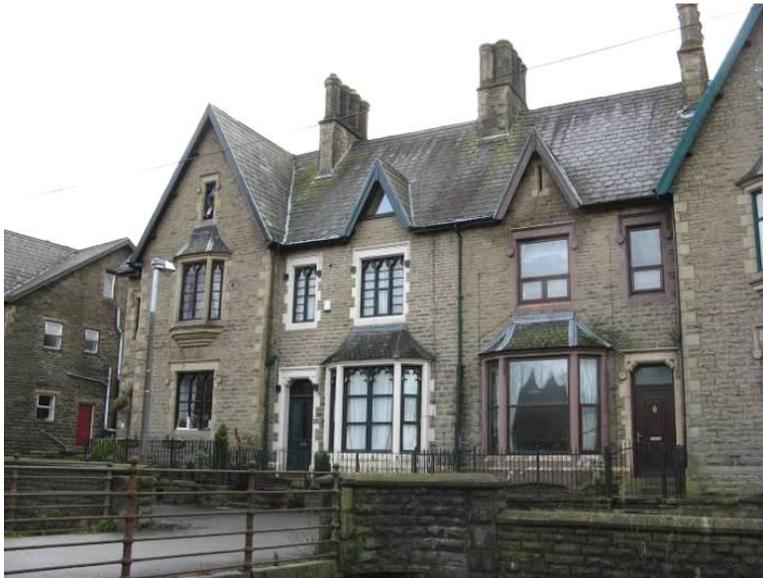
An Article 4 Direction would protect the original slate roofs on Merry Trees

As previously recommended in the 2007 Character Appraisal, it is therefore suggested that the Council serves an Article 4 Direction to bring under planning control all alterations to the existing roofs including:

- Changing roof materials
- The insertion of a roof light
- Alternations to chimney stacks, including their full or partial demolition
- Changes to the rainwater goods
- Changes to windows and front doors (whilst accepting that existing windows or doors may remain or be replaced 'like for like')
- The addition of porches

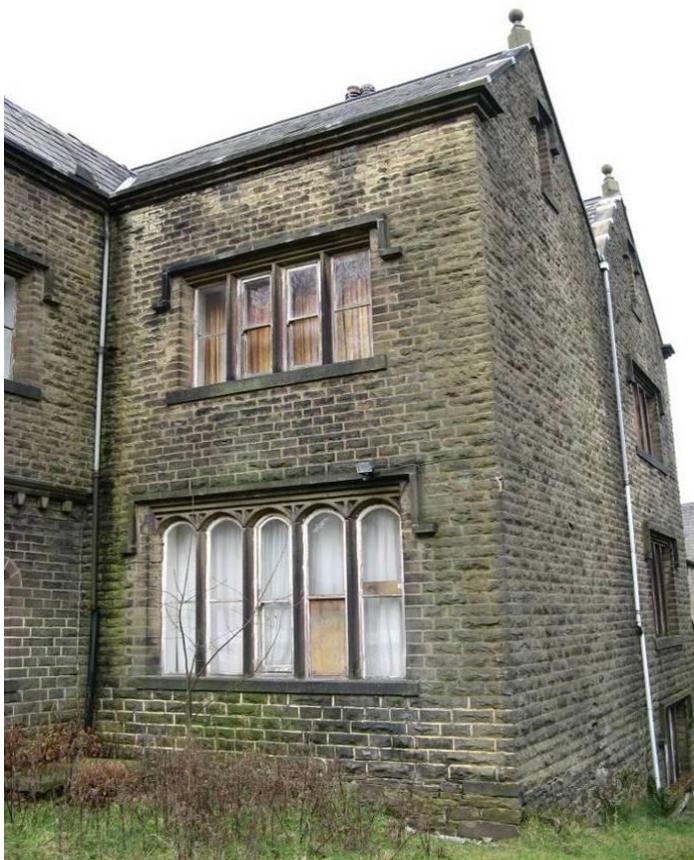
Cherry Tree House is vacant and neglected

As a matter of urgency, the Borough Council should ensure that these important buildings are wind and weather-tight and that measures to protect them from further deterioration are undertaken. If the owner is not prepared to do this work voluntarily, the Borough Council has powers to carry out the work on his behalf and to charge the cost of this work to the owner – the work is undertaken in much the same way as with an Urgent Works Notice for a listed building, but requires the Secretary of State's approval.

- The Borough Council should undertake a survey of Cherry Tree House and Nos. 3 and 5 Dam Top to assess their current condition and should inform the owner of any remedial works which it considers may be necessary
- If the owner of these buildings is unable or unwilling to carry out the necessary work, the Borough Council should consider carrying out the work on his behalf (subject to the Secretary of State's approval) although the cost will have to be met by the owner or become a charge on the property
