Edenwood Mill (2020/013) – Binder 3

ENGINEERING REPORT 7170

**EDENWOOD MILL
EDENWOOD LANE
OFF BOLTON ROAD NORTH
RAMSBOTTOM
BL0 0EX**

13.03.2020 MP/CH

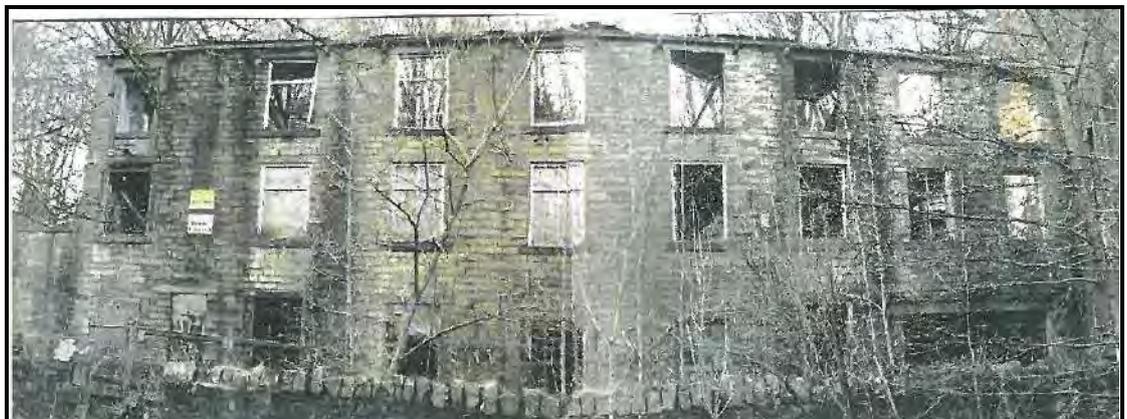
- 3.2 The building is aligned on an approximate North/South orientation with the front elevation having a predominantly Eastern aspect.
- 3.3 The elevation incorporates a repeated window pattern at ground, first and second floor levels, the windows framed with natural stone heads and cills, with regular stone coursing. The wall thicknesses (not confirmed) probably in the order of 450mm thick.

- 3.4 For identification purposes the windows are numbered from left to right, Bays 1 – 8 with exception of a blank Bay between Bays 1 and 2 on a regular pattern. (Photographs 075, 076, 077).

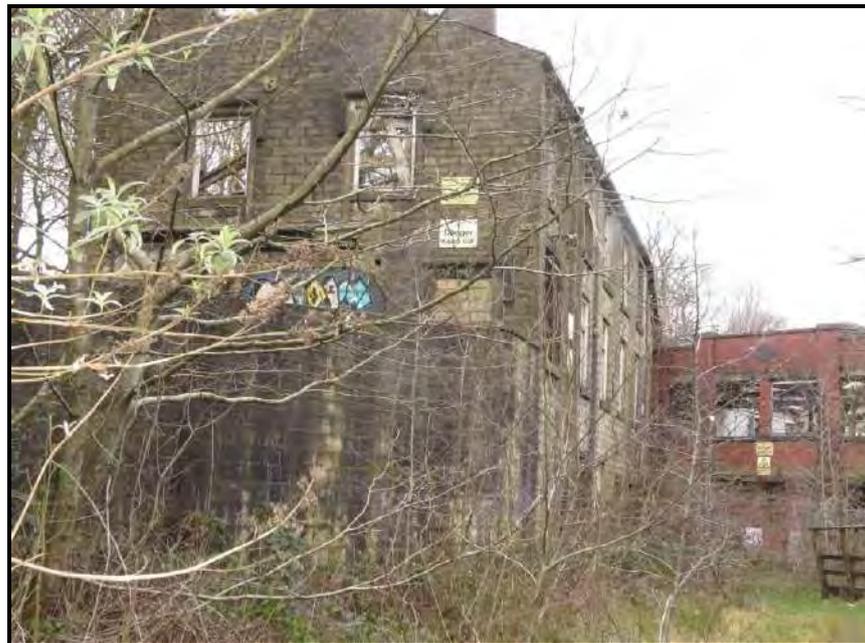
- 3.7 Pattress plates (4 number) originally located at first floor head level between Bays 2 and 3 possibly for wall deflection or internal factory fittings. (Photographs 136, 137).

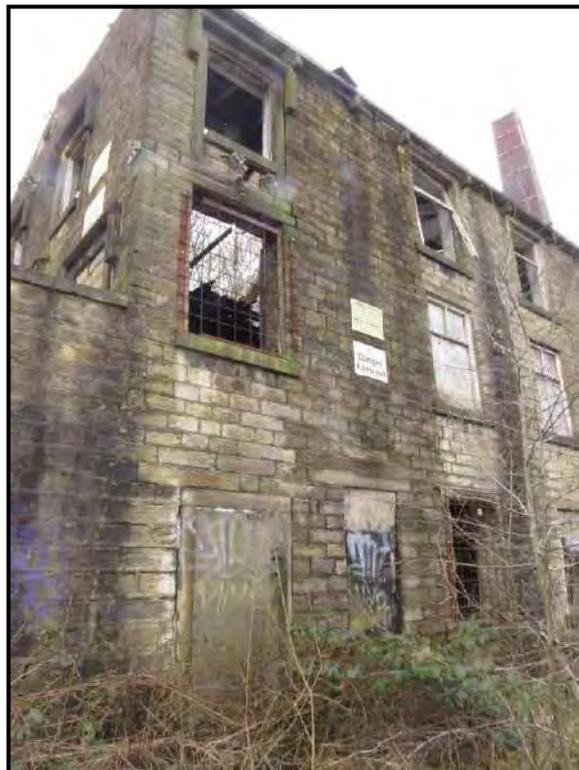
- 4.2 The gable elevation incorporates a sliding doorway on the left hand Western side with a former personnel door completed with an original stone head detail, the doorway has been infilled in stone. (Photograph 001).
- 4.3 At upper level (second floor from front elevation) two original ‘taking-in’ doors with drip stoner details have been partially infilled with matching stone. The gable elevation is asymmetrical in profile.

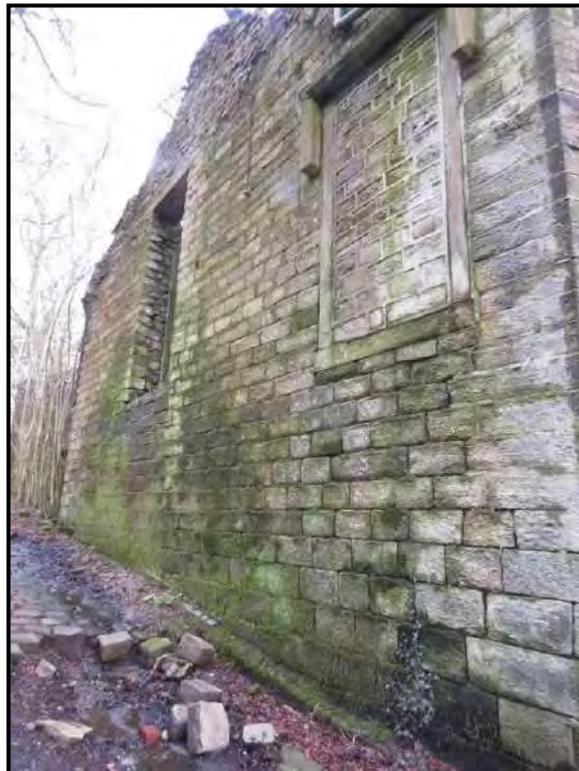
- 5.3 The profile of the upper pike stonework to the original canopy is still present although the roof trusses and purlins have collapsed.
- 5.4 The central wall section incorporates 3 number windows at second floor level with a partial cover window to the first floor level. (Photographs 003, 004).
- 5.5 Internally the roof incorporates king post trusses approximately 3 metre centres. Collapse of the main roof slope has occurred over the majority of the roof area. (Photograph 168).

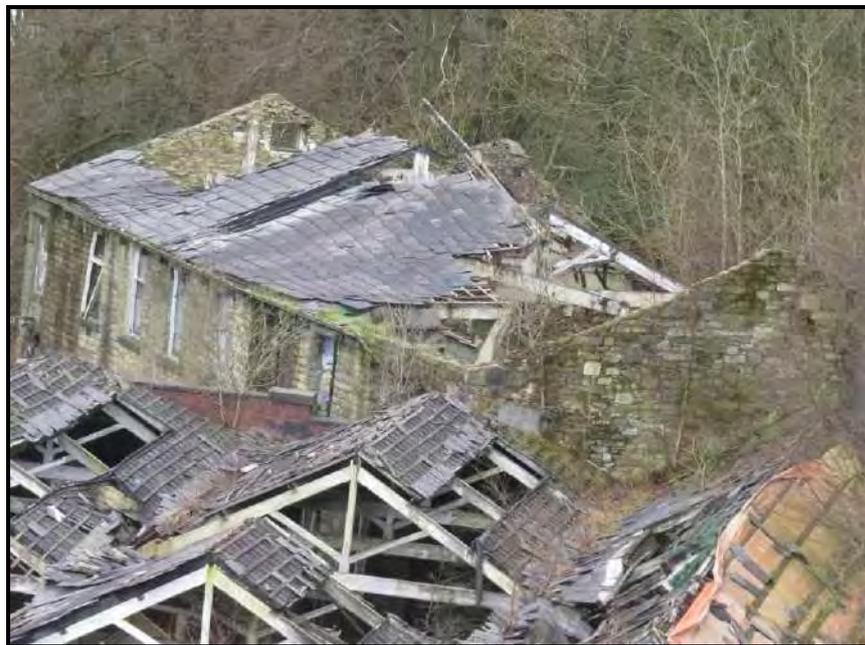
- 5.6 The Northern gable of the original mill has no roof or restraints and is free standing. (Photograph 007).
- 5.7 The rear wall incorporates 4 number windows at second floor level with an increased frontage to that on the front elevation.
- 5.8 The horizontal alignment at wall plate level follows a slight hogging profile. (Photograph 009).

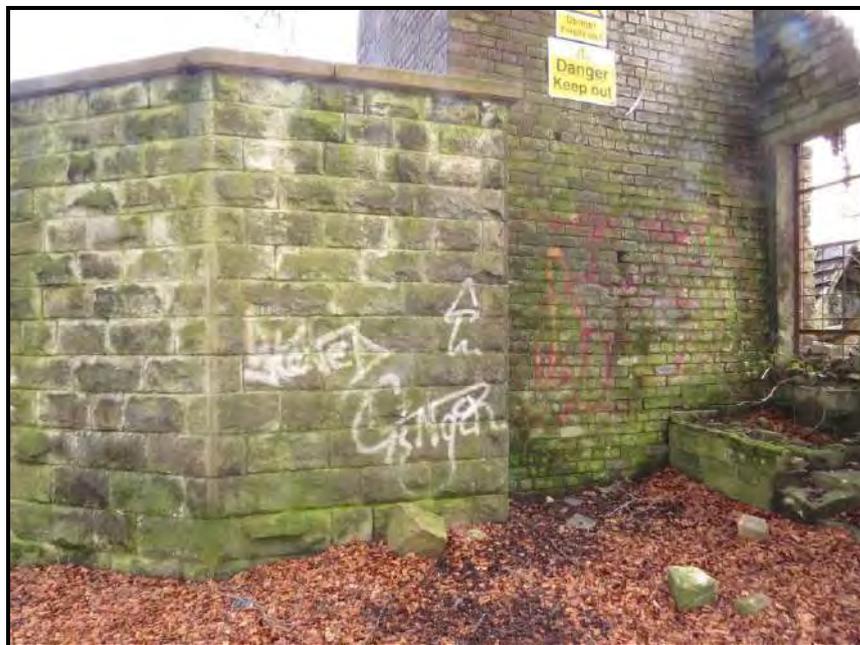
- 6.2 The horizontal and vertical profile of the wall is reasonable. (Photographs 019, 020, 021).
- 6.3 From the open windows the interior of Unit 2 can be observed with significant loss of roof structure and slating. (Photographs 022, 023, 175).

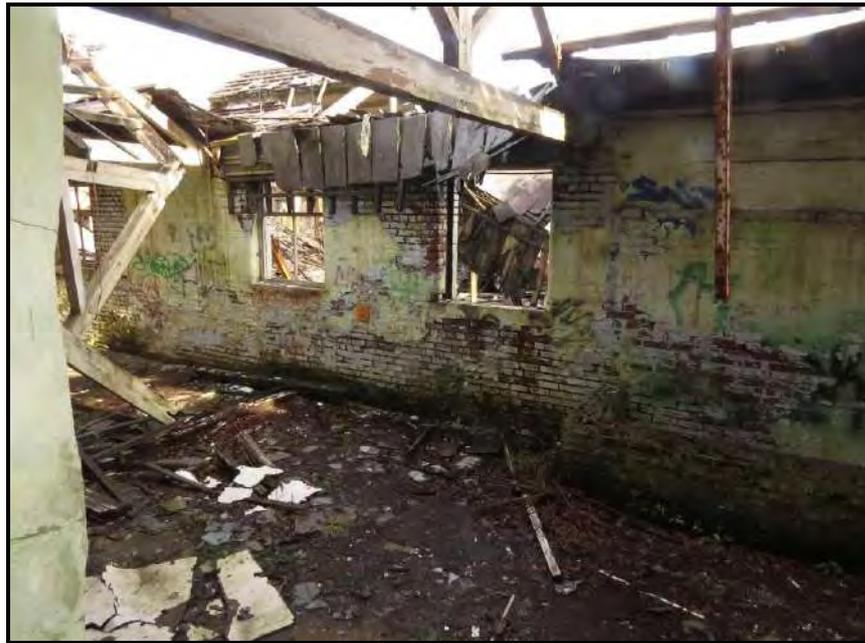
- 6.4 Limited view of unit from (East) section of Units 3 and 4. (Photograph 024).

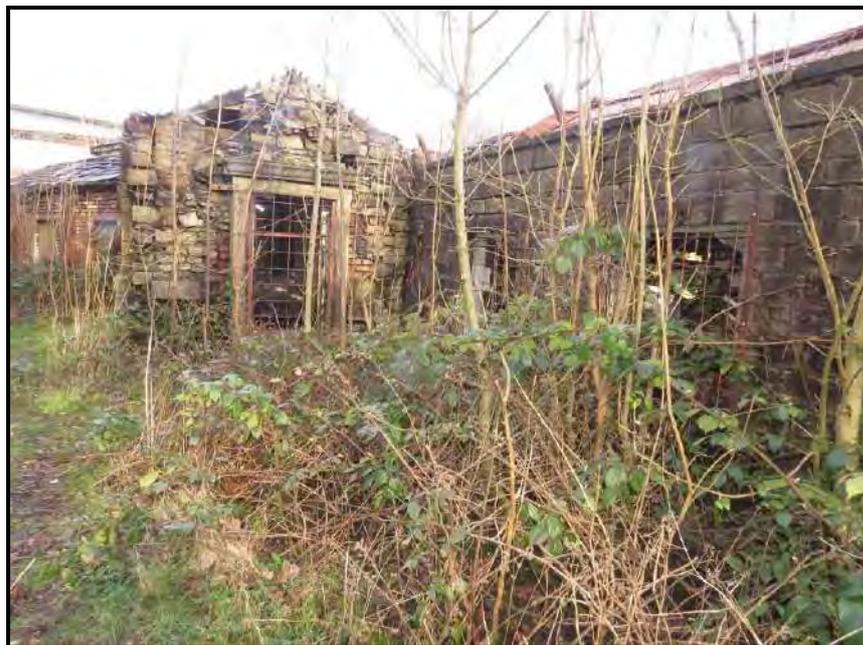
- 7.2 The original outer leaf of dressed stone has been removed from the doorway exposing the random inner wall construction. (Photographs 026, 027).
- 7.3 The external rear wall to the entrance of Unit 3 is completed in dressed stone incorporating three rectangular windows. Some of the stonework at wall plate level is missing. (Photograph 030).
- 7.4 From the entrance into the rear wall follows a skew alignment to the larger area of the main Unit towards the North East. (Photographs 028, 029).
- 7.5 The flank wall constructed in Accrington brick, both wall thicknesses circa 300mm, and incorporating 375mm x 100mm wide piers beneath a four course deep corbelled brickwork at eaves level. (Photographs 030, 031, 032).

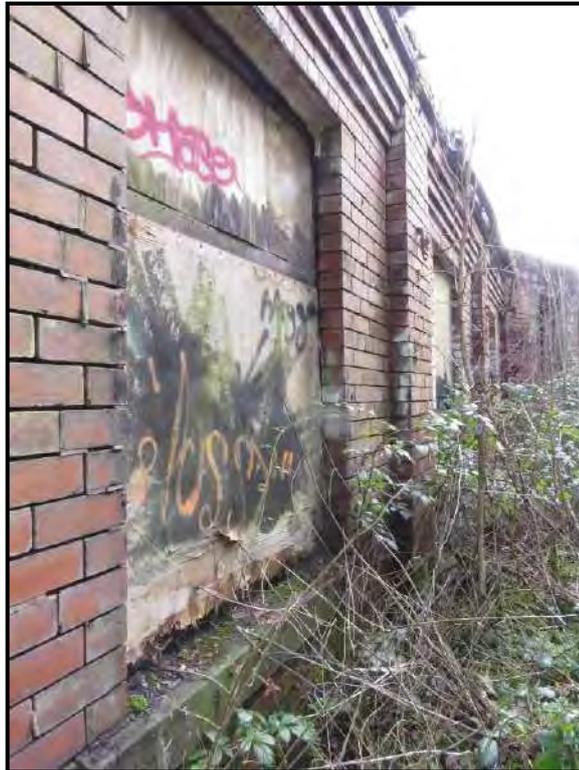
- 7.5 The rear North Western wall to Unit 3 extends for a further 30 metres with a 2 metre square opening flanked on the right hand side (South West) by two Bays between brickwork piers incorporating rectangular windows on stone cills beneath a four course deep corbelled brickwork head. (Photographs 034, 035).

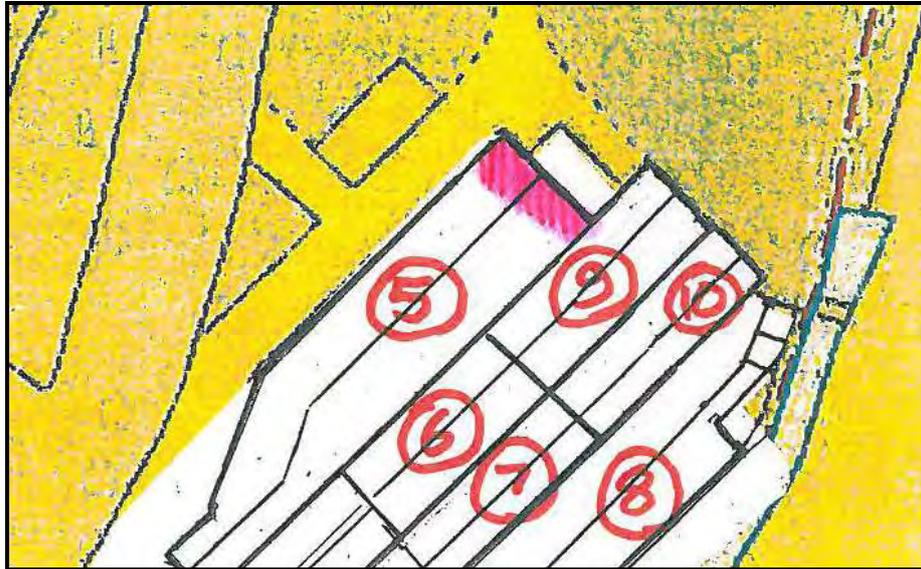
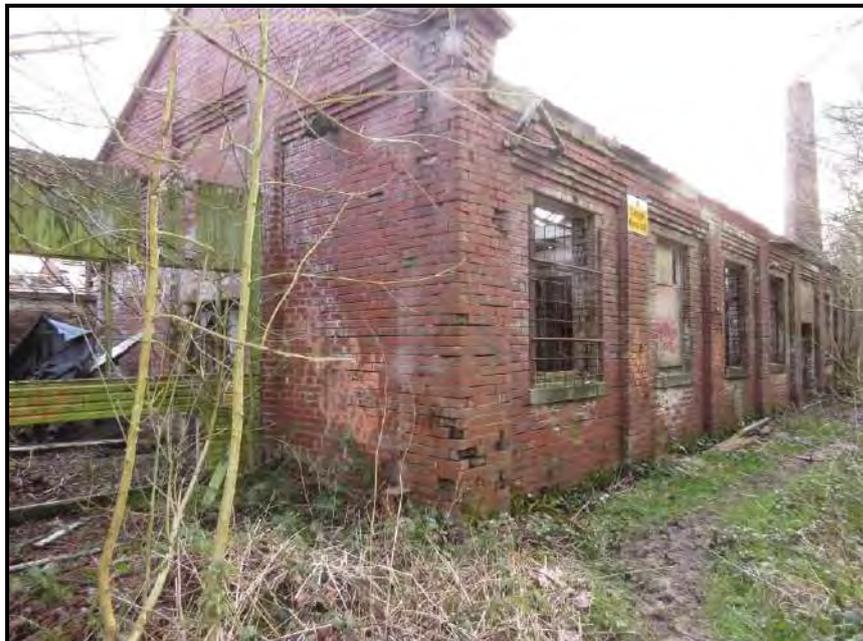
- 8.1 The gable to Unit 5 extends for a width in the order of 10 metres incorporating three indented panels completed with four courses of brickwork to the upper pike level and a doorway in the central section. (Photographs 049, 050).

- 8.2 The overall profile and condition of the brickwork is satisfactory notwithstanding weathering to the pointing. (Photographs 049, 050).

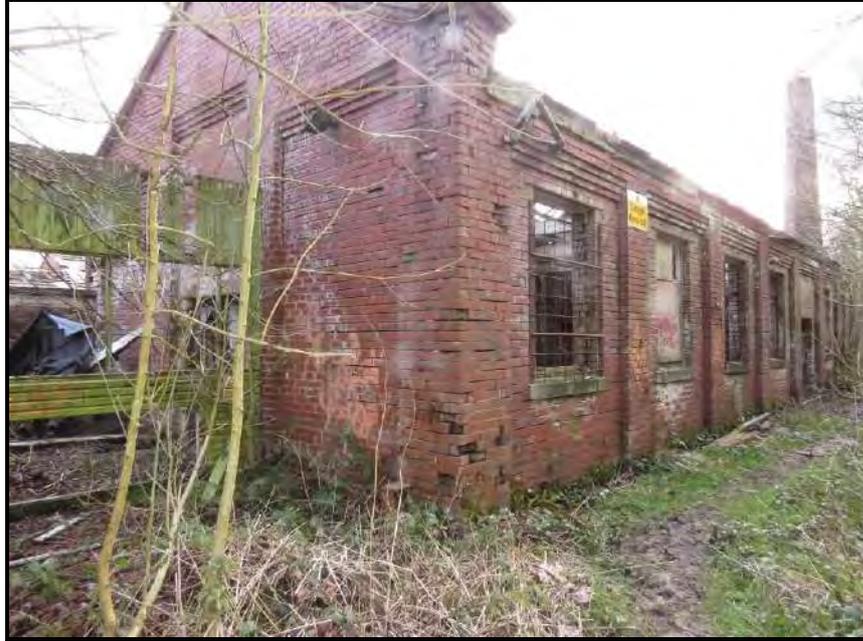
- 8.3 There is an eroded slope (former footpath) forming a water channel following recent rainfall, running from North to South. (Photograph 051).

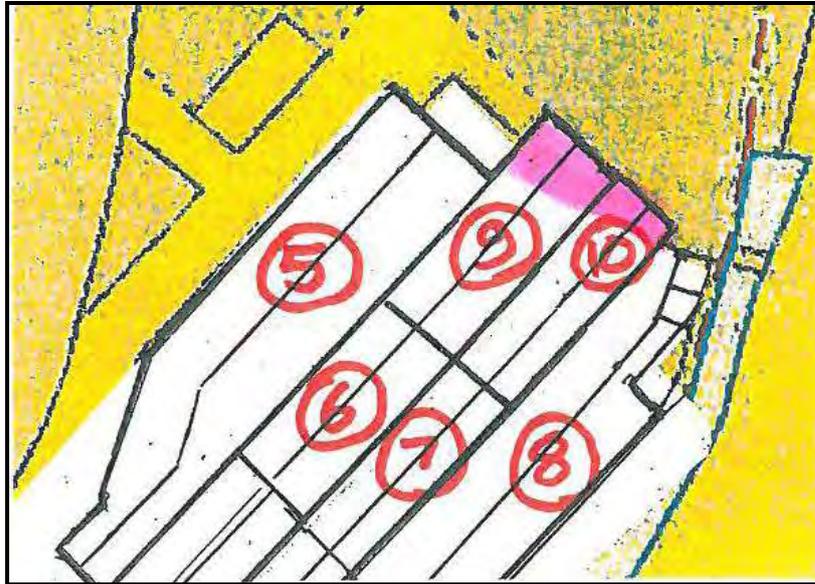
9.1 The North Eastern elevation to the two units is a full height wall in brickwork laid in stretcher bond extending for a total width in the order of 12 metres, incorporating a 1400mm square pier on the right hand Northern corner and a smaller pier on the left hand South Eastern corner. The wall is completed with a probable concrete coping. (Photograph 052).

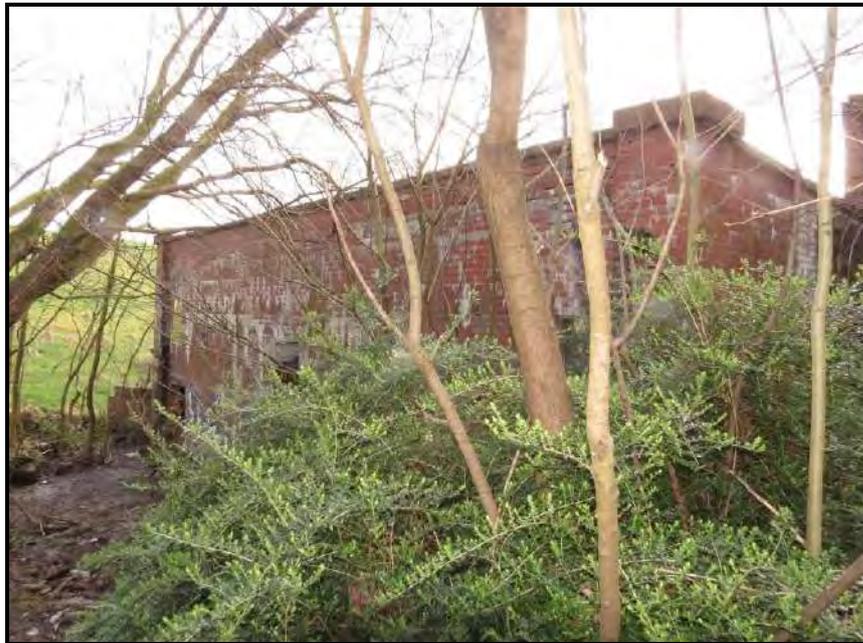
- 9.2 Considerable efflorescence is evident to the brickwork but the vertical profile is reasonable. (Photographs 053, 054).

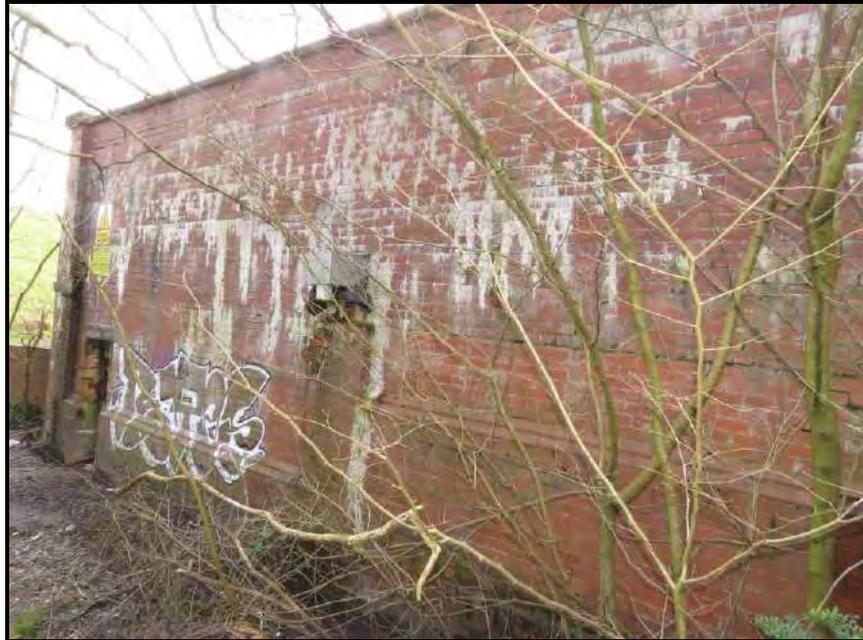
- 9.3 The eroded water channel on the Northern aspect is shown in photograph 055.
- 9.4 The rainwater hopper from the roof valley between Units 9 and 10 still exists against the flank wall, with a personnel door on the left hand North Eastern corner. (Photographs 054, 055).

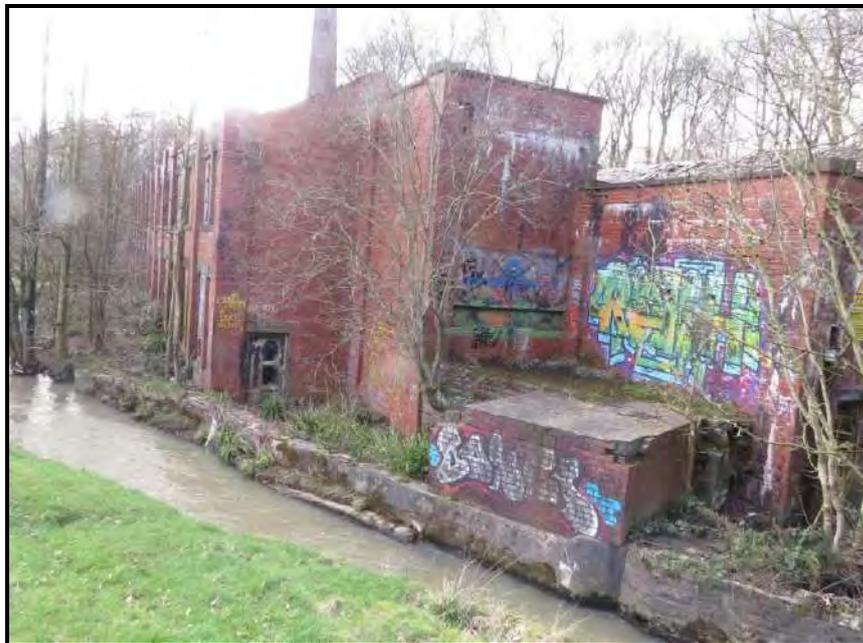
- 10.1 The North Eastern corner of the main mill overlooks the River Irwell incorporating twin culvert discharge pipe diameters approximately 1.5 metres constructed in a head wall overlooking the downstream section. (Photographs 059, 060).
- 10.2 The North Eastern corner incorporates a 10 metre return wall from Unit 10 with a full height rectangular infill construction between the part gable elevation of Unit 8. (Photographs 061, 062, 063).

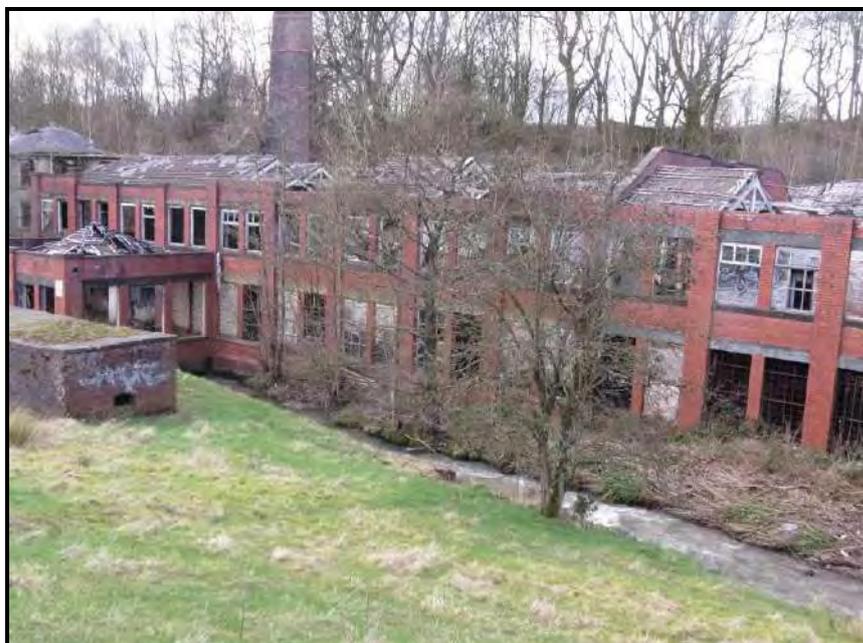
- 11.9 The North Eastern corner incorporates a rectangular infill structure between the North Eastern gable of Unit 11 and the South of the flank of Unit 10. (Photographs 062, 063).
- 11.10 On the left hand end of the front elevation (South West) there is a single storey brick faced outshoot spanning over the River Irwell extending for a width in the order of 4 metres incorporating 3 number window openings on the two flank walls, with double window openings with adjoining piers on the front South East aspect. (Photographs 0.73, 078, 086).

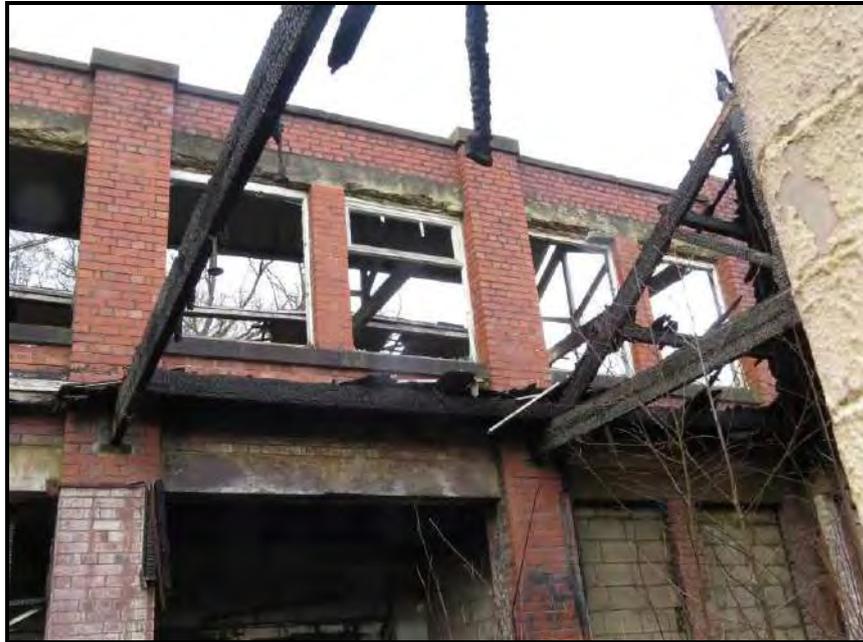
- 11.12 At first floor level on the main unit (Unit 4) severe spalling is evident to all the concrete lintels at first floor level to Bays 1 – 4 with spalling of the concrete and exposure of the main reinforcement. (Photographs 081, 082, 083 – close up).

- 11.13 On the river frontage the first floor lintels to Bays 1 – 9 (18 number) are constructed in reinforced concrete and severe spalling is evident exposing the reinforcement and this will involve the replacement of the eighteen windows including wall replacement above the windows.

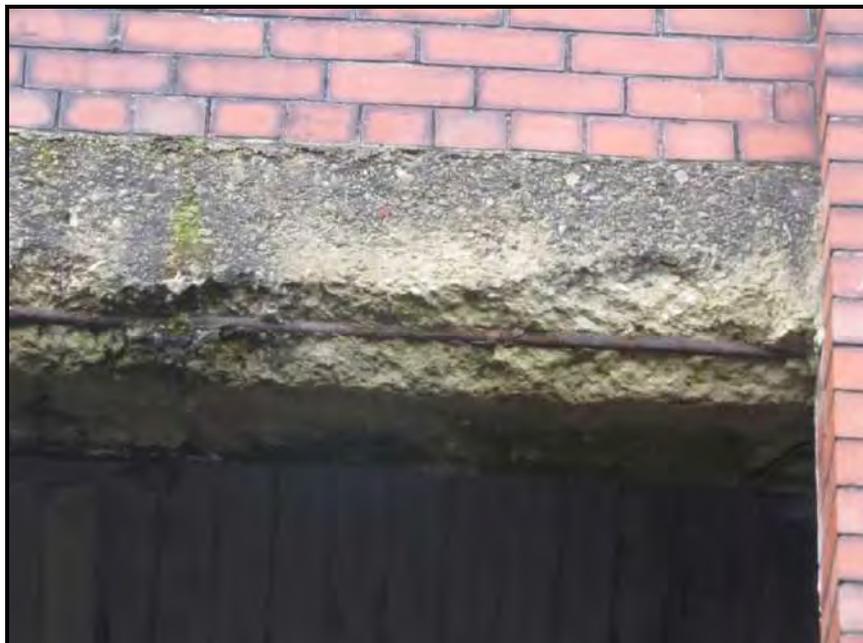
12.1 The window heads to Bay 5 follow a slight hogging profile with settlement towards the right hand and left hand aspect. Spalling to the concrete lintels is evident with exposure of the reinforcement, copings are missing at eaves level with spalling to the concrete window heads at first floor level. (Photographs 070, 072, 087, 088 089, 090, 091, 092).

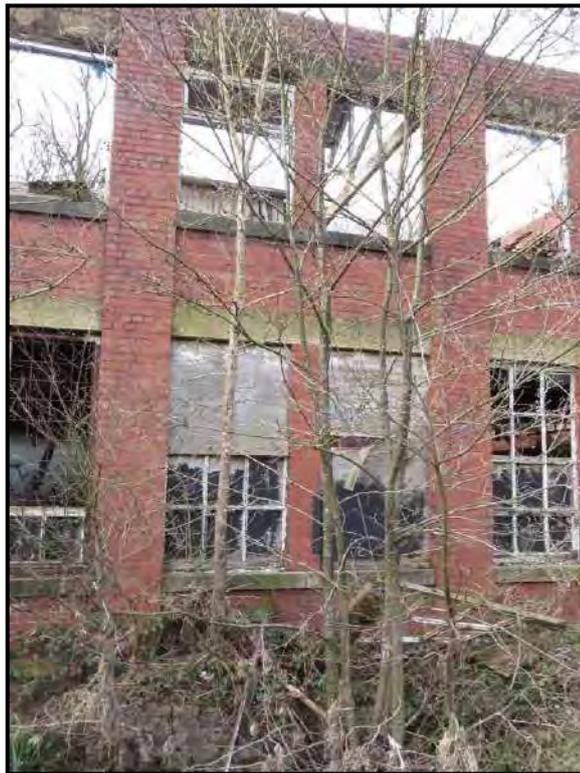
- 13.1 A later construction evidenced with a slightly improved finish to the concrete lintels at first floor level, although horizontal crazing at mid beam depths is evident to most window heads at ground and first floor level with some cracking and spalling to the ground floor head (Bay 11) and leachate in the parapet brickwork (Bay 12). (Photographs 065, 066, 093, 094, 096).

- 11.14 On the remaining window sections of the later construction faint crazing is evident to the face of the concrete lintels with further spalling, and again some remedial work will be required to the lintels, although whether repaired concrete lintels of this age could be retained in a new development is questionable.

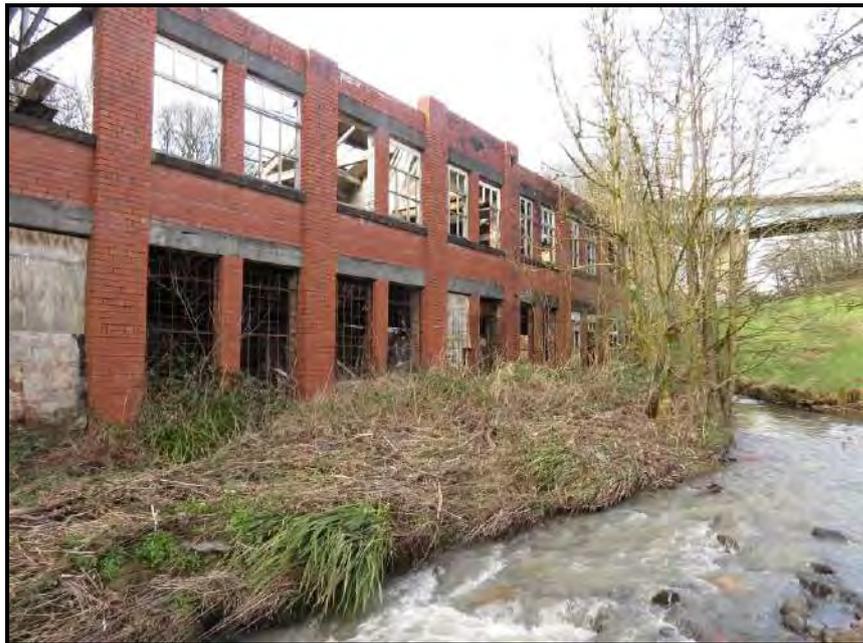
- 14.1 The end Bay 16 is set back from the right hand bank of the river by a distance in the order of 2 – 3 metres, the bank sustaining intensive tree growth, all copings are absent and crazing is evident to the concrete lintels. The brickwork and pointing are in fair condition. (Photograph 099).

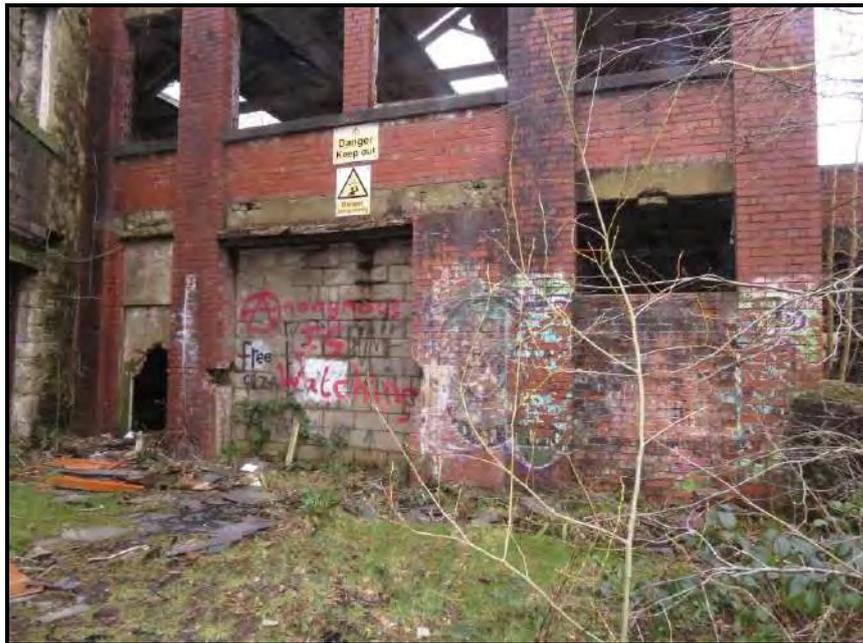
- 15.1 The South West elevation to the wall extends for a length in the order of 6 metres incorporating a central double bay between single windows. (Photographs 144, 145).
- 15.2 Spalling and reinforcement exposure is evident to all four lintels at both levels. (Photographs 146, 147).

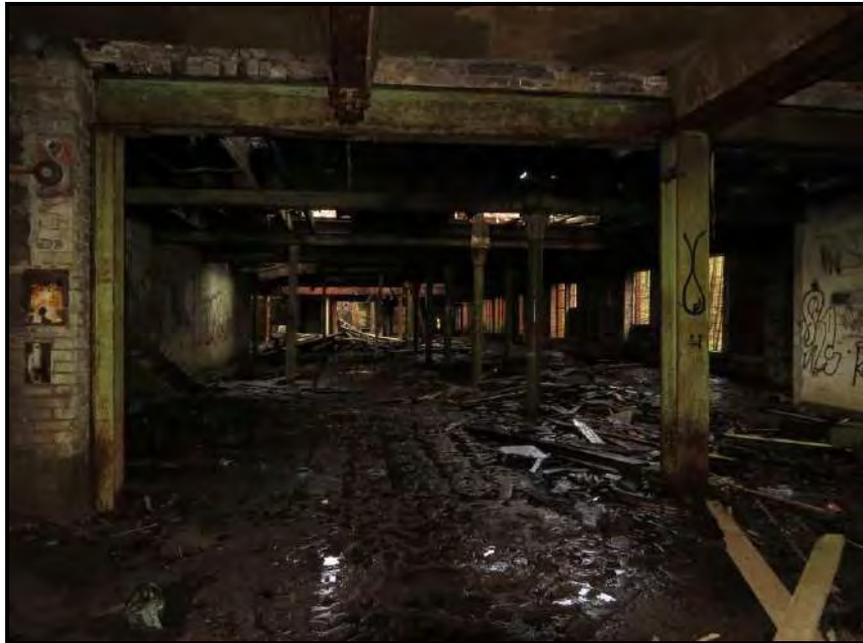
- 16.1 A limited inspection of the ground floor of Units 3 – 4 was made adjoining the windows to the river elevation around Bay 5 (outshoot) to Bay 9.
- 16.2 The section was one of the earlier constructions incorporating 150mm cast iron columns with additional steelwork column supports, and a mixture of timber and steel beams and timber floor joists.
- 16.3 Collapse of the upper floor and roof has occurred to several locations with the remains of the timber debris on the floor. (Photographs 148, 149, 150, 151, 152).

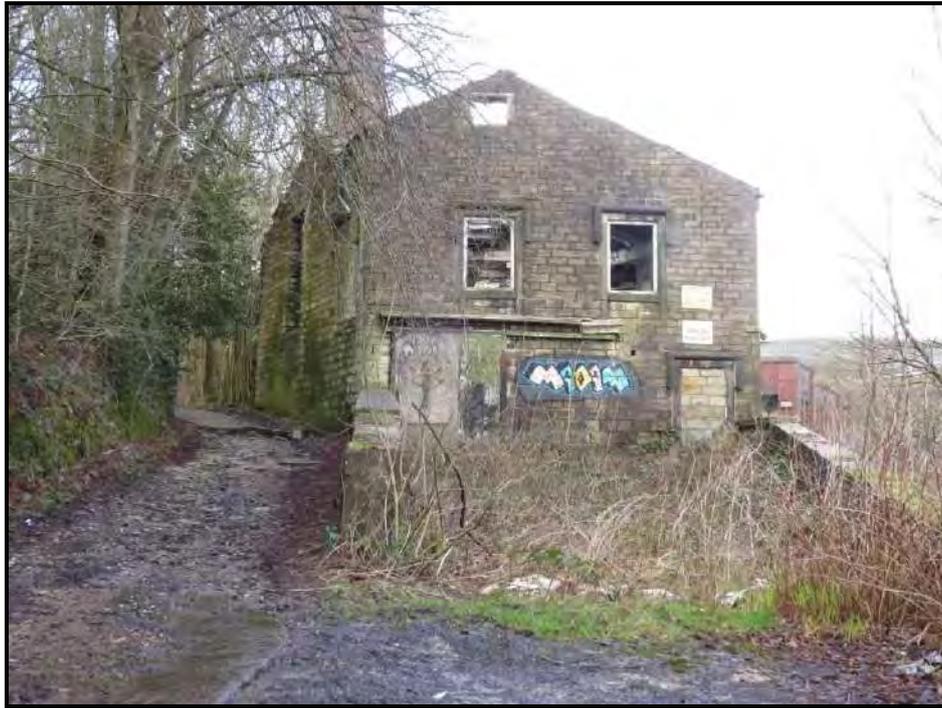
179E Roof to Unit 5

- 7.6 The window details are repeated to the left hand (North East) of the opening with four matching windows. (Photograph 036).
- 7.7 Internally the roof construction incorporates king post with a central steel tie on the largest spans whilst the smaller spans towards the entrance are of tied rafter configuration. (Photographs 037, 038, 039).
- 7.8 The roof is over-boarded but all the slates have been removed. (Photographs 179E, 041, 042, 048).

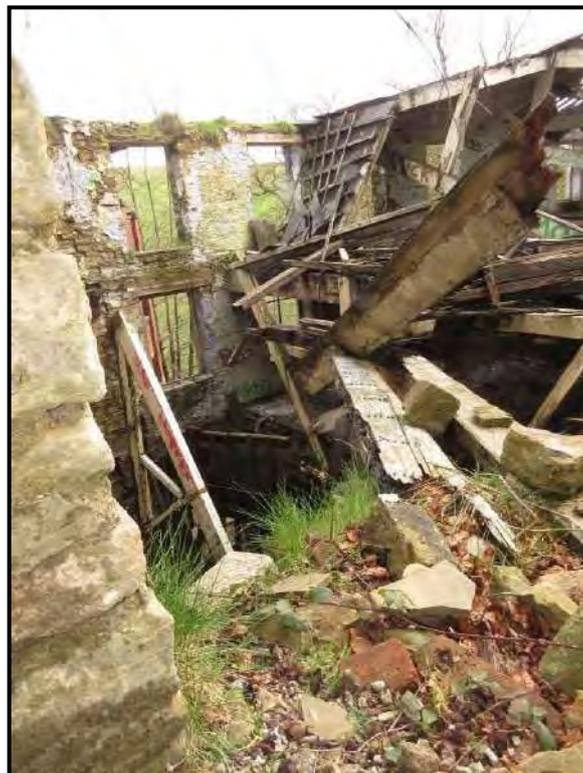
014 Debris looking North - South

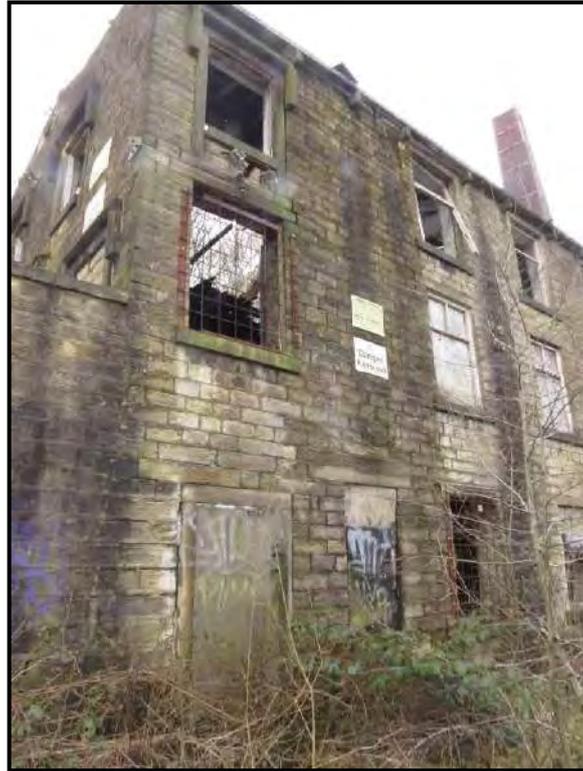
134 Loss of vertical alignment to front

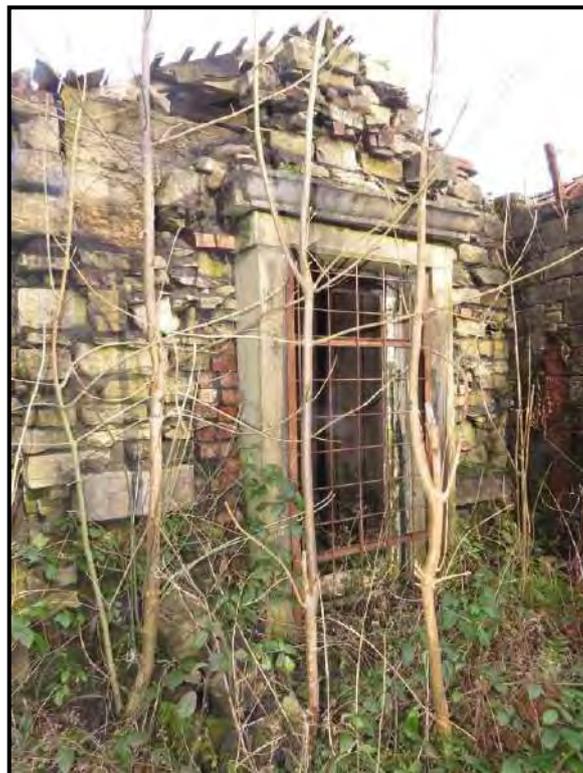
027 Original door, Unit 5

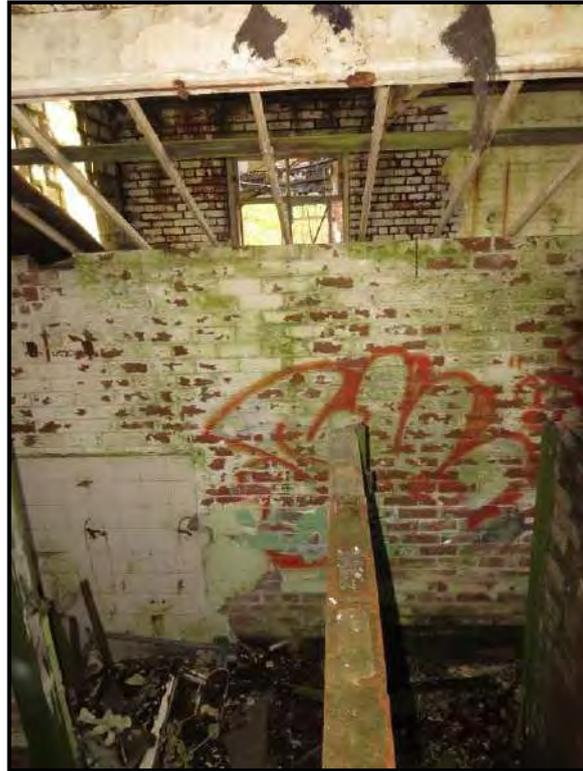
028 Internal cross wall Units 5 - 6

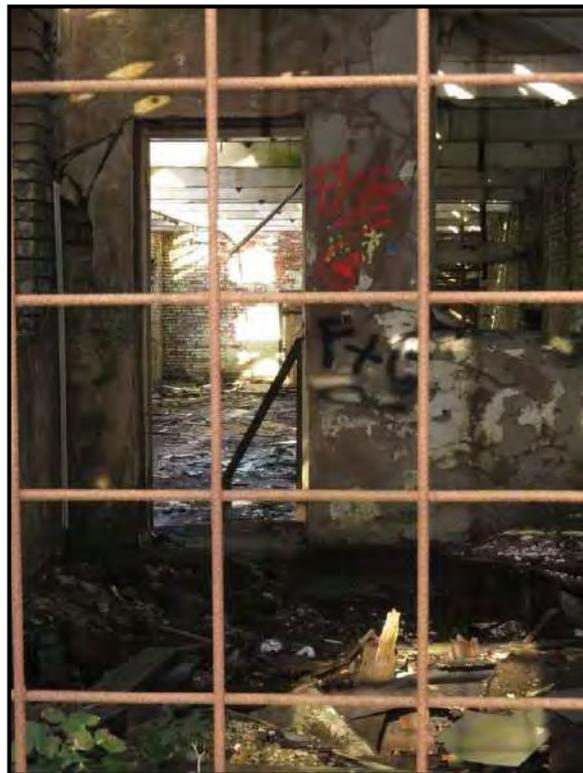
029 Internal cross wall Units 5 - 9

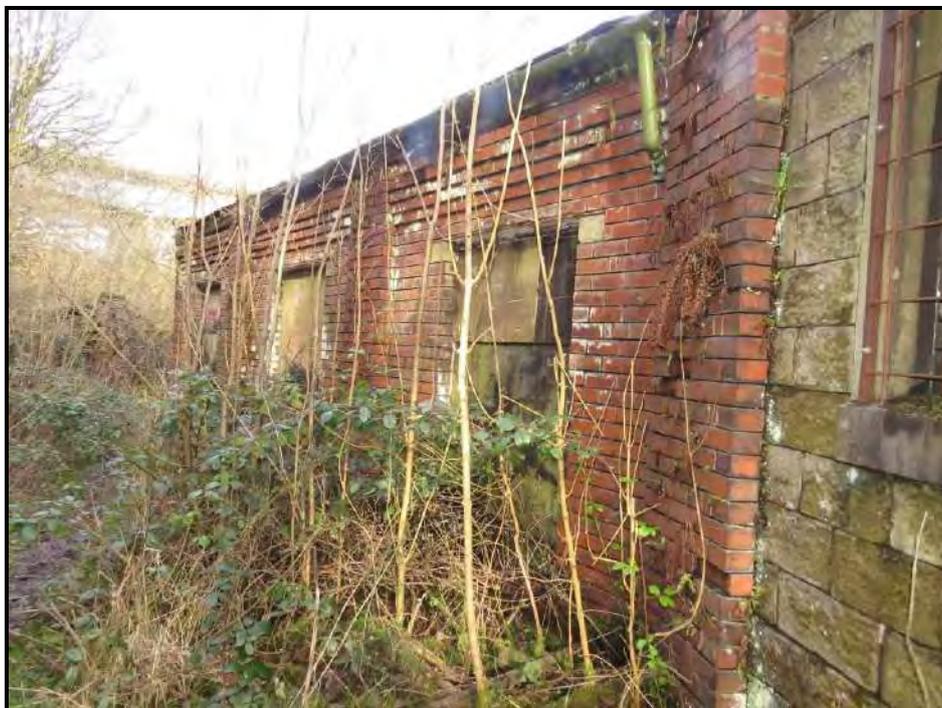
031 Skew link to Unit 5

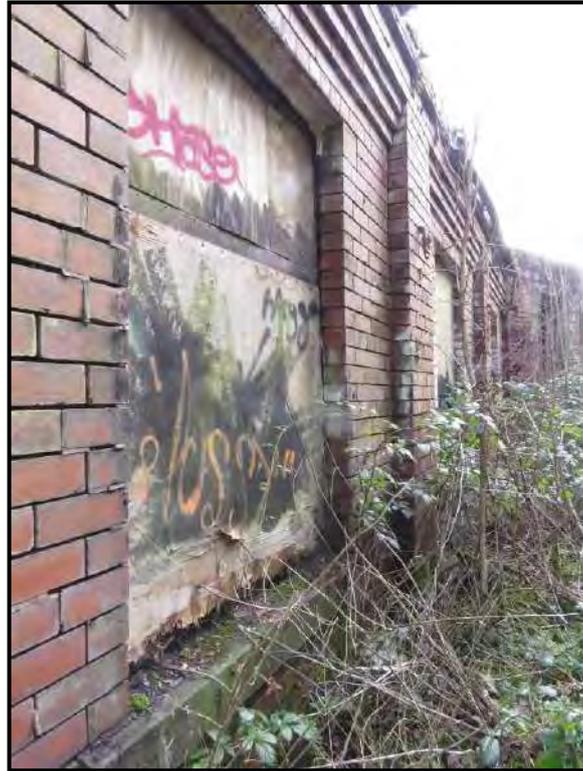
032 Skew link to Unit 5

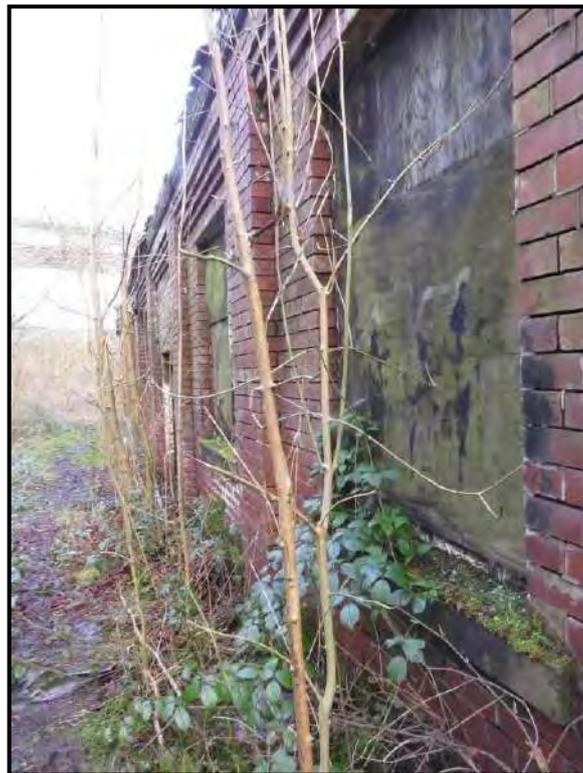
033 Skew link to Unit 5

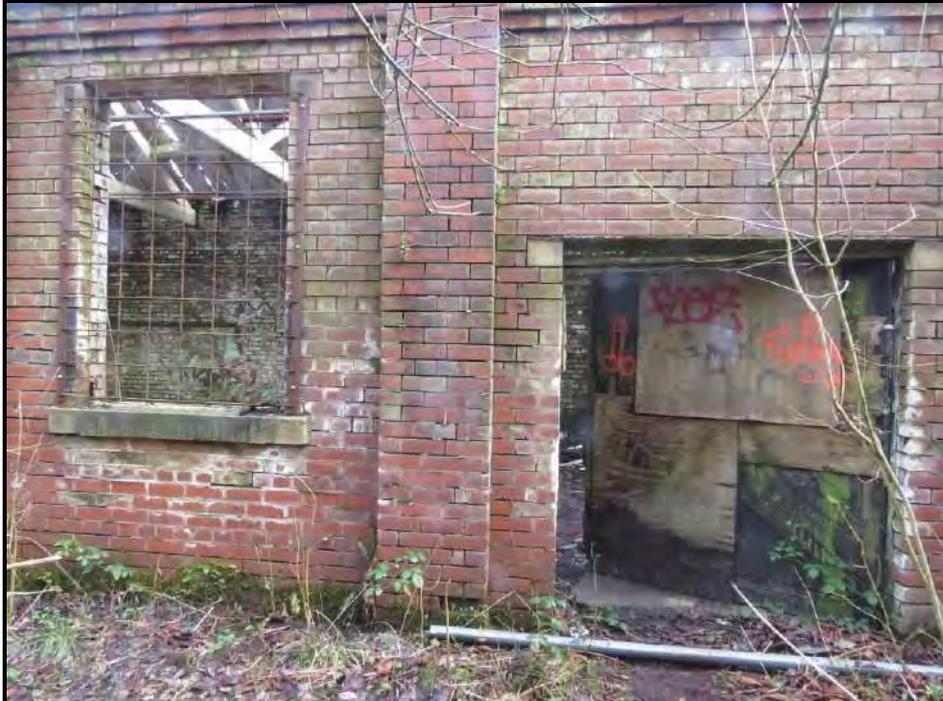
035 Doorway and panel 3

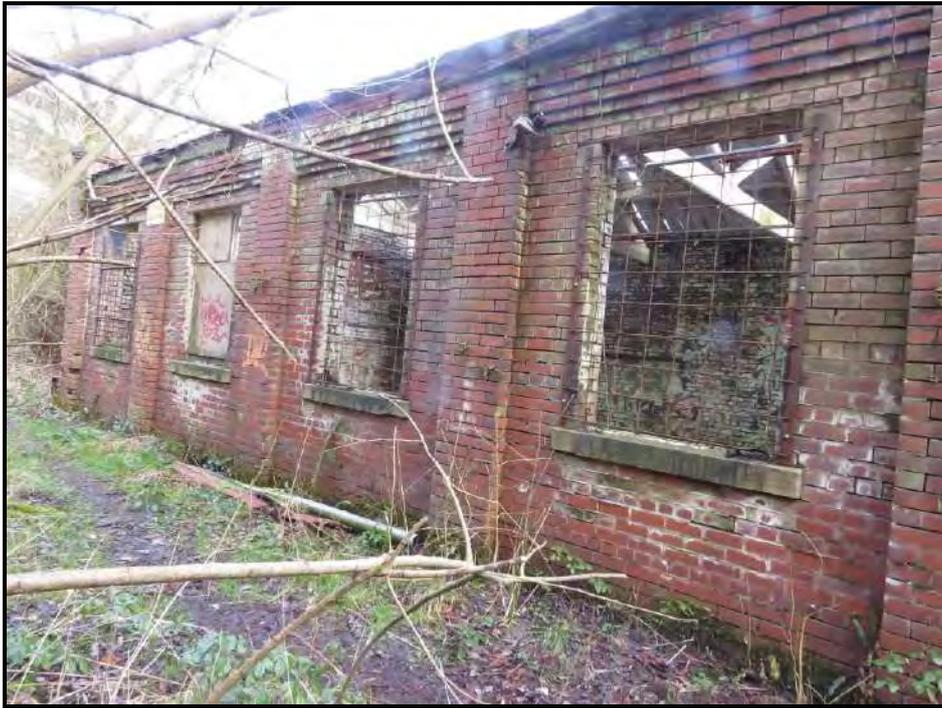
036 Panels 3 – 6, Unit 5

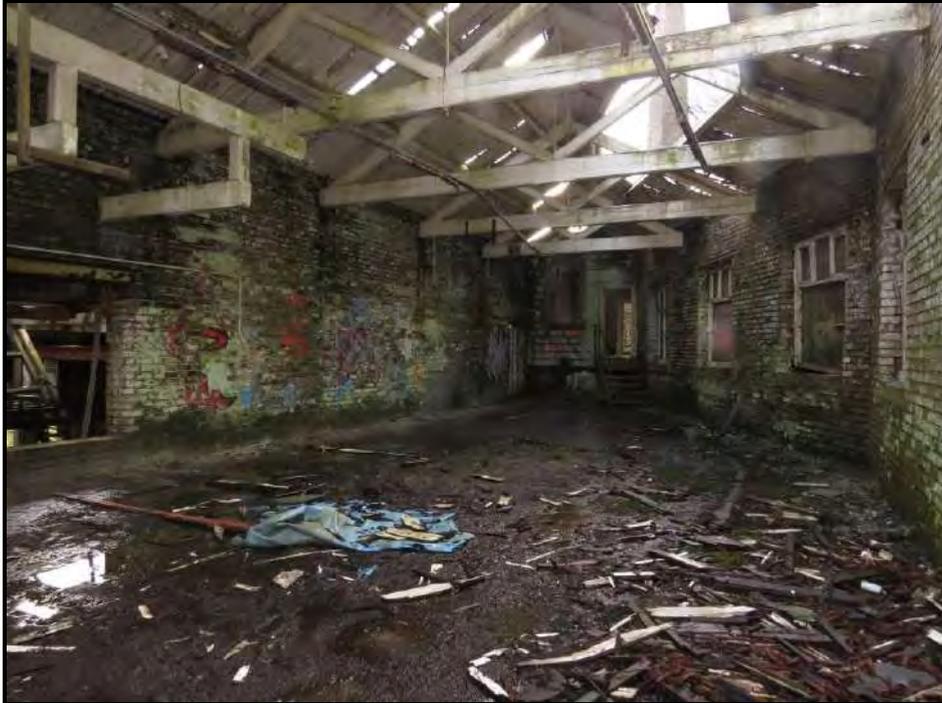
037 Unit 5 internal looking North East – South West

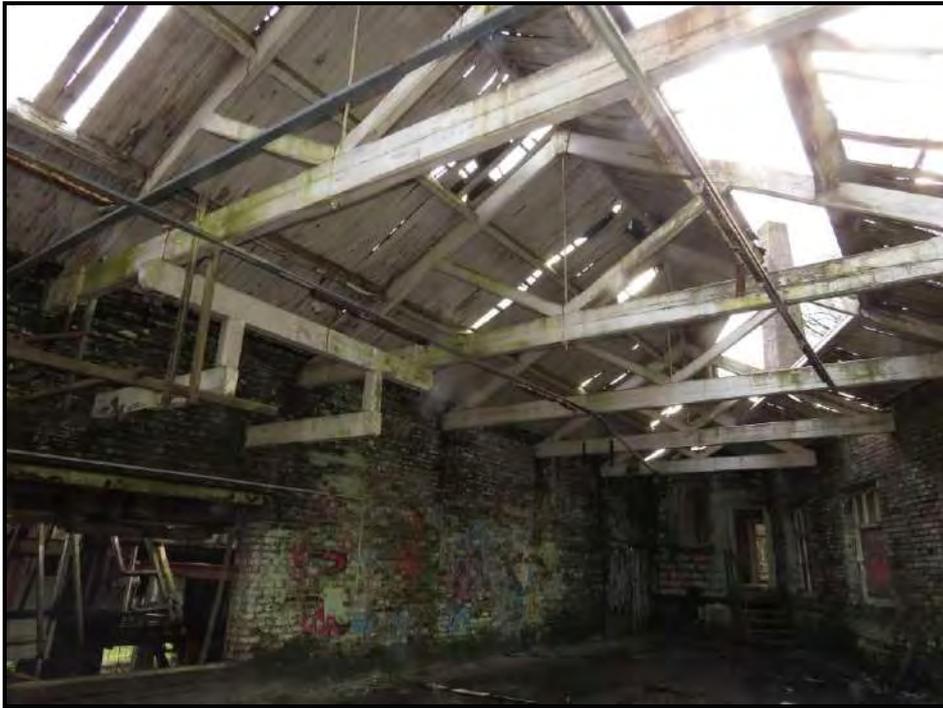
038 Tied rafter roof support

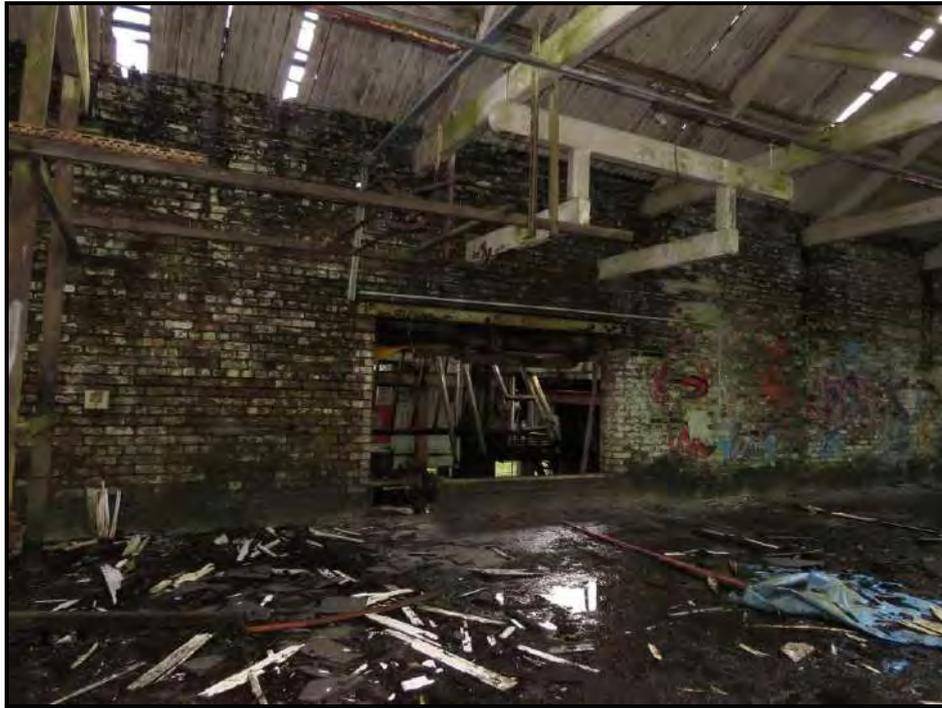
040 Cross wall to Unit 6
