Edenwood Mill (2020/013) – Binder 3

ENGINEERING REPORT 7170

**EDENWOOD MILL
EDENWOOD LANE
OFF BOLTON ROAD NORTH
RAMSBOTTOM
BL0 0EX**

13.03.2020 MP/CH

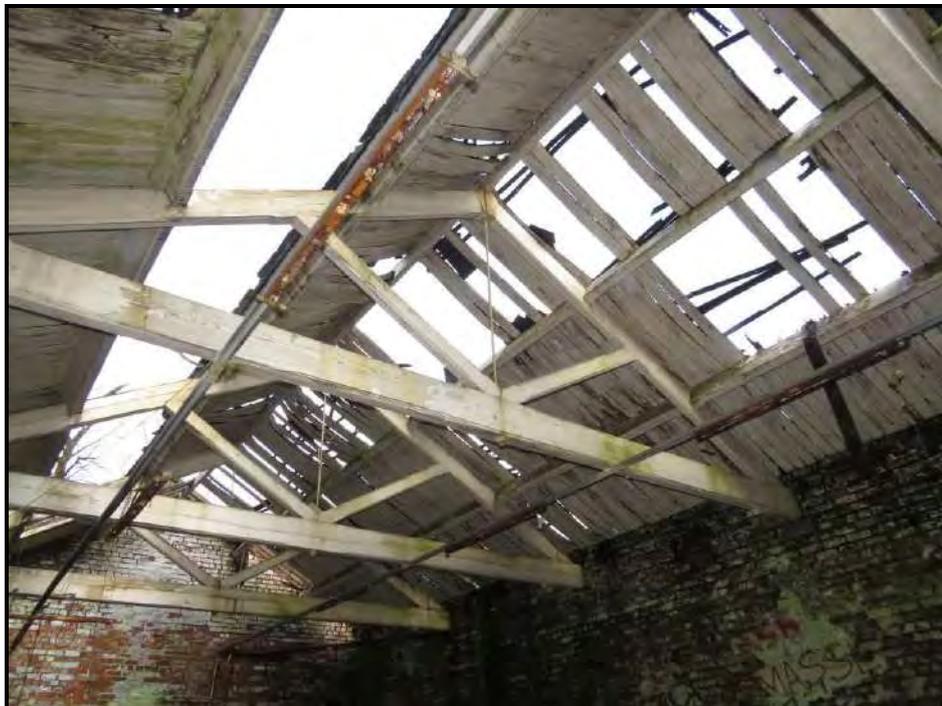
041 King post truss – general arrangement

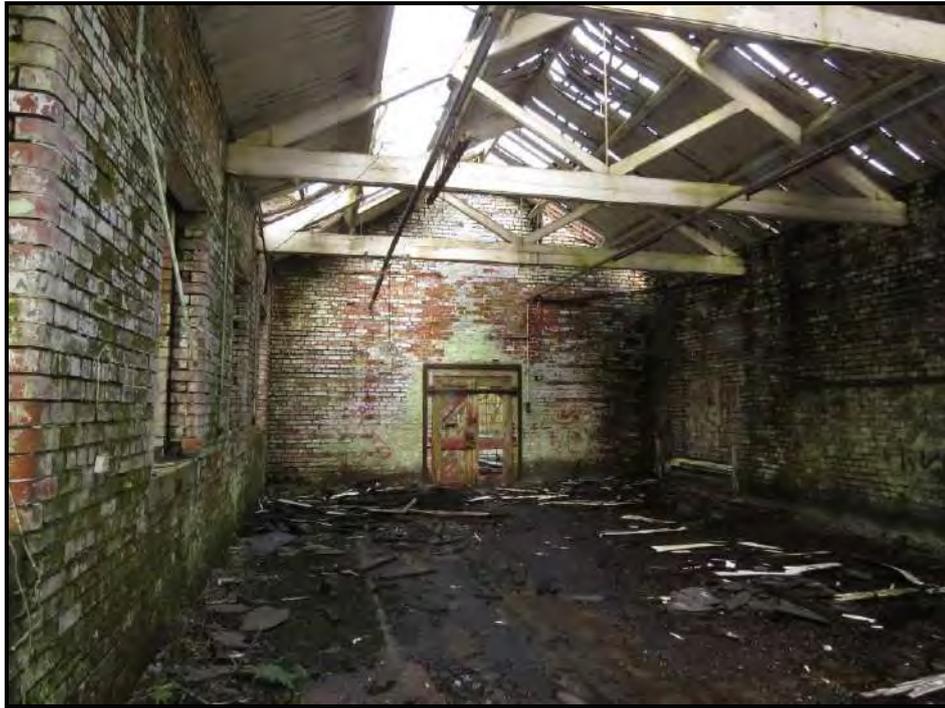
042 North East gable Unit 5

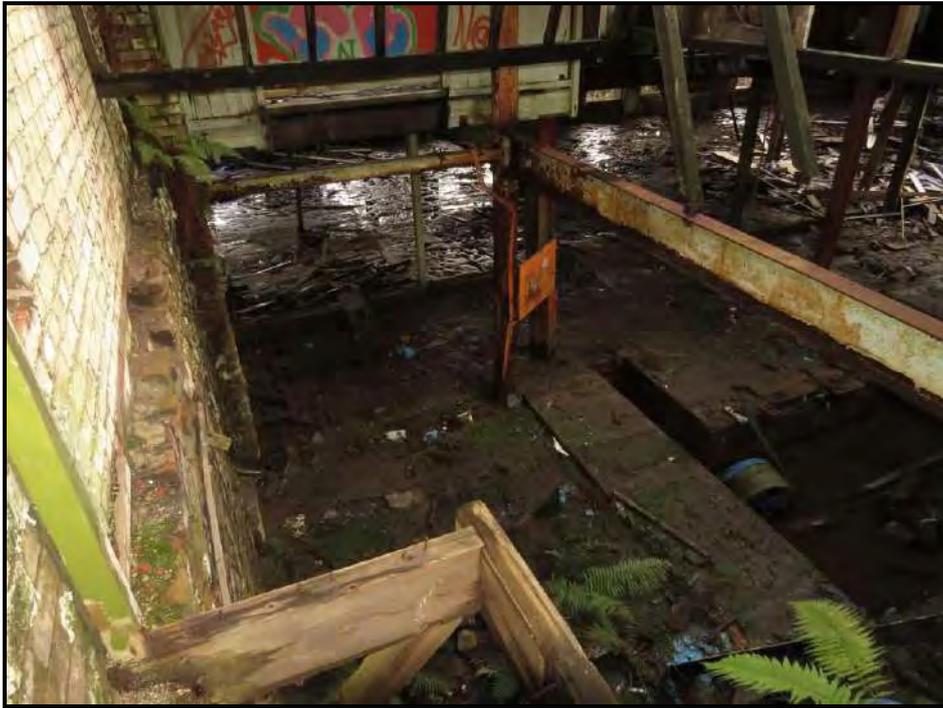
044 Collapsed first floor Unit 6 to ground floor Unit 6

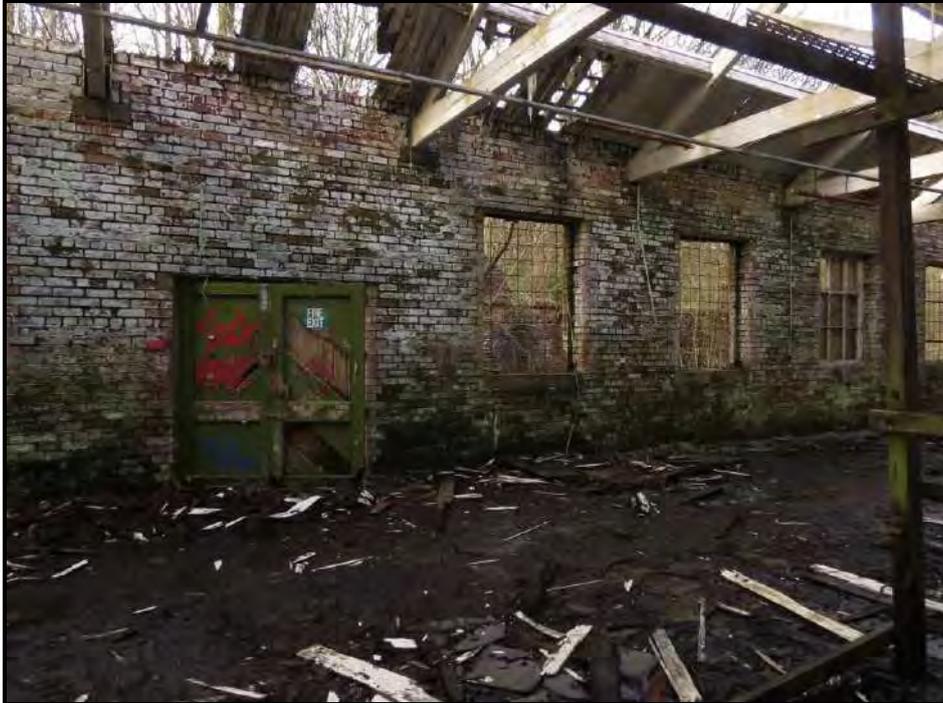
045 North West wall to Unit 5

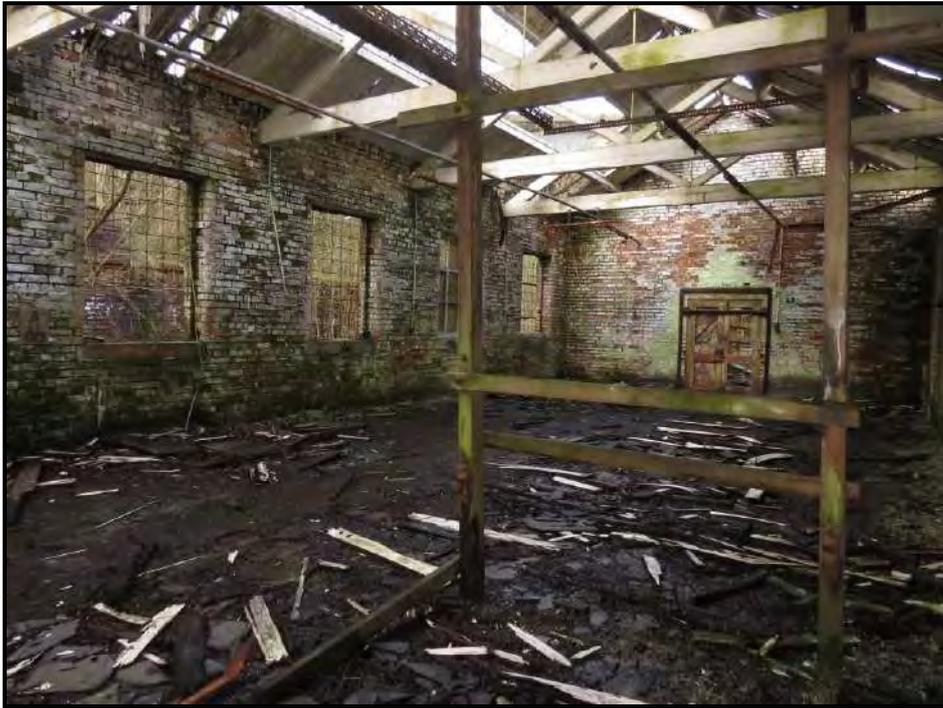
046 Northern corner Unit 5

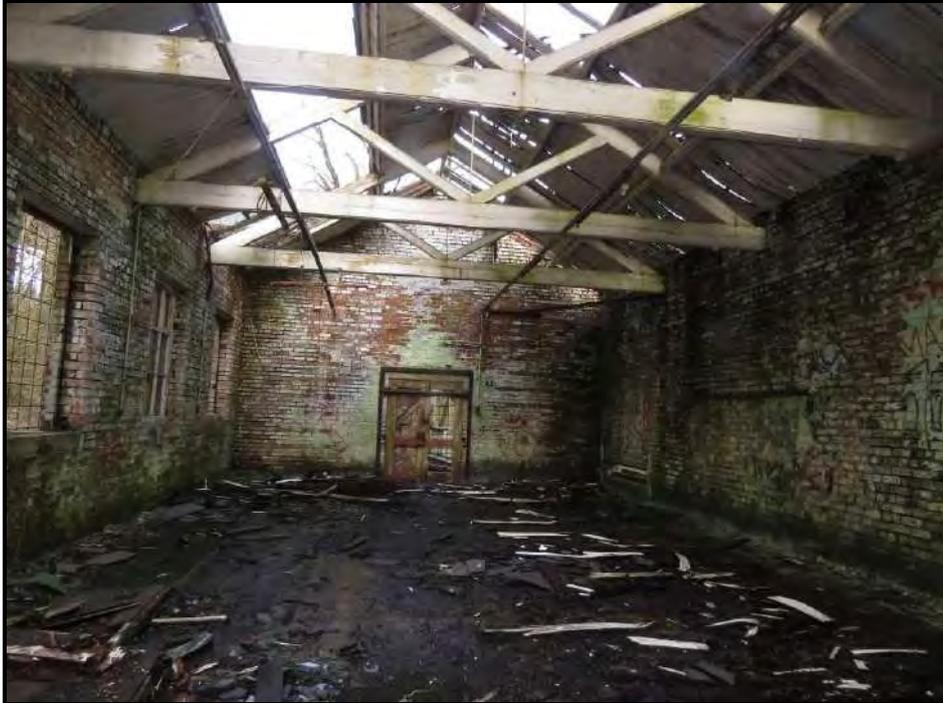
047 North East gable to Unit 5, internal

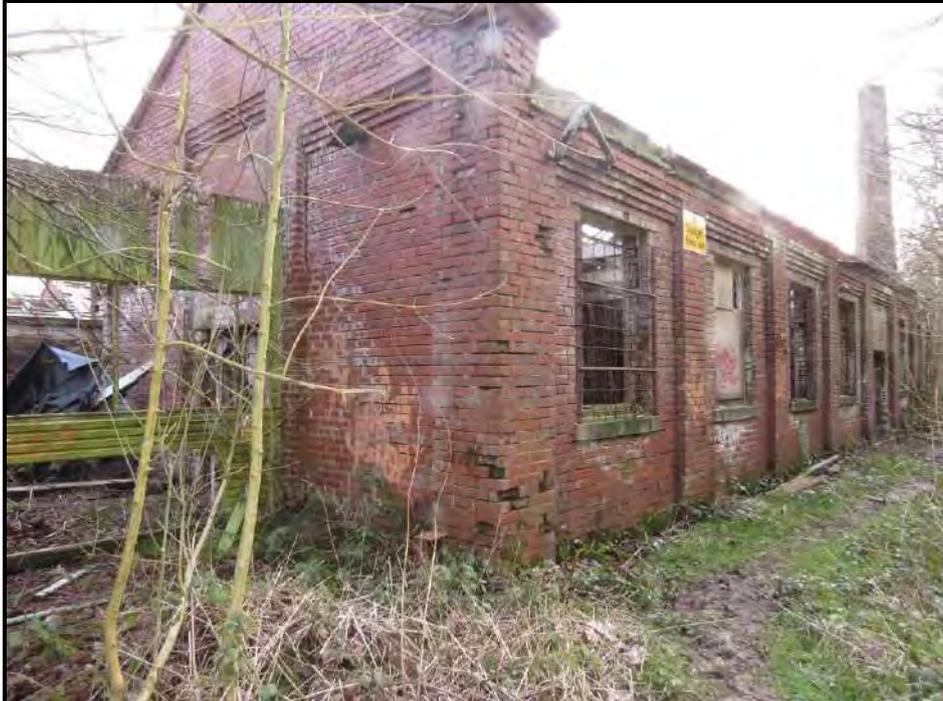
049 Northern corner

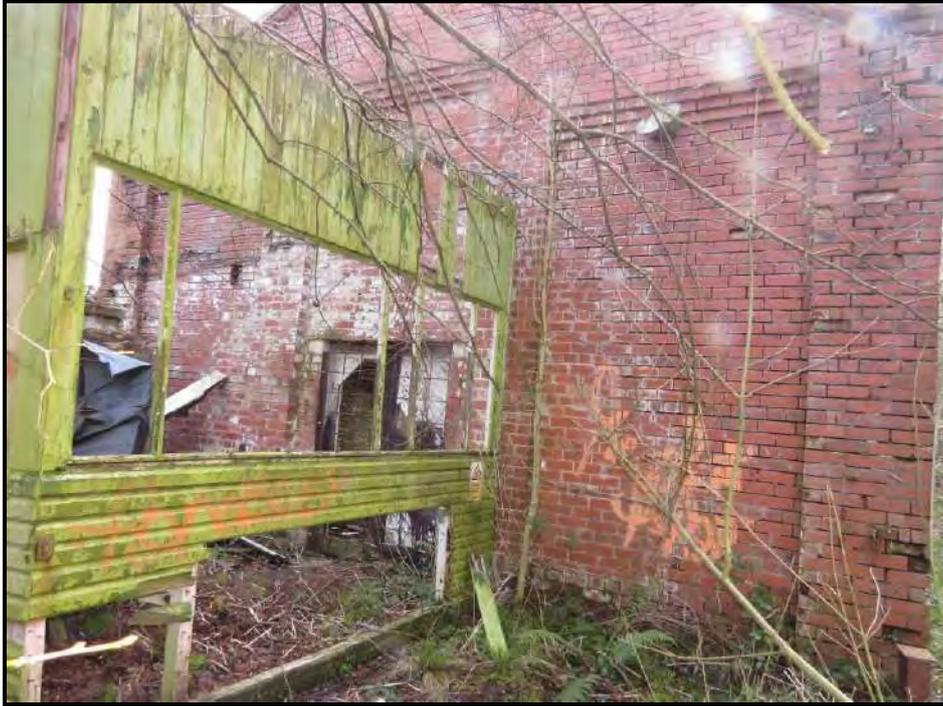
050 North Eastern gable

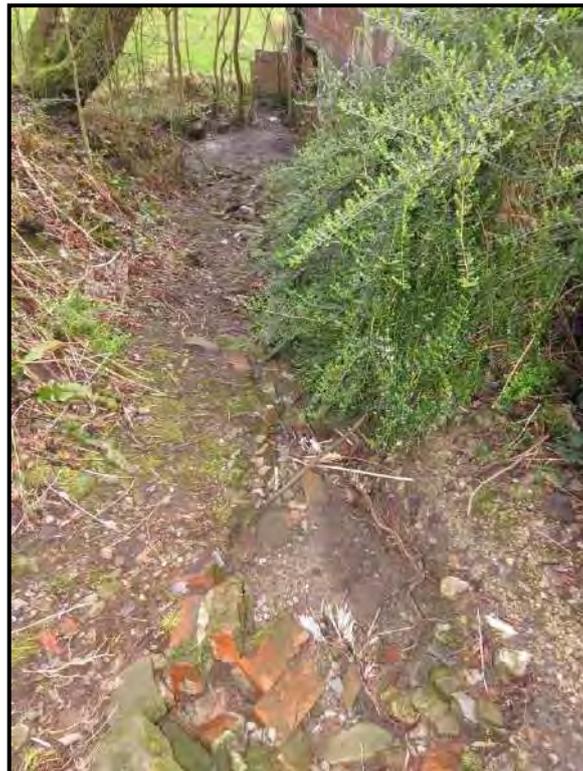
051 Water erosion to slope

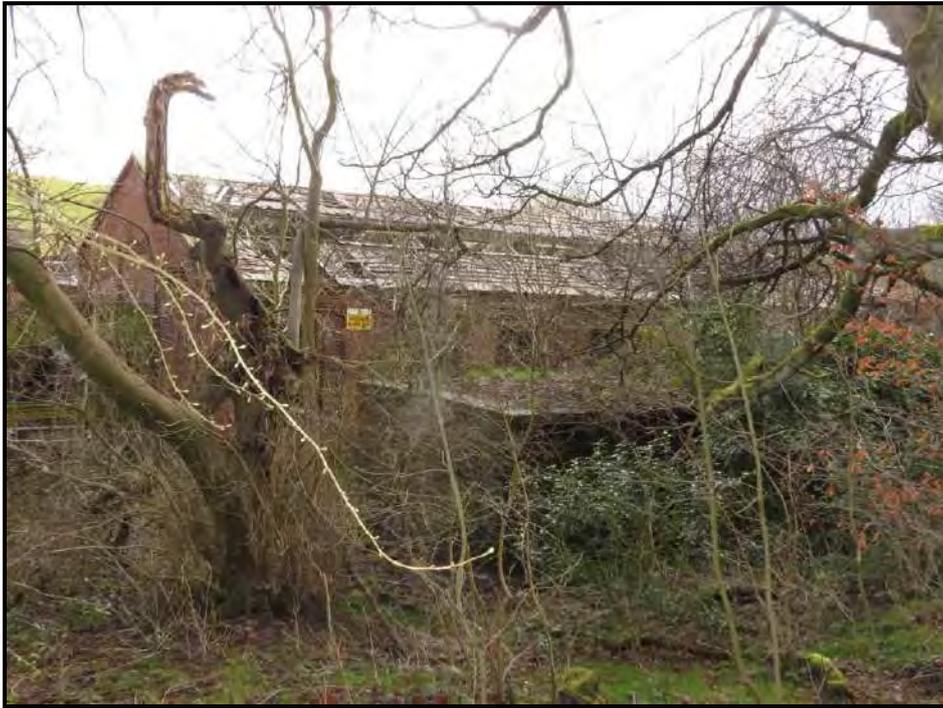
117 Unit 5, Northern corner

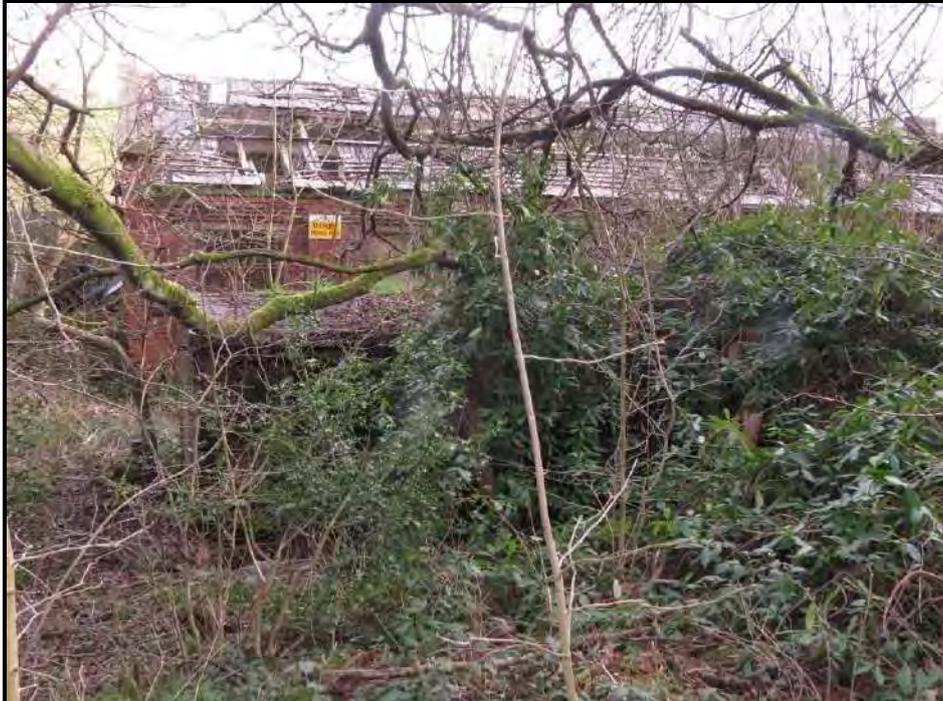
118 Unit 5, North West6 rear wall

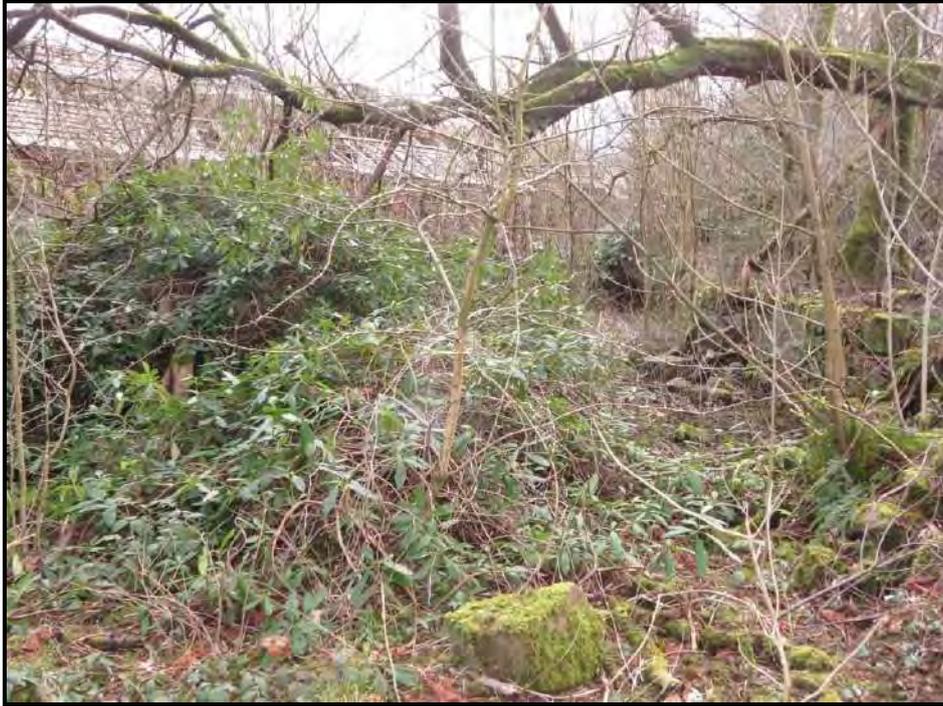
119 Unit 5, North West rear wall

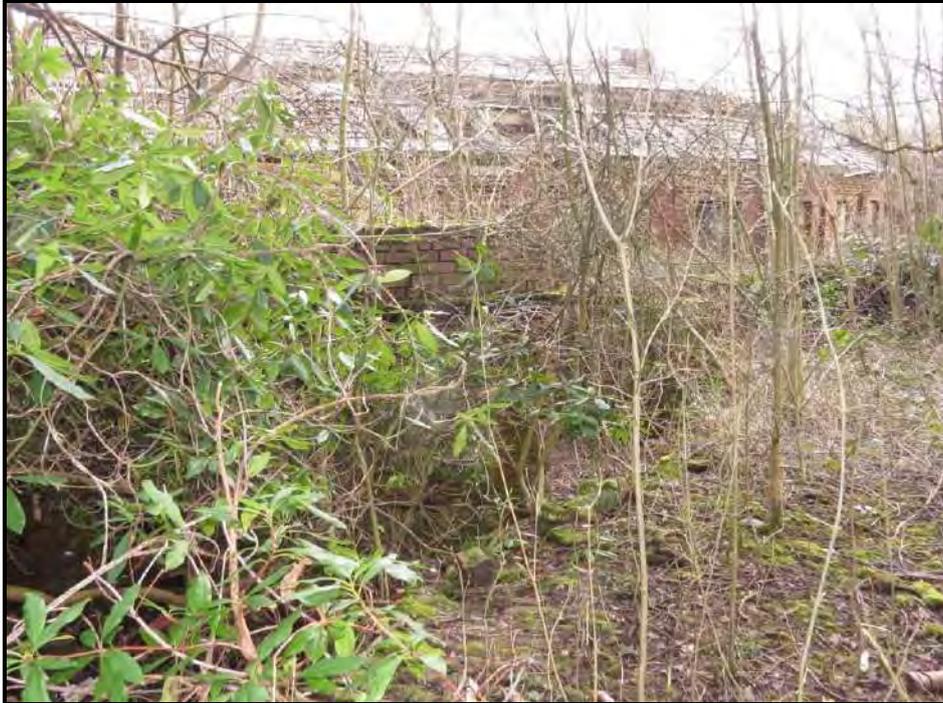
120 Unit 5, North West rear wall

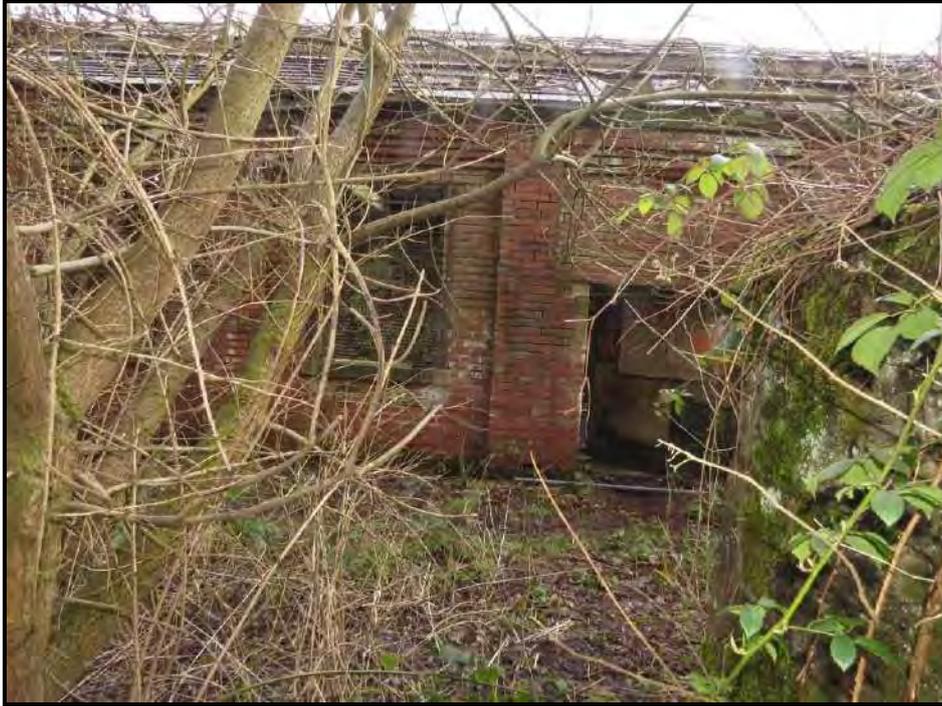
121 Unit 5, doorway – Panel 3, North West elevation

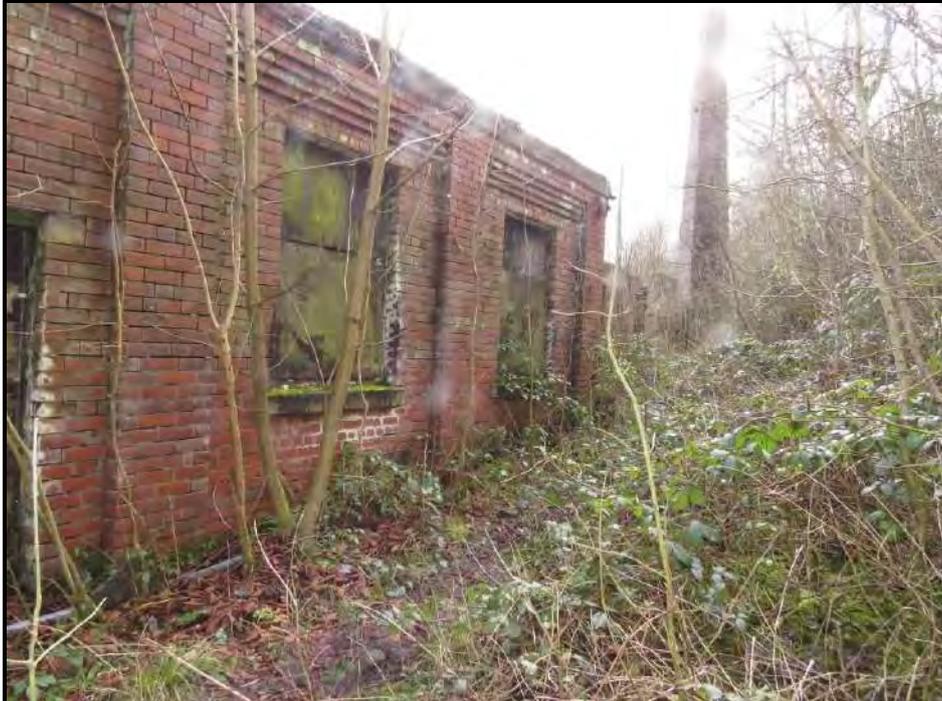
122 Unit 5, doorway – Panels 1 – 2, North West elevation

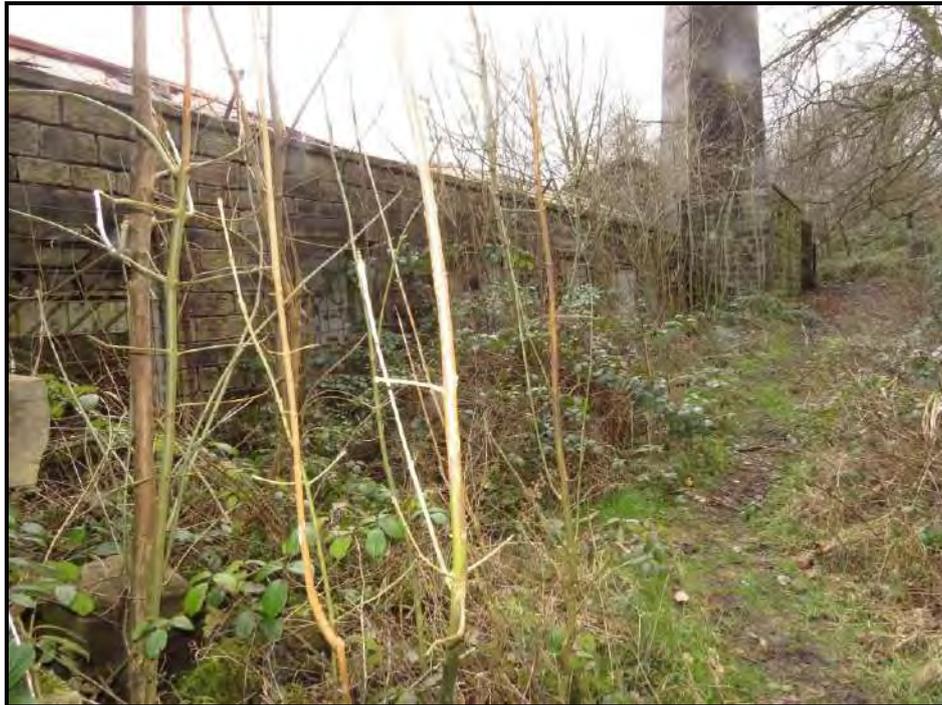
123 Unit 5, North West wall

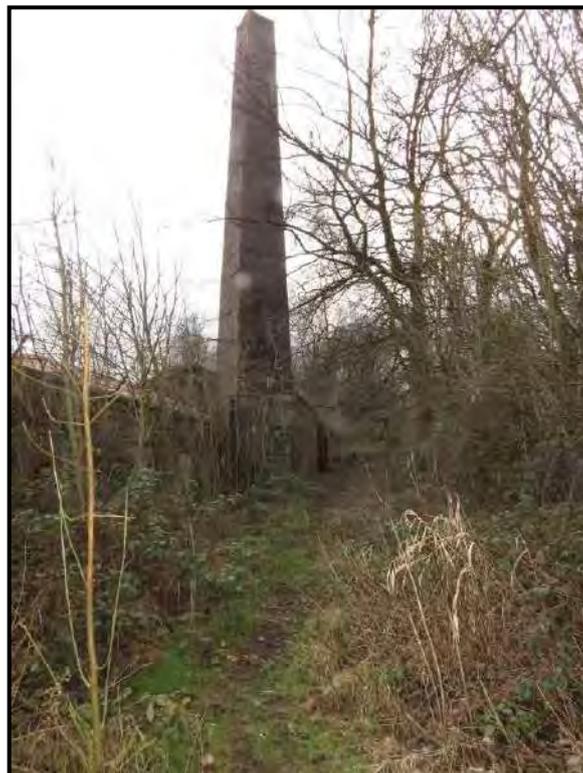
124 Chimney from North

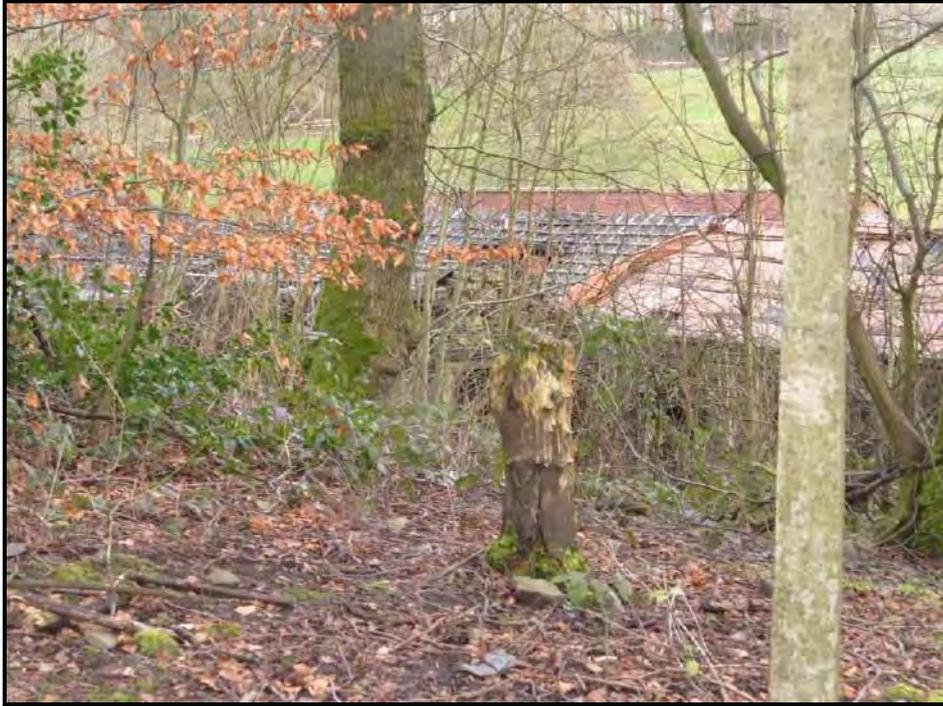
125 Rear roof, North West Unit 5

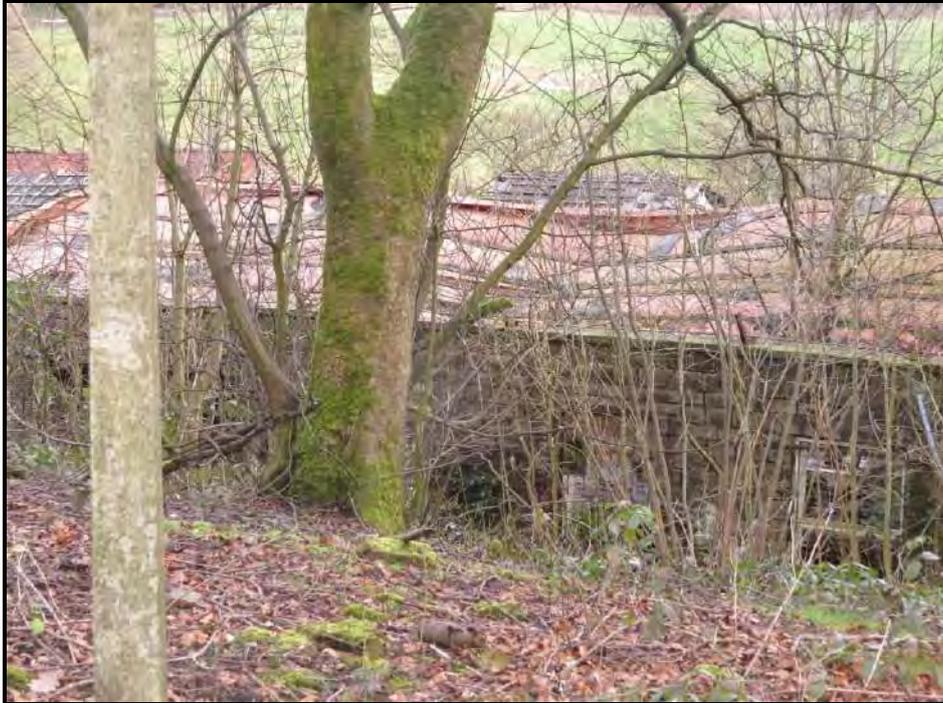
126 Rear roof, North West Units 2 - 6

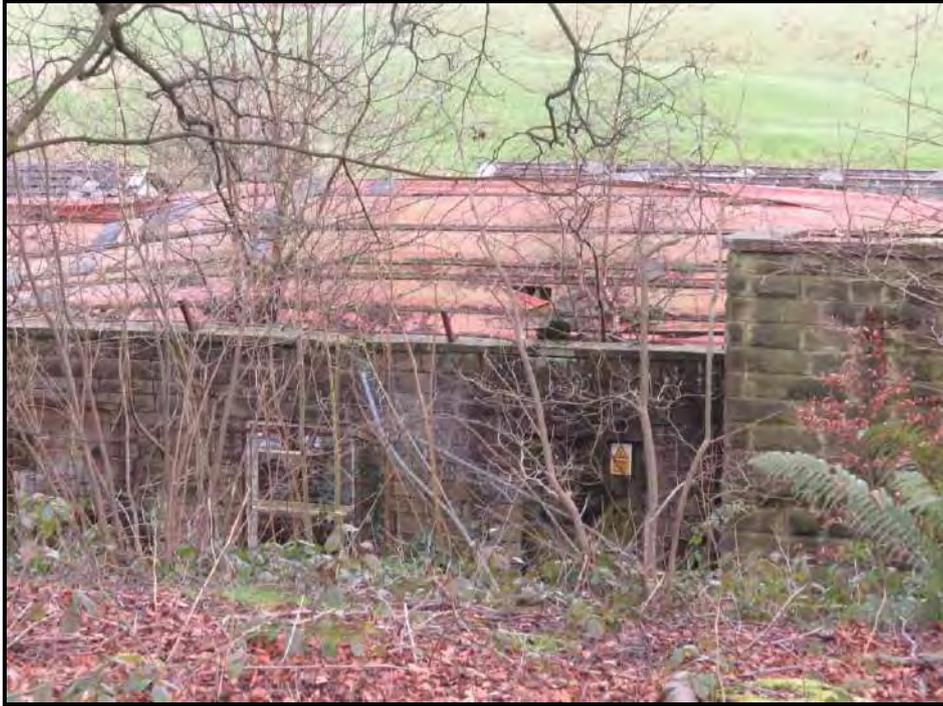
127 Rear roof, North West Units 2 - 3

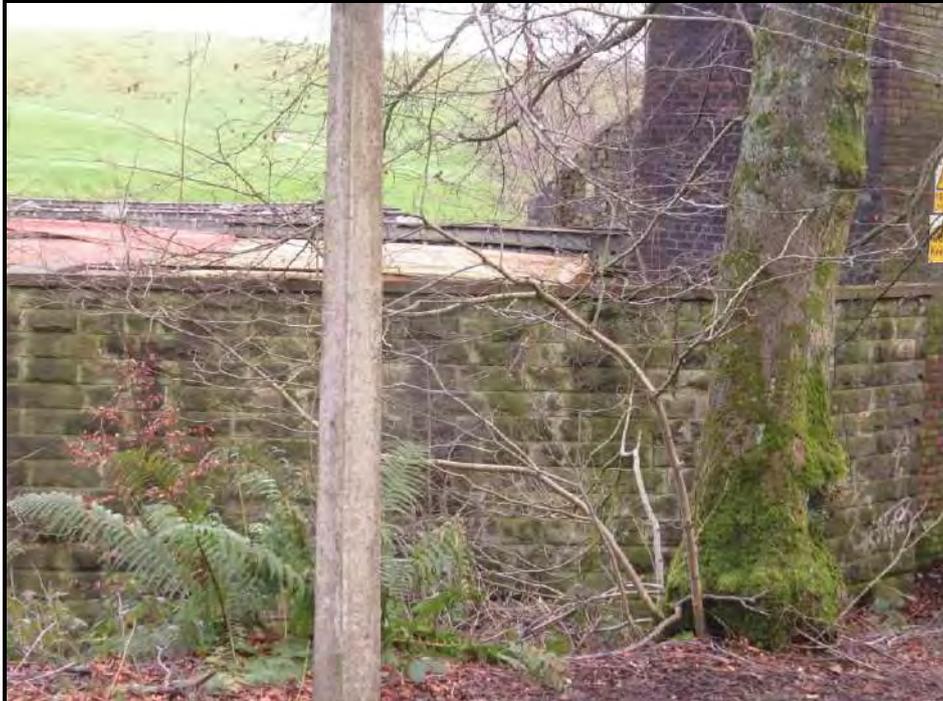
128 Rear roof, North West Unit 2 and chimney base

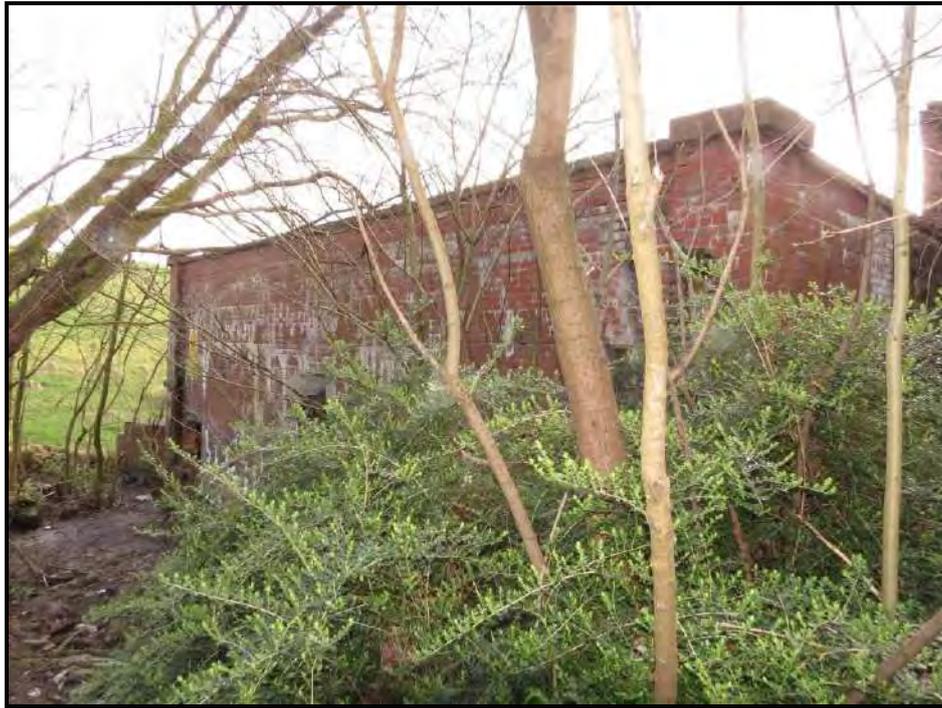
052 North Eastern wall

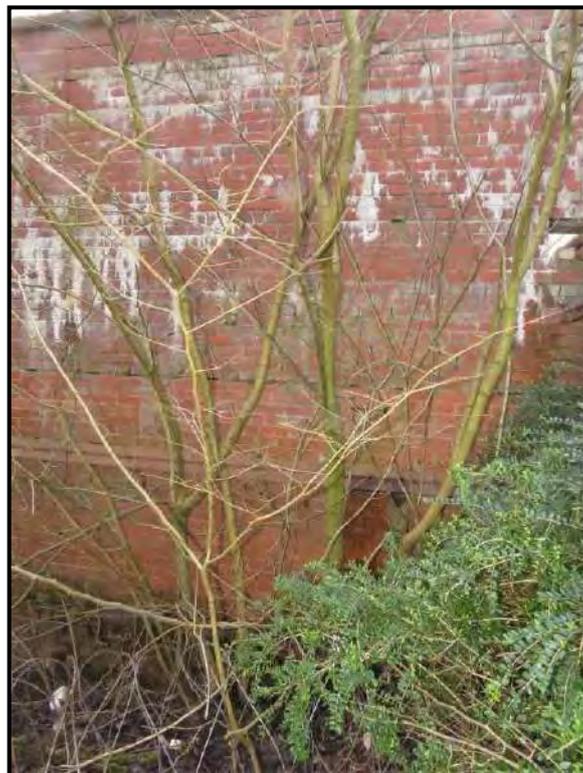
053 North Eastern flank to Unit 10

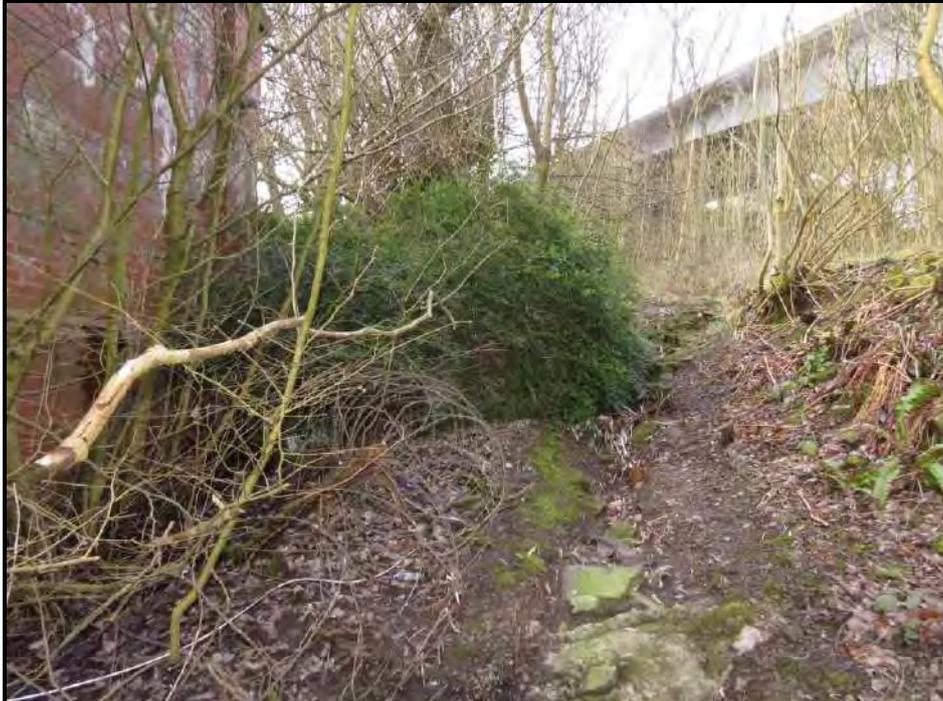
055 Eroded channel

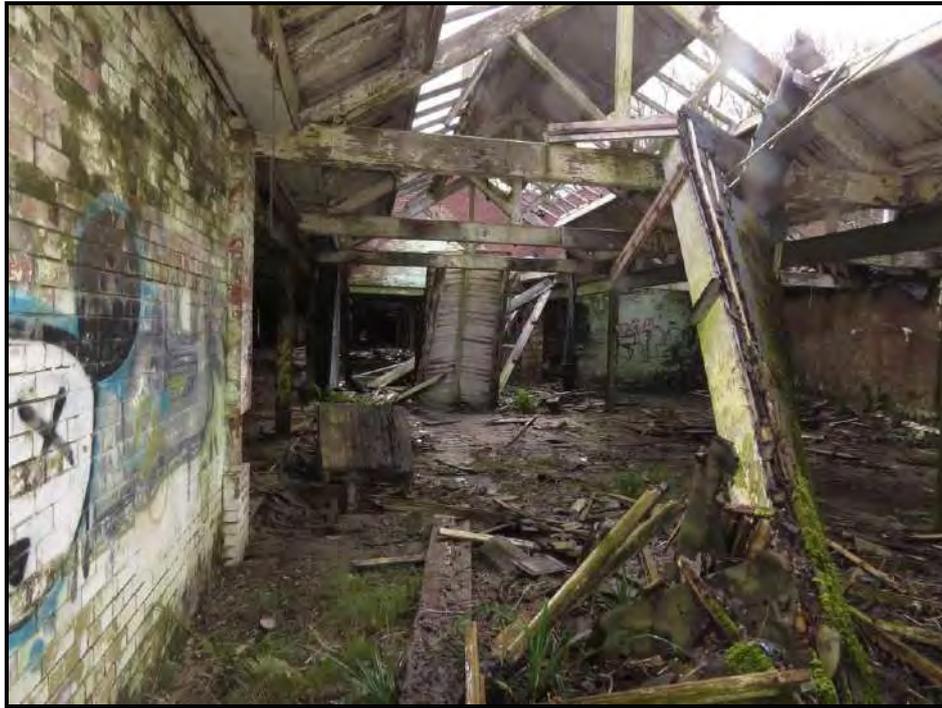
056 Ground floor, North East – South West (Unit 10) looking North East – South West

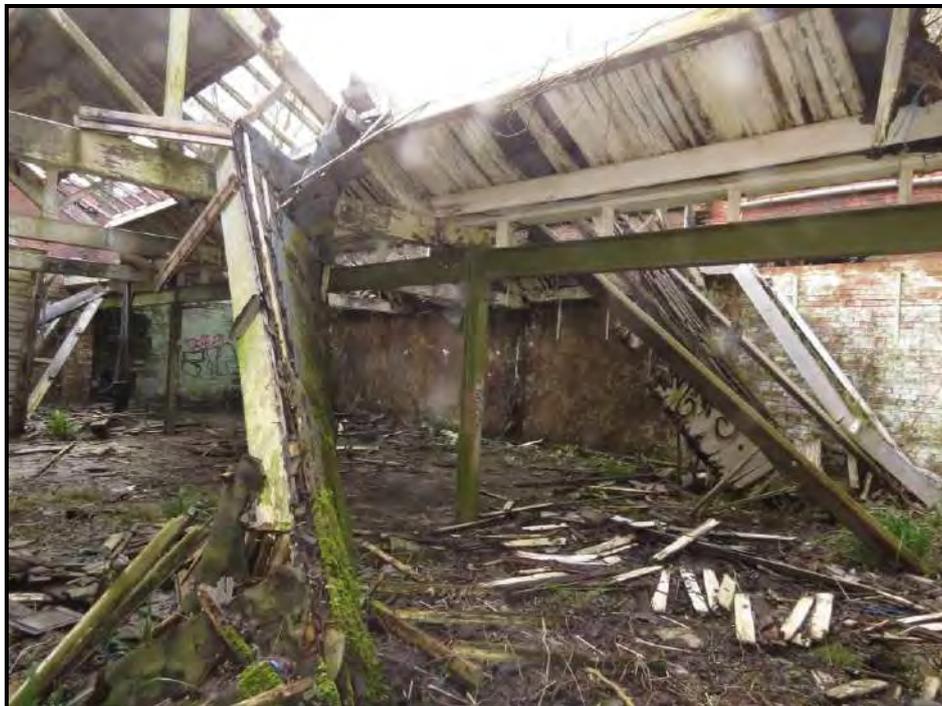
057 Unit 10 – 9, roof collapse

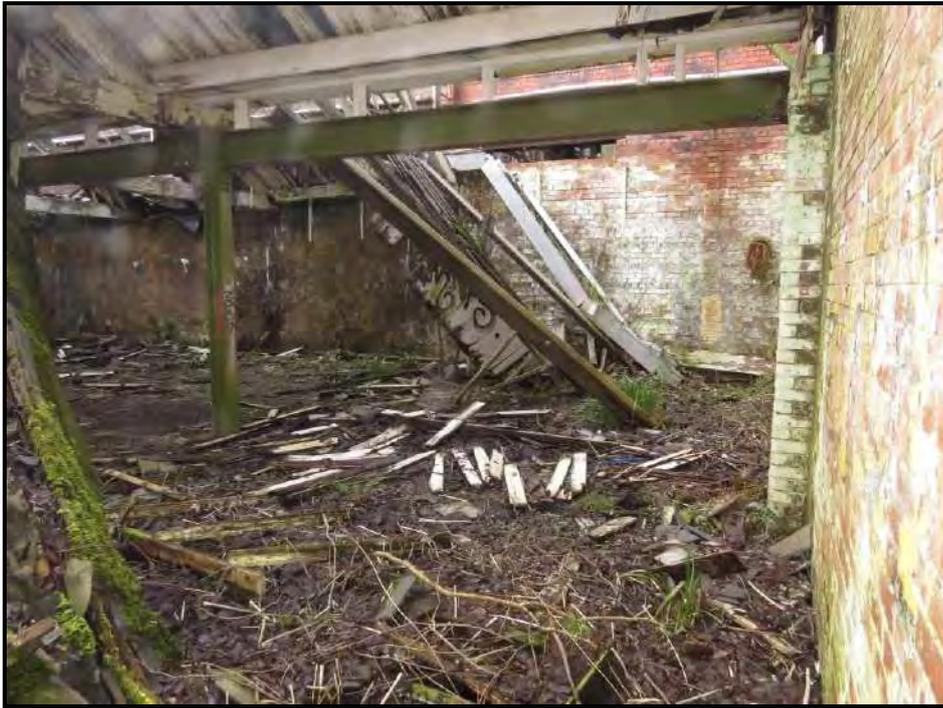
058 Unit 10 – 9, roof collapse

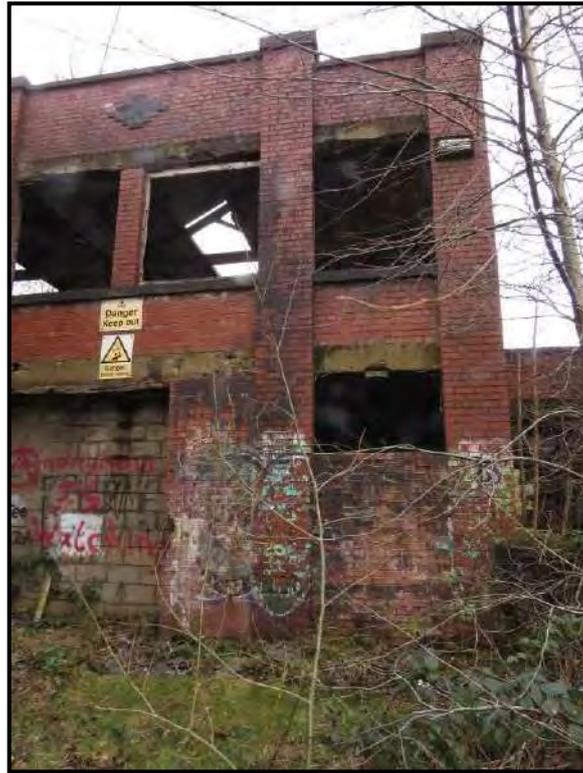
- 15.1 The South West elevation to the wall extends for a length in the order of 6 metres incorporating a central double bay between single windows. (Photographs 144, 145).
- 15.2 Spalling and reinforcement exposure is evident to all four lintels at both levels. (Photographs 146, 147).

145 Unit 4 South West elevation

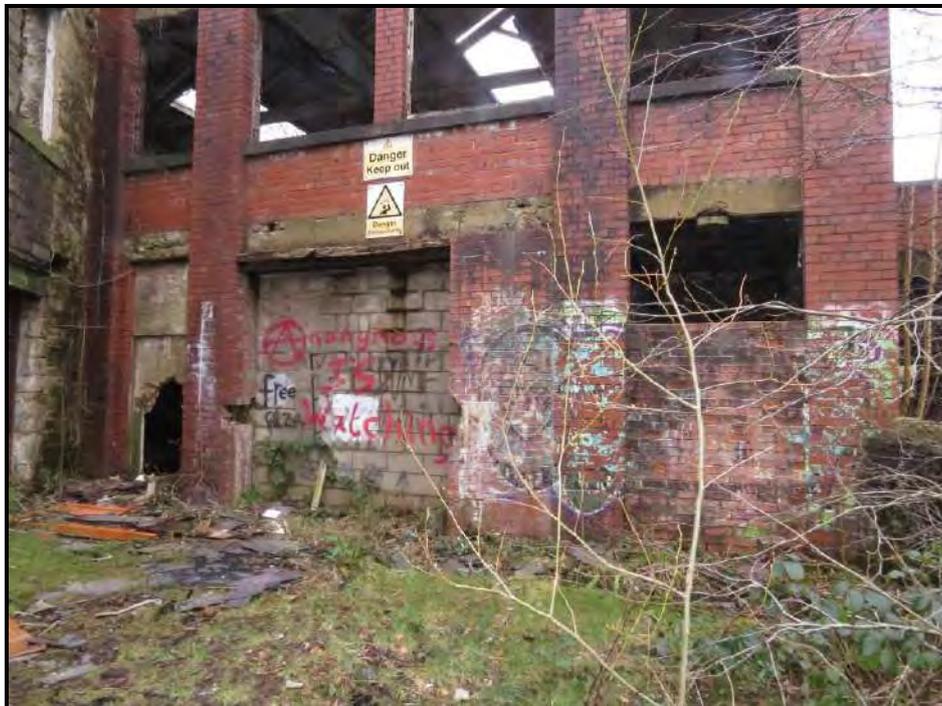
146 Ground floor, South West elevation, Unit 4

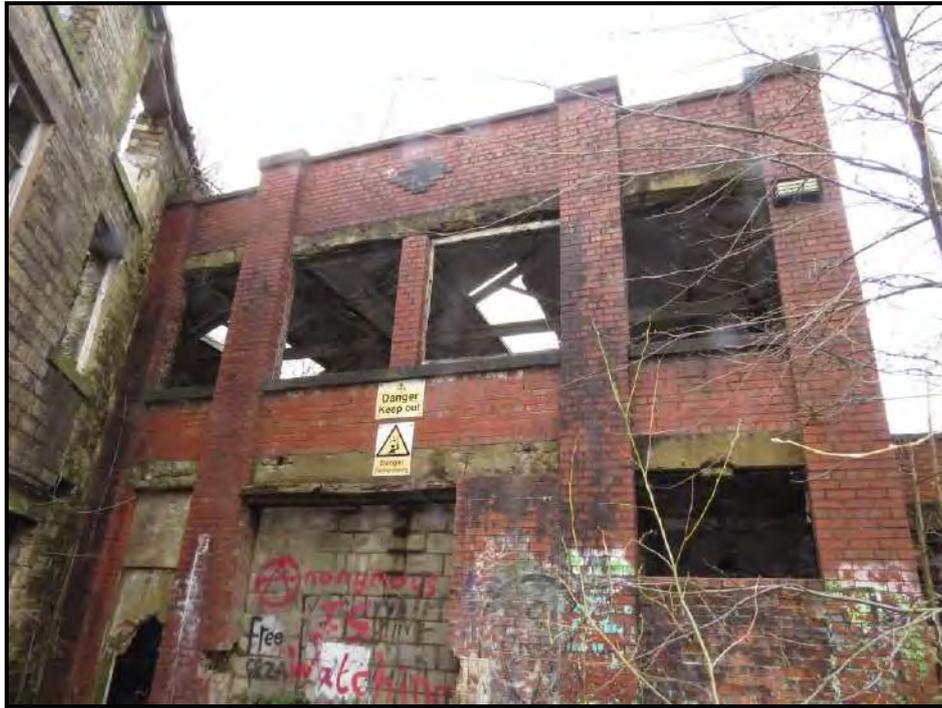
147 South West elevation Unit 4

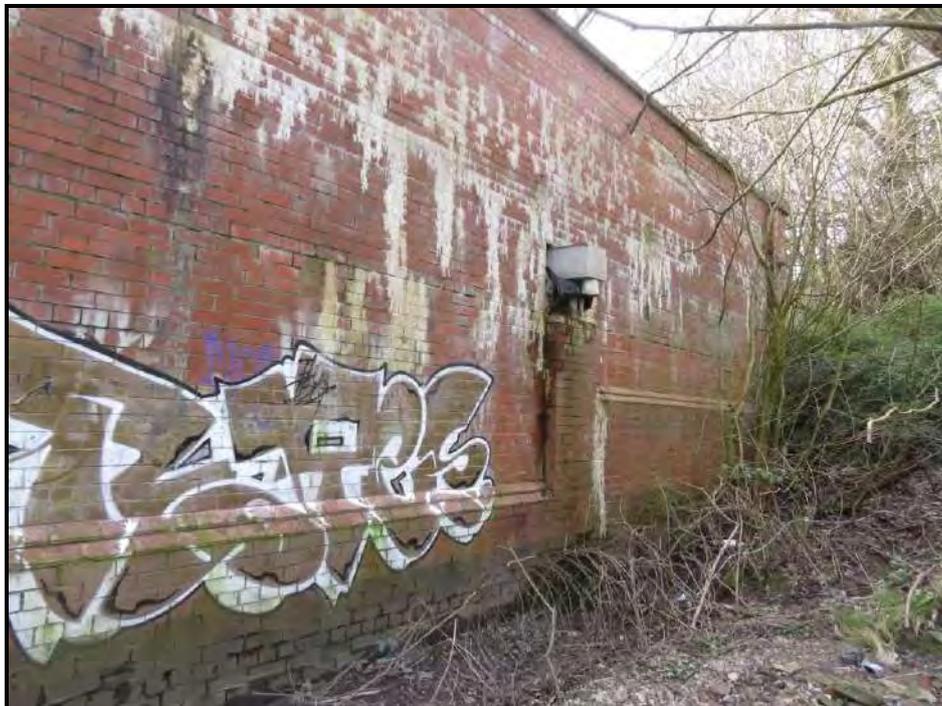
116 Valley gutter outlet, Units 9 - 10

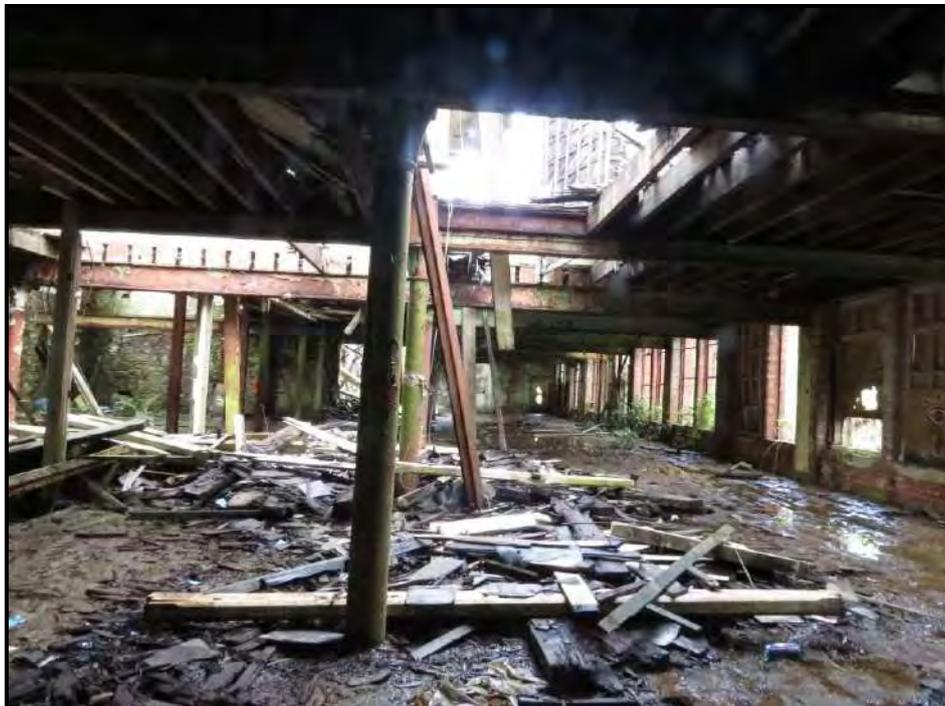
- 11.3 On the original three storey back to earth Unit no safe internal access was available but the condition of the second floor and roof structure viewed from the rear windows clearly emphasises the total roof collapse with high probability of further deterioration to timber floors.

157 Centre floor and roof collapse

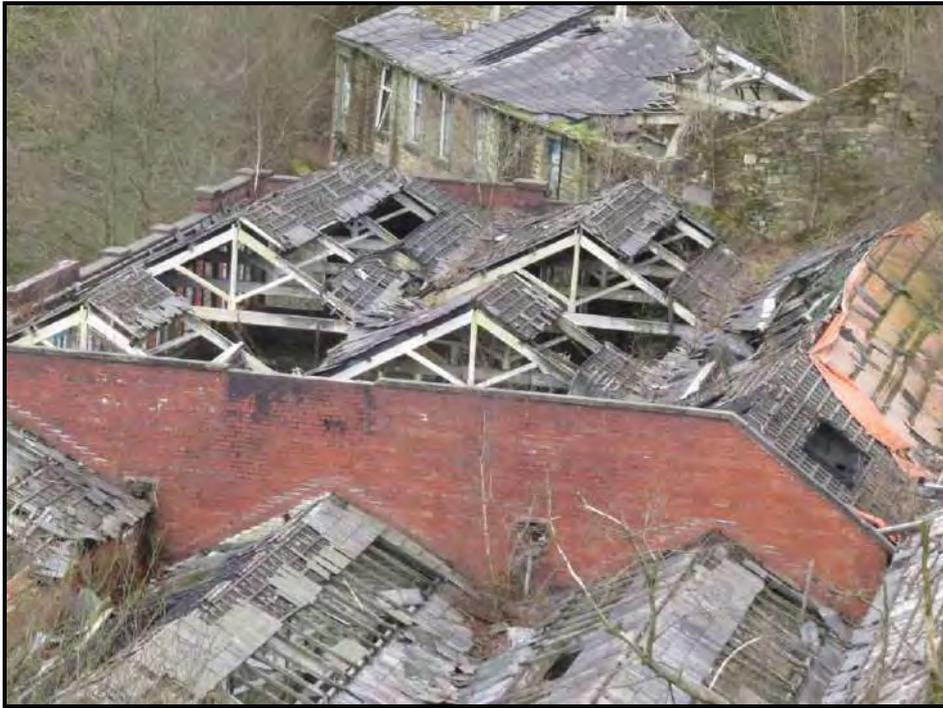
169 Cross wall centre/South East, Units 2, 3 and 4

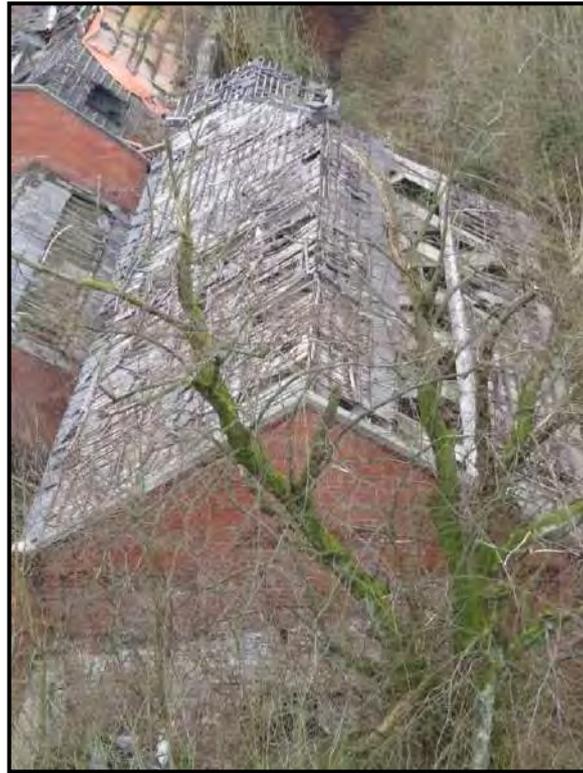
171 Damaged roof Unit 5

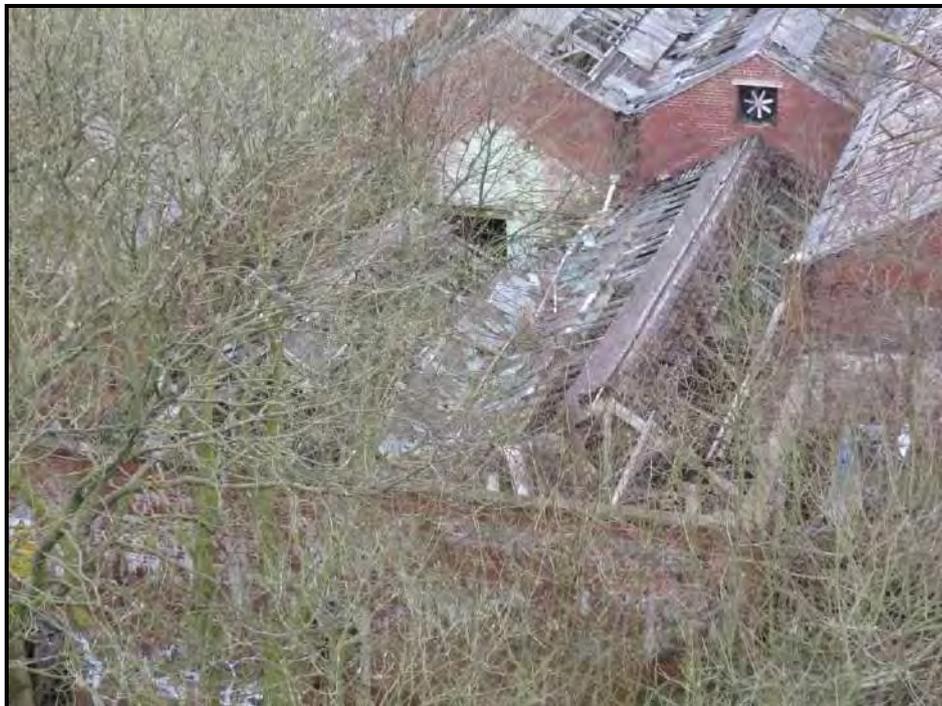
172 Damaged roof Units 9, 10 and 8
