Edenwood Mill (2020/013) – Binder 3

ENGINEERING REPORT 7170

**EDENWOOD MILL
EDENWOOD LANE
OFF BOLTON ROAD NORTH
RAMSBOTTOM
BL0 0EX**

13.03.2020 MP/CH

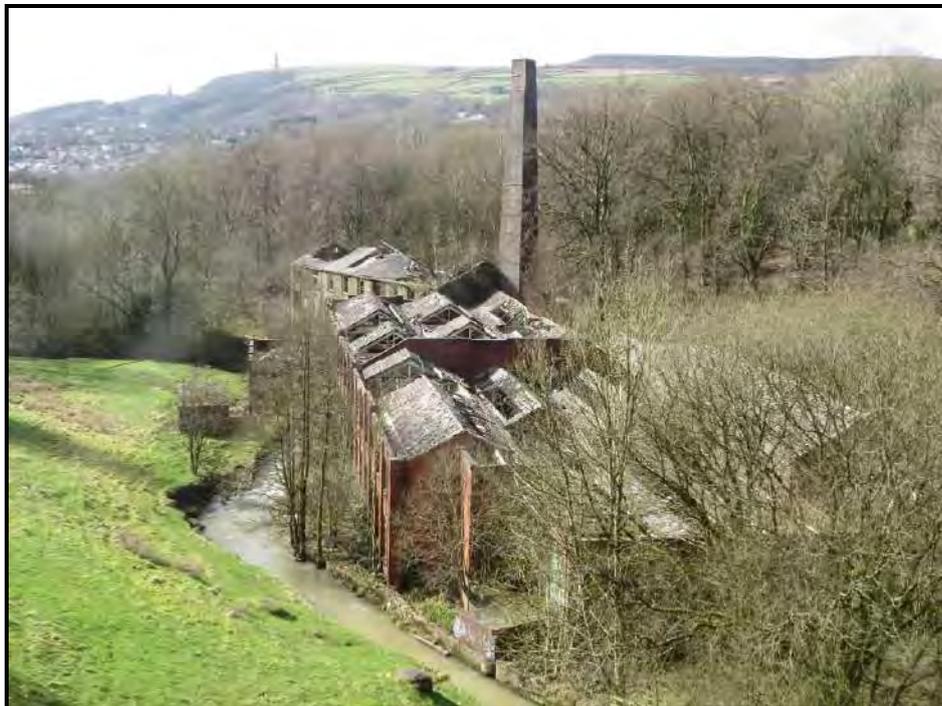
174 Deterioration to mill view from North West

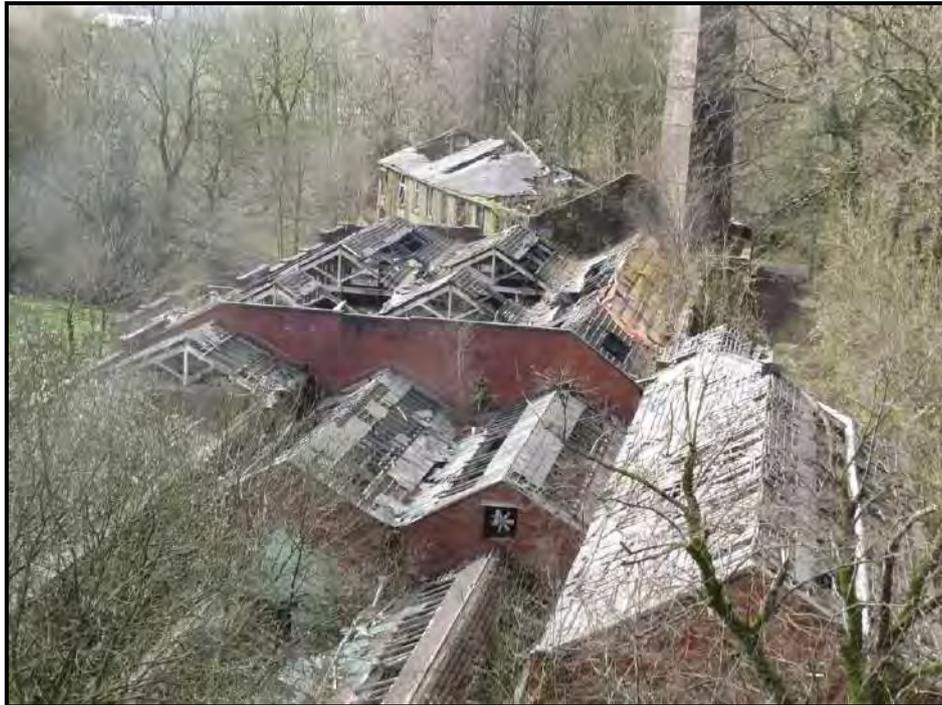
- 16.10 In the central section Units 7 – 10 roof debris is evident. (Photographs 271, 272, 273).
- 16.11 Photograph 179 shows the general poor condition of the roof structures to the whole of the mill complex.

179 Rear Northern aspect

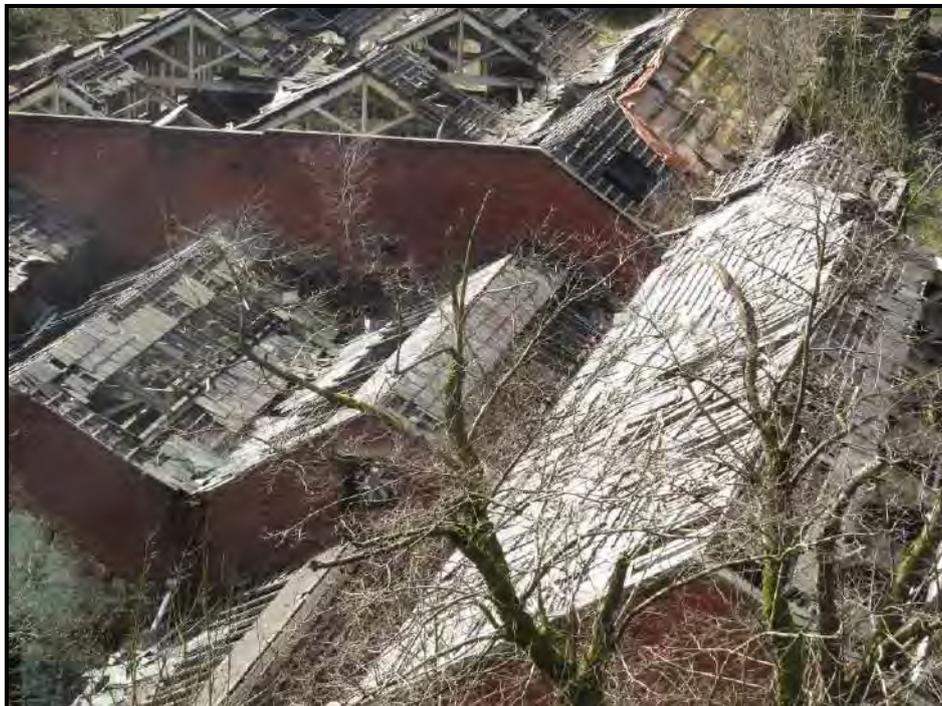
184 Roof damage North – North East corner

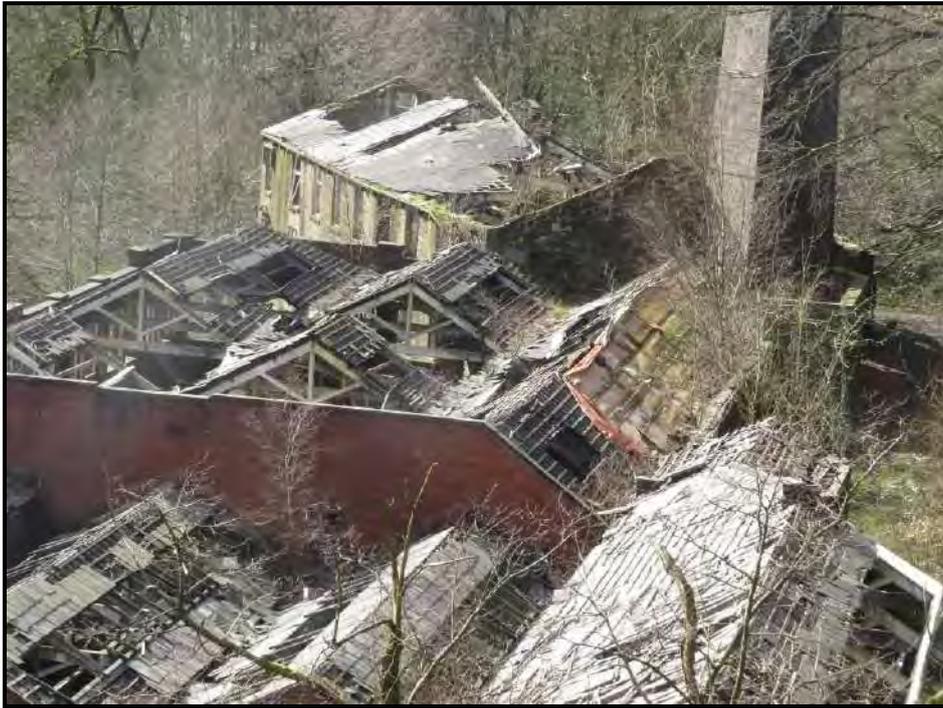
185 Damage to South Western section and original mill

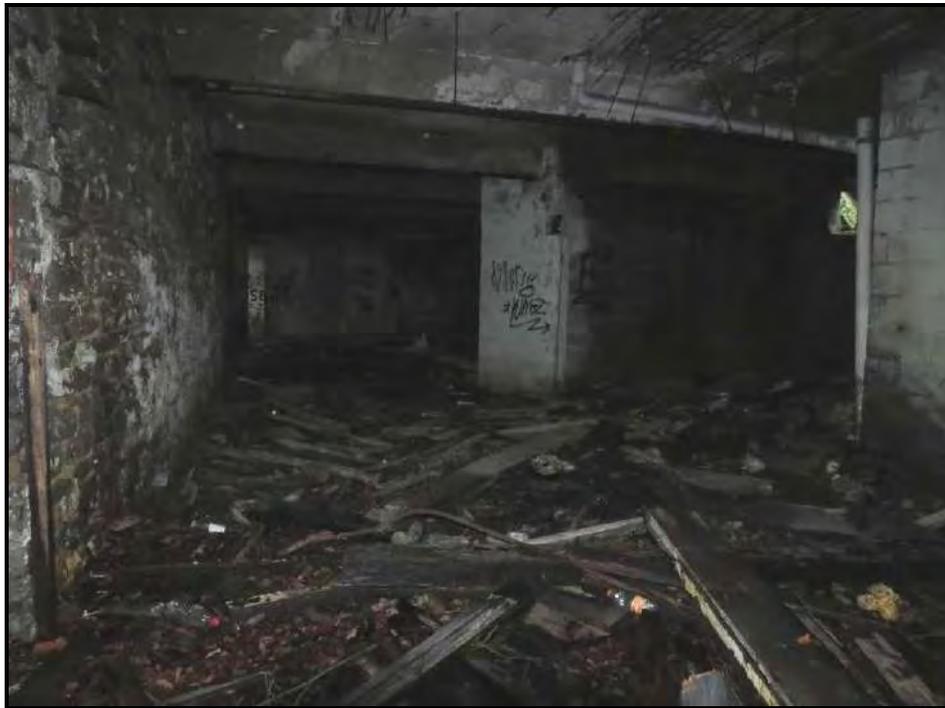
244 Chimney base

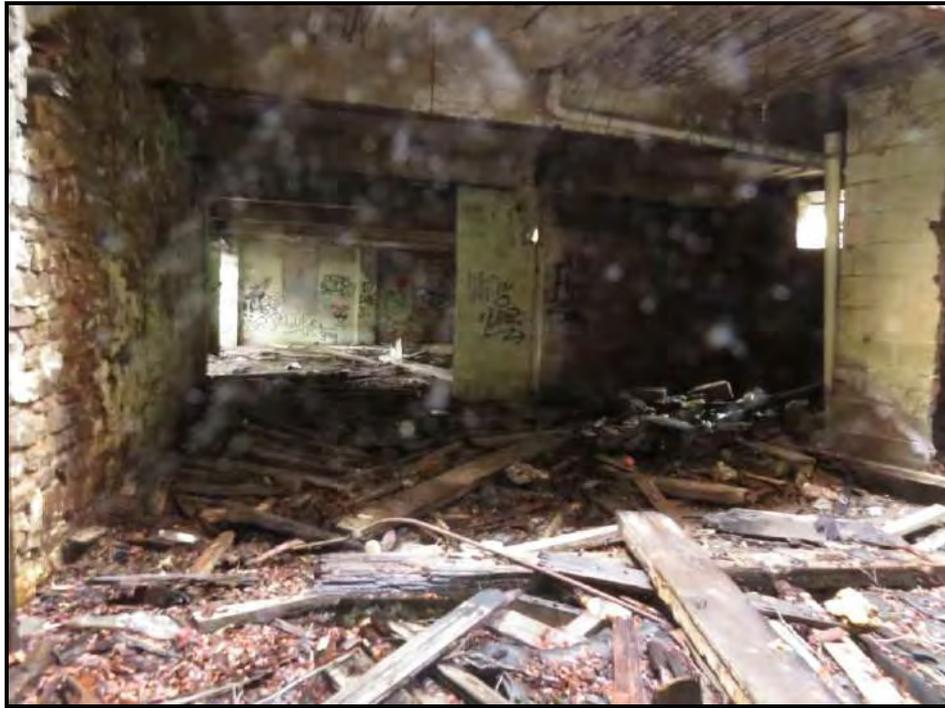
245 Ground floor Unit 4 looking South West

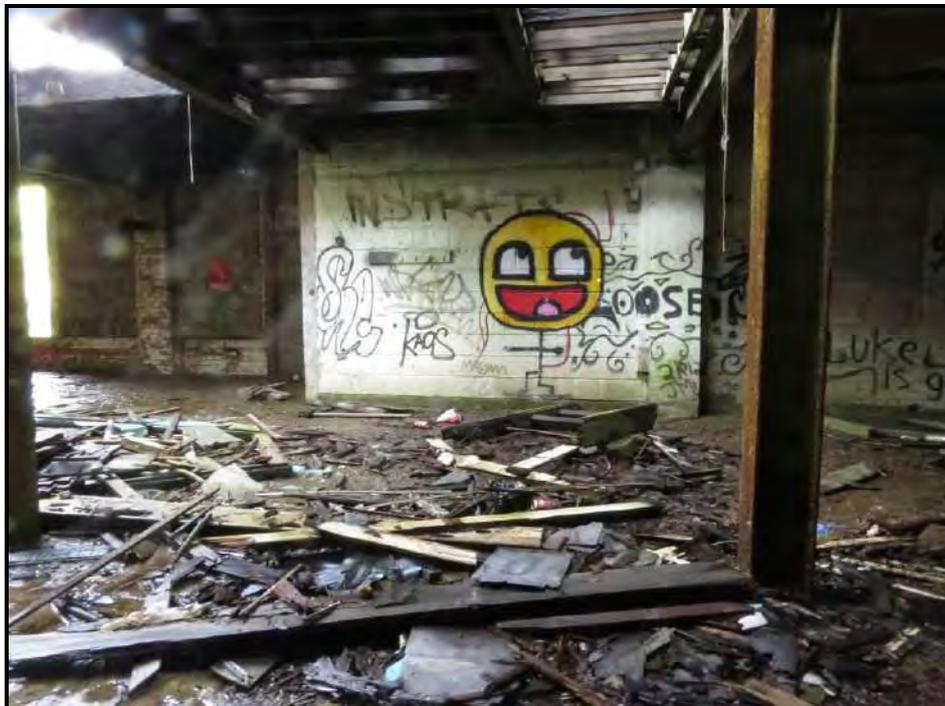
247 Internal wall to river outshoot

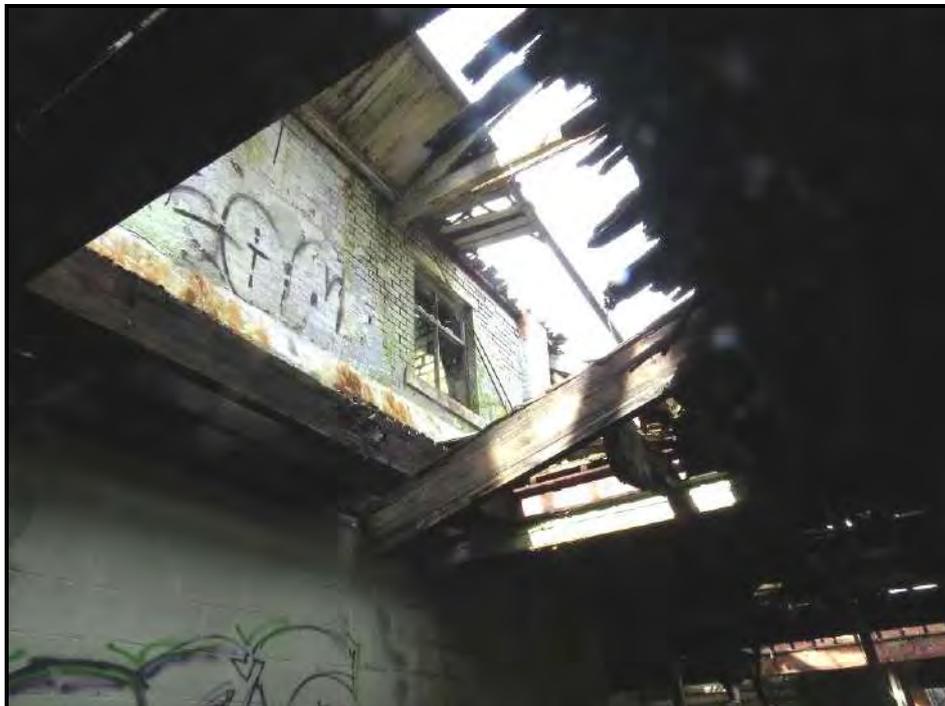
249 Unit 3 – 2 floor and roof collapse

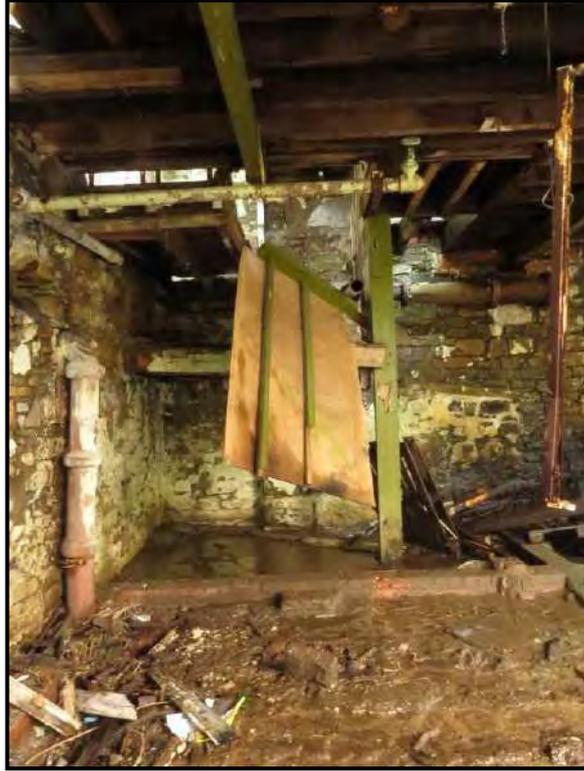
251 Internal cross wall, floor collapse

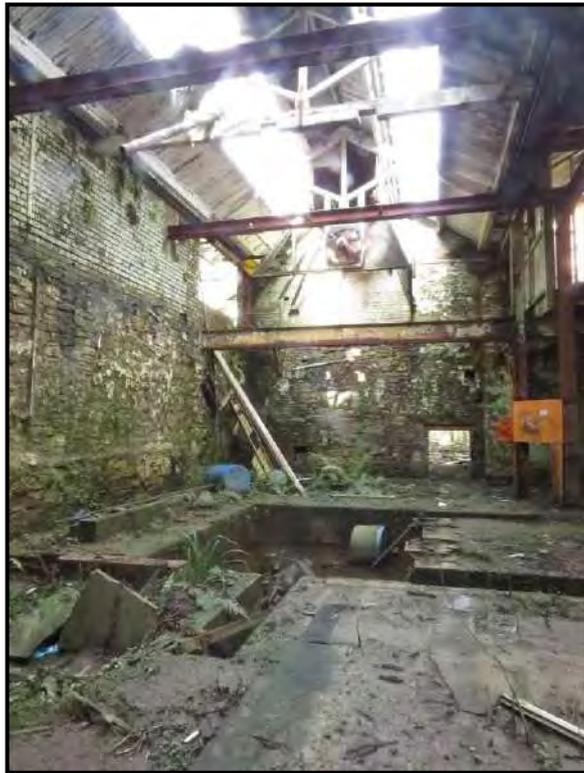
252 Ground floor, Units 3 - 2

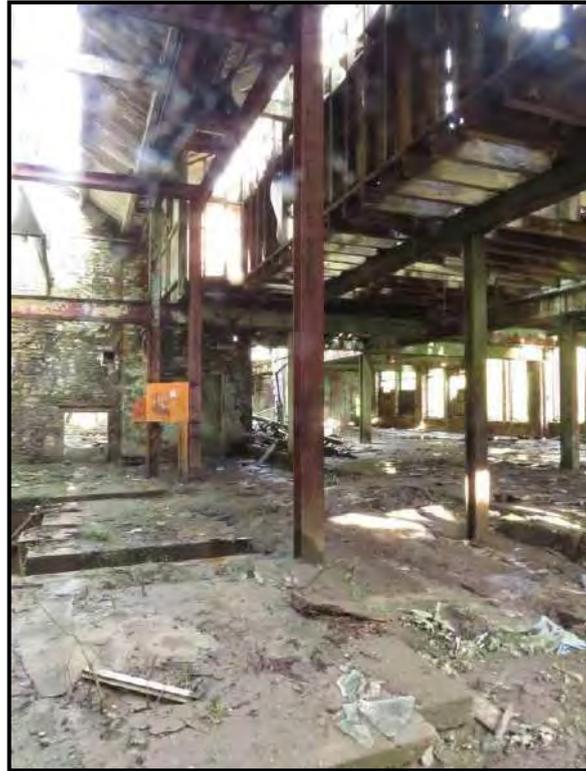
253 Ground and first floor, Units 3 - 4

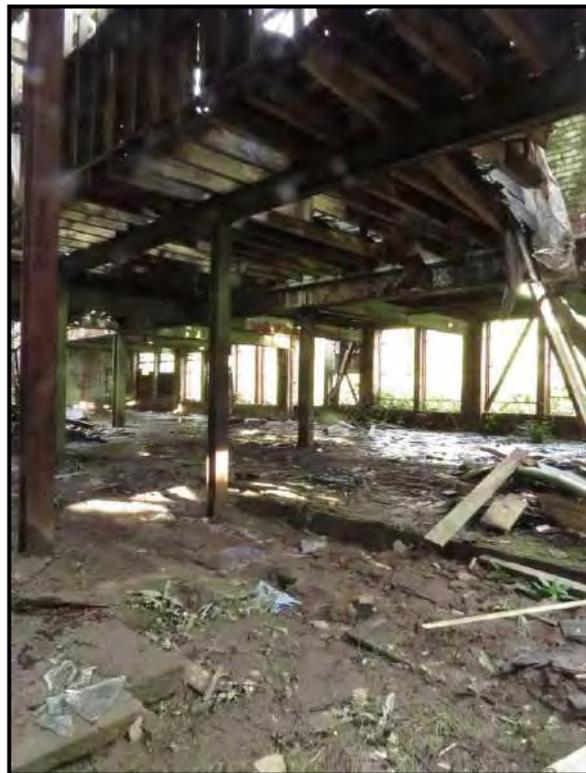
254 Unit 4 – 3, river elevation, ground floor

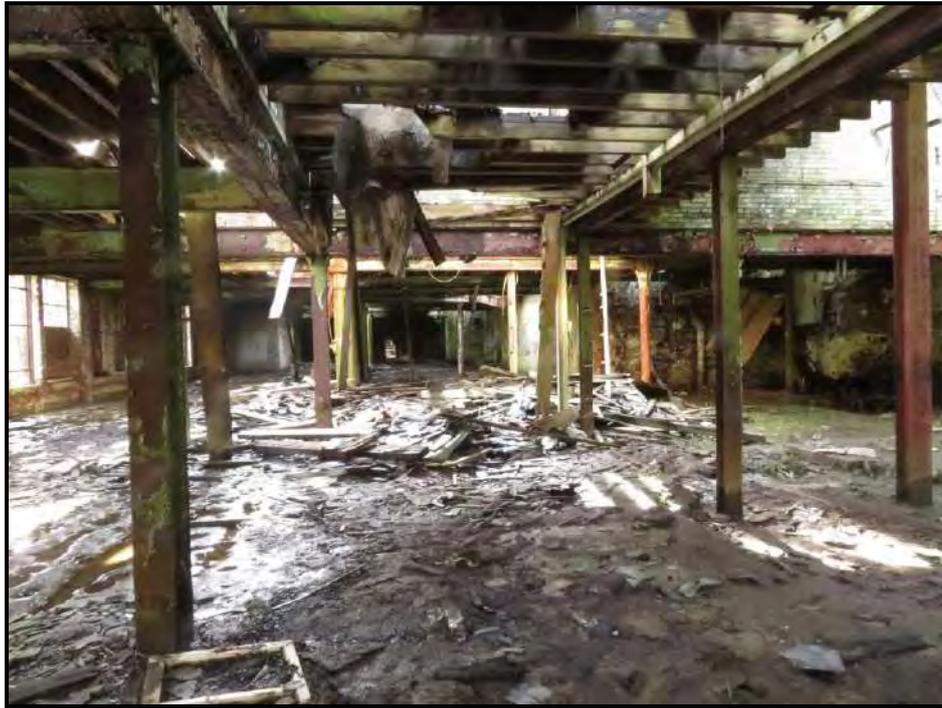
255 Units 4 – 3, ground floor collapse, North East – South West

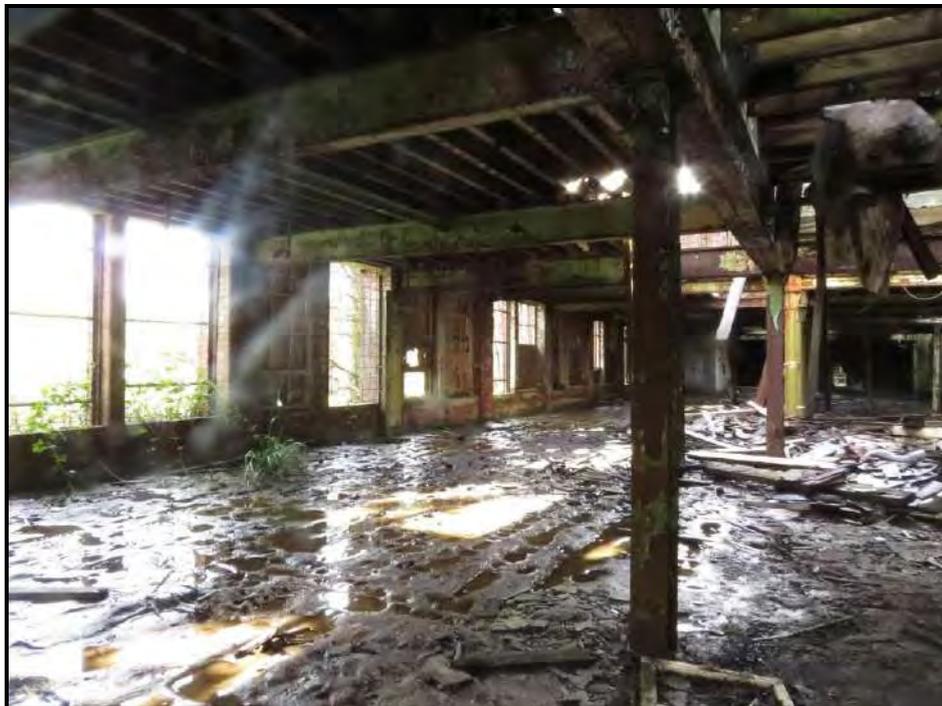
256 Unit 4 – 3, ground floor river wall

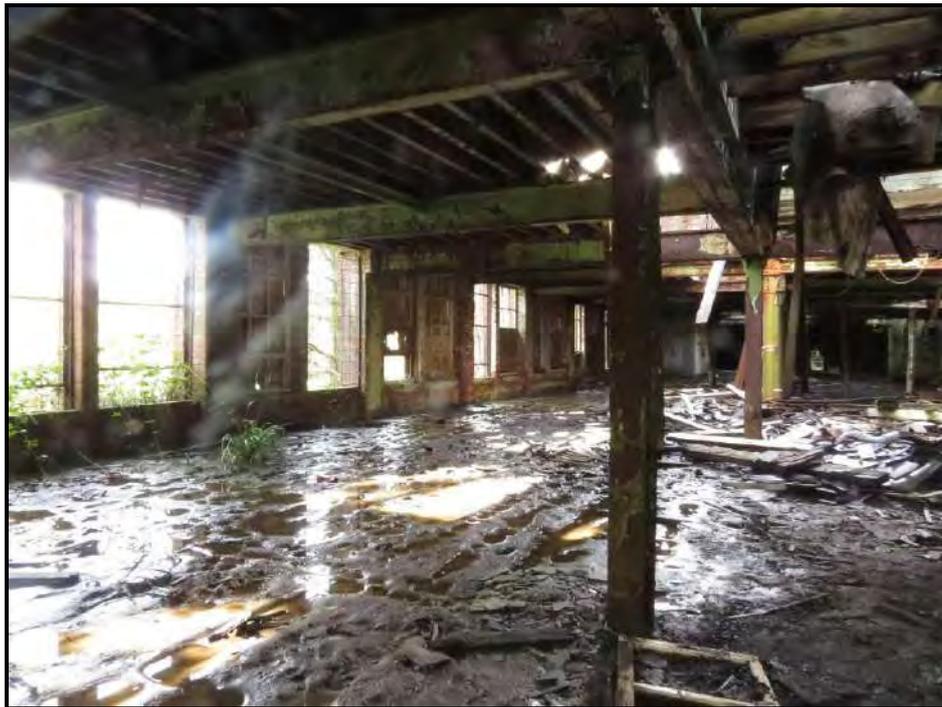
257 Units 4 – 3, ground floor river wall

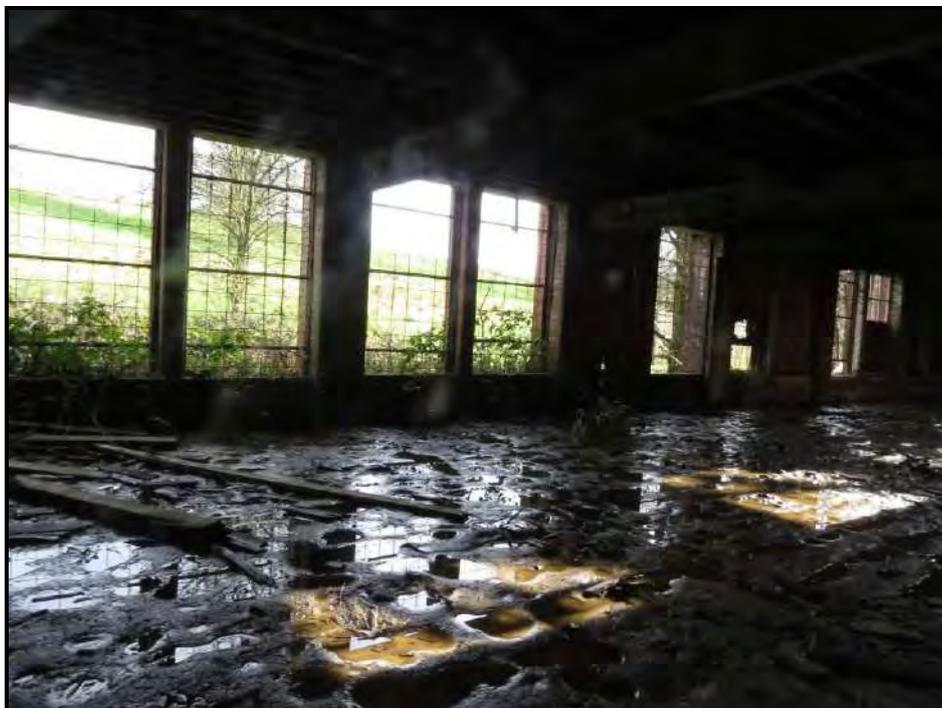
258 Units 4 – 3, ground floor river wall

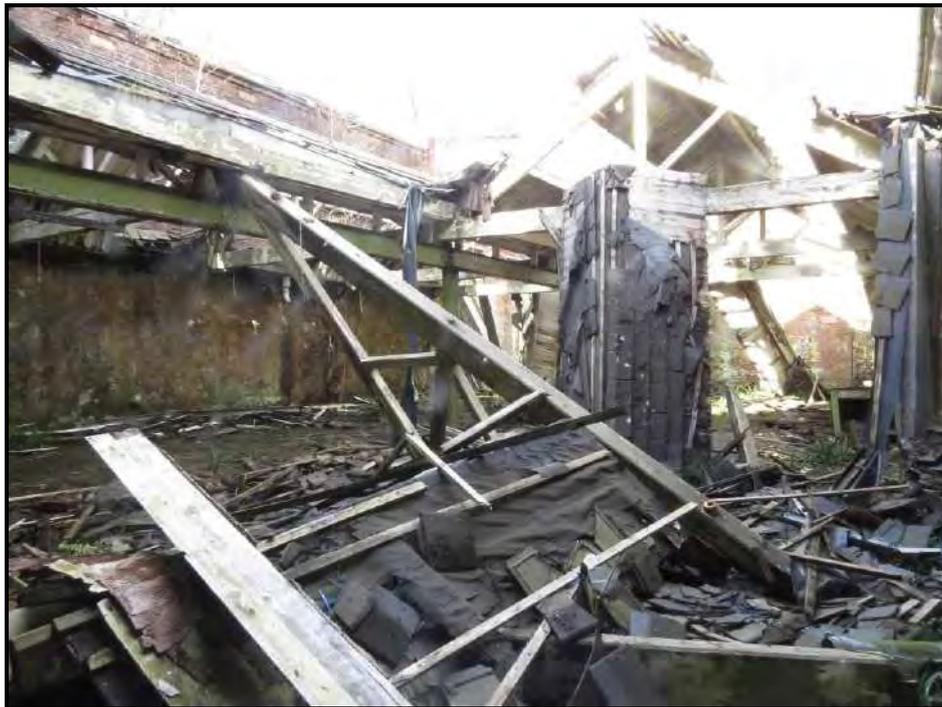
259 Roof collapse, Unit 3

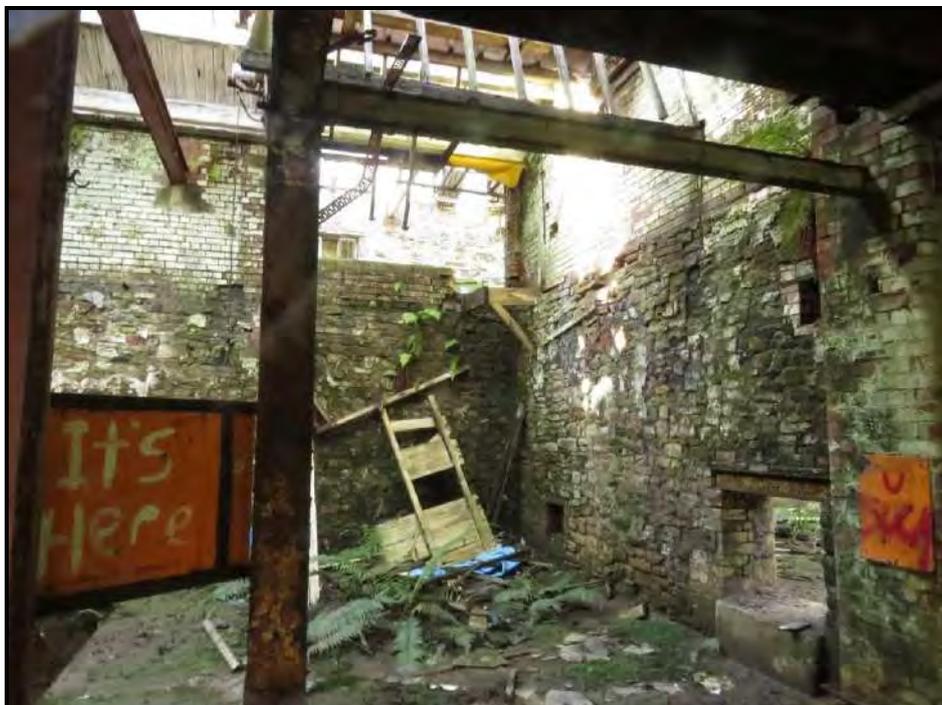
260 Unit 3, cross wall 3 – 2 floor collapse

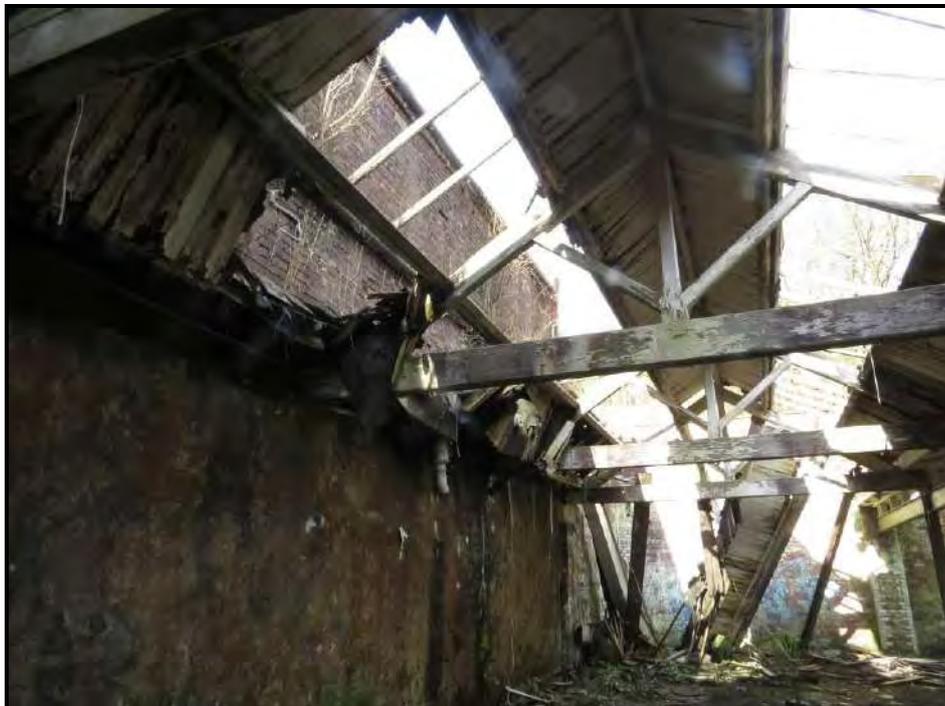
262 Units 7 – 4, king post truss

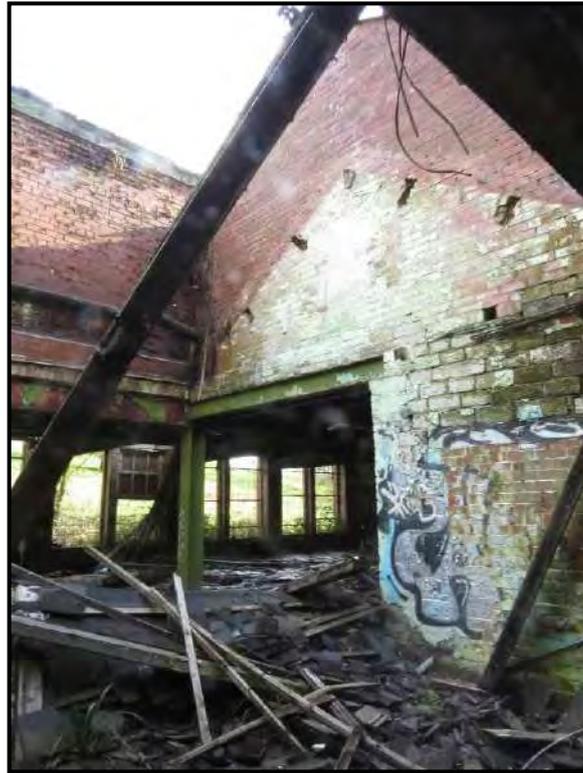
263 Units 8 – 7, internal cross wall to river elevation

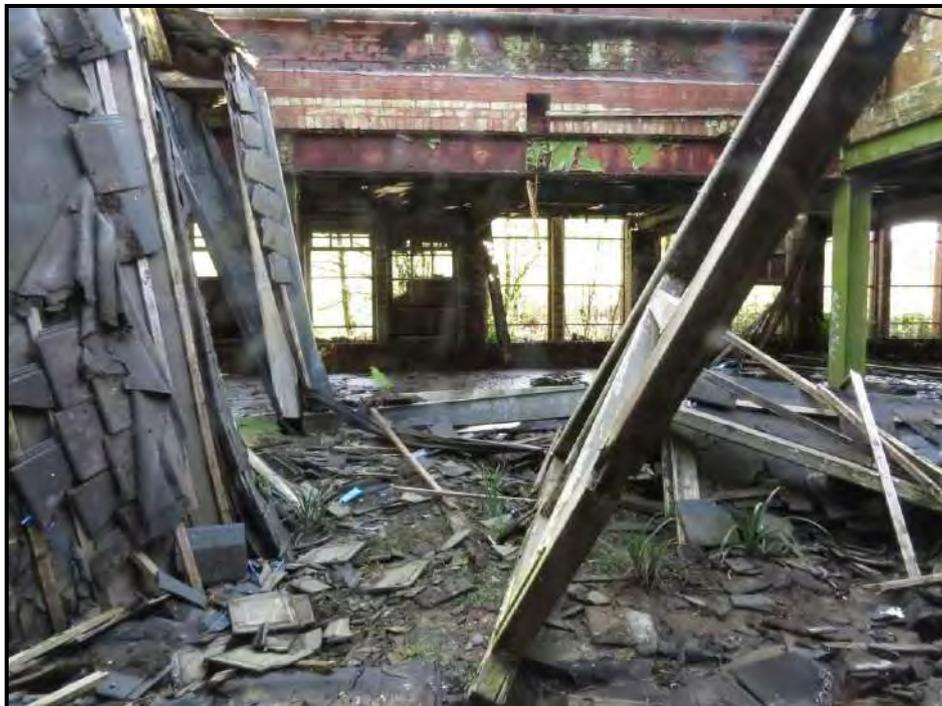
264 Floor and roof collapse looking North West – South East

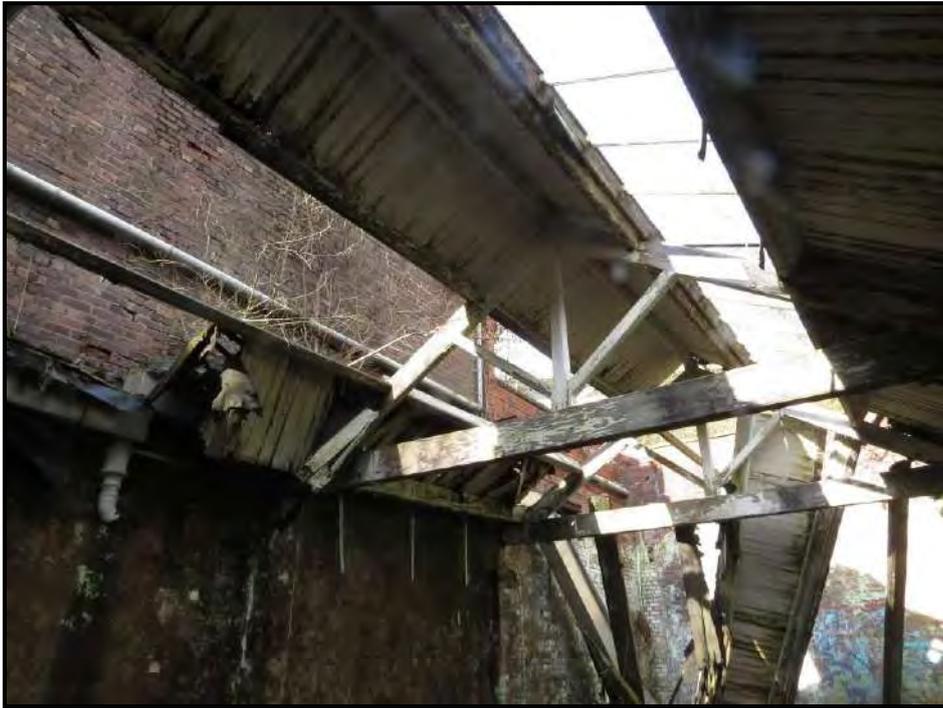
265 Floor and roof collapse, cross wall Unit 2 - 3

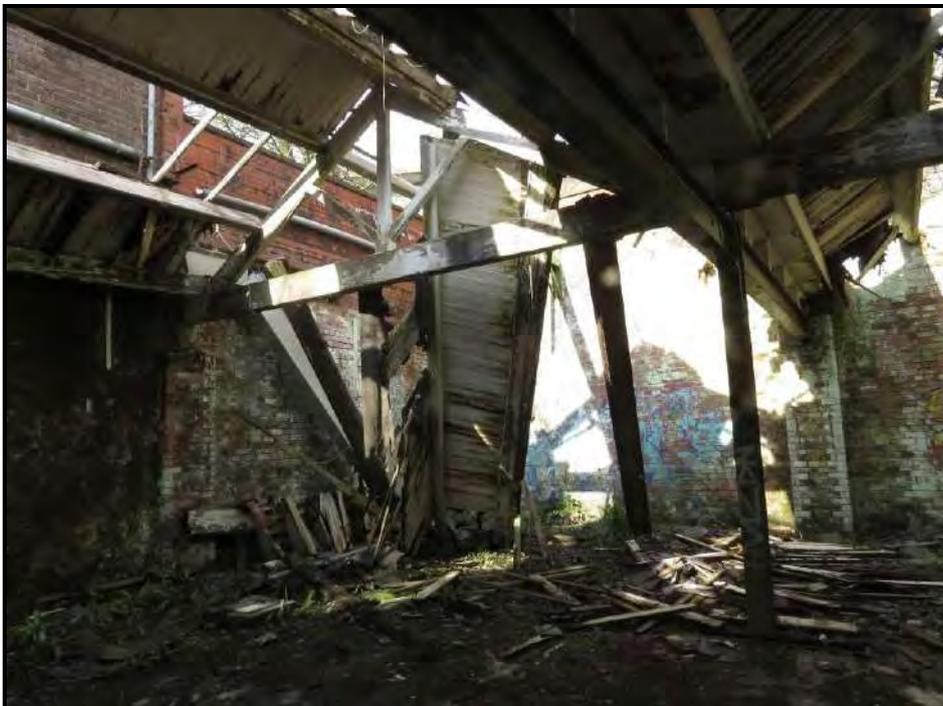
266 Floor and roof collapse, cross wall Units 2 - 3

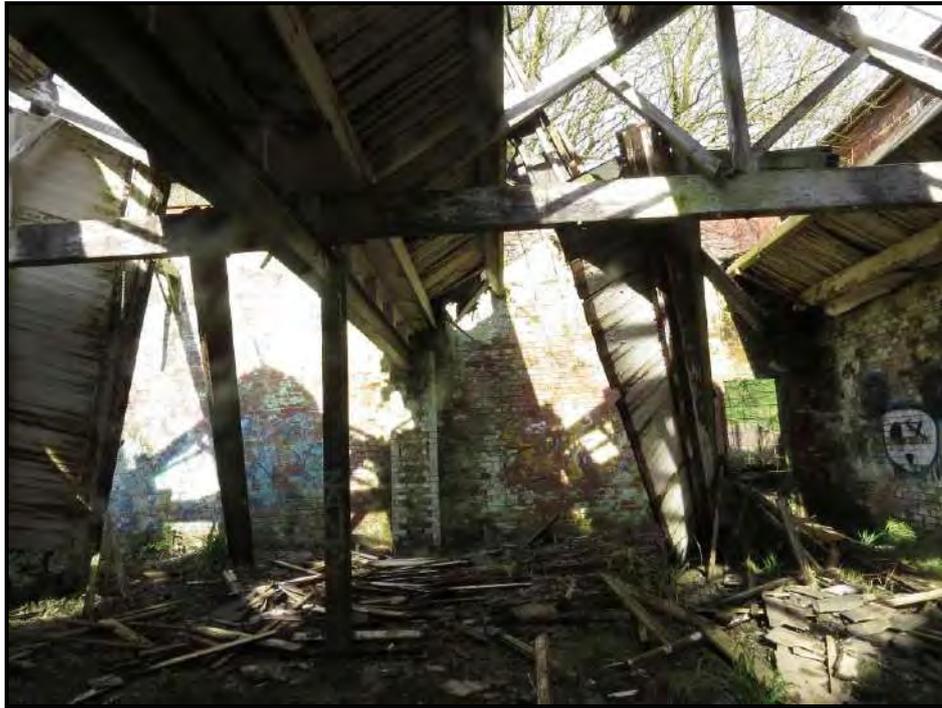
267 Floor and roof collapse, Units 8 – 10

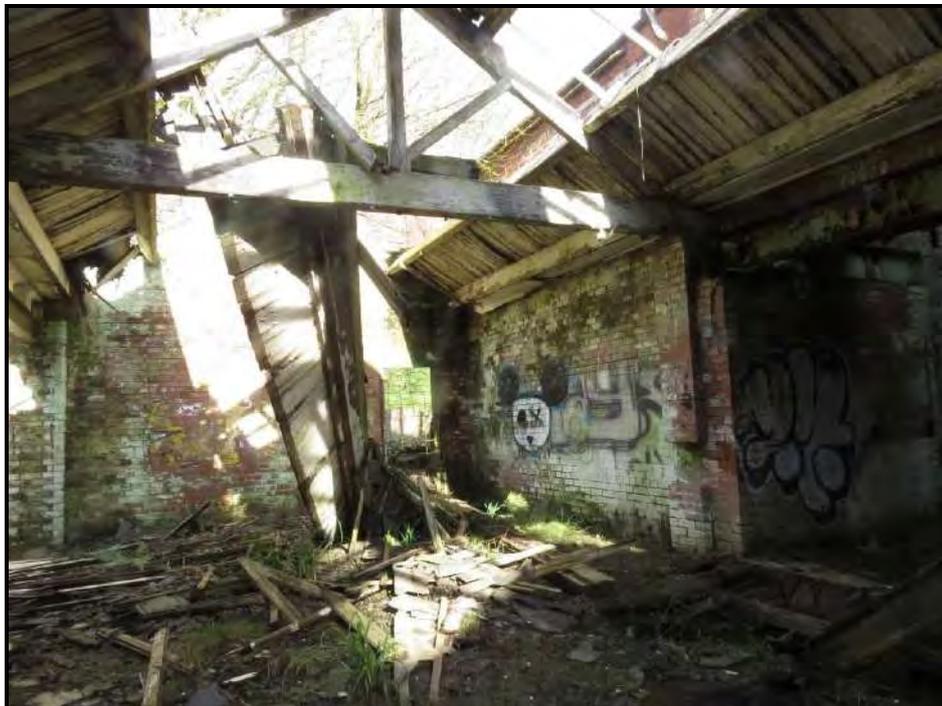
268 Units 10 – 8 North East elevation

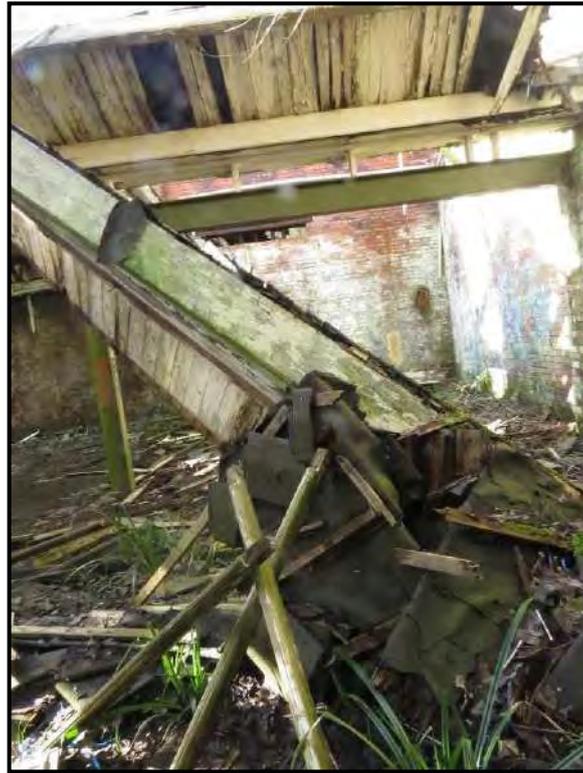
269 Floor and roof collapse, Units 10 – 8 looking North West

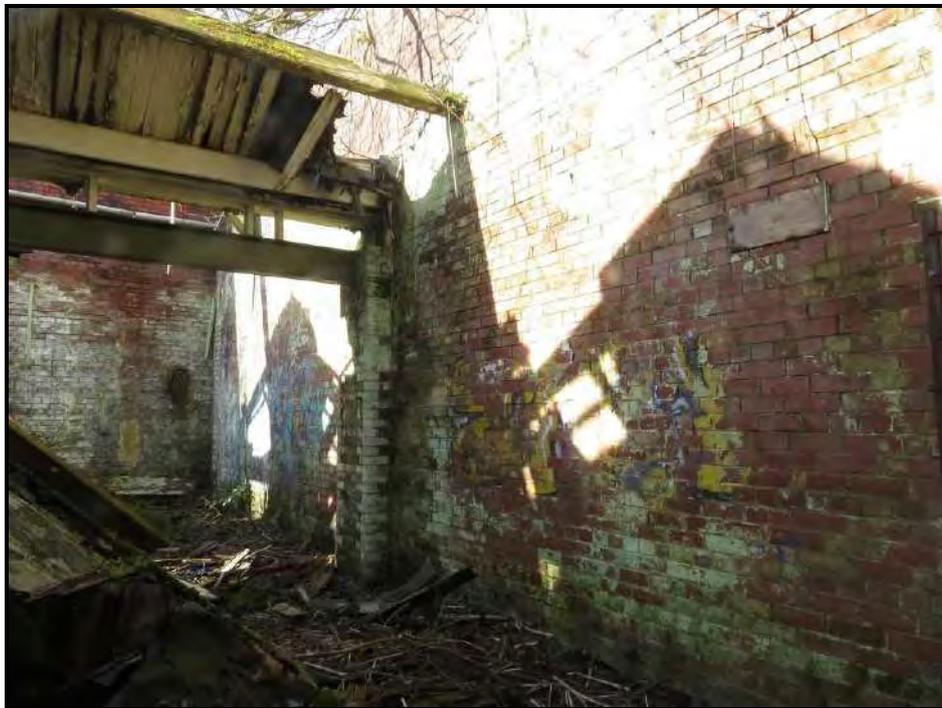
270 Looking North East, Units 9 - 10

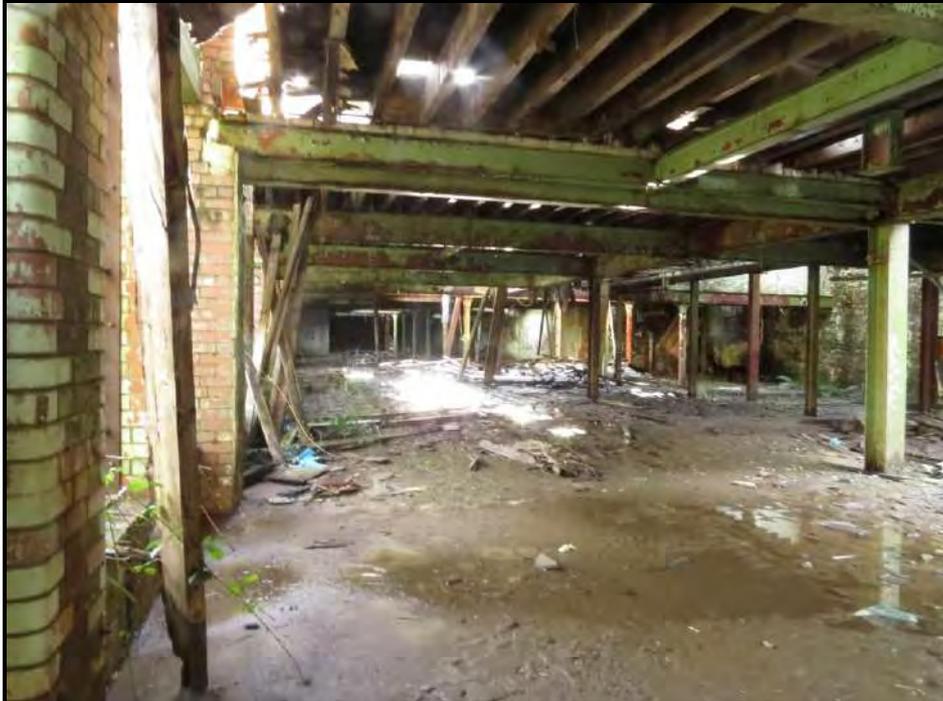
272 Unit 8 river wall looking North East – South West

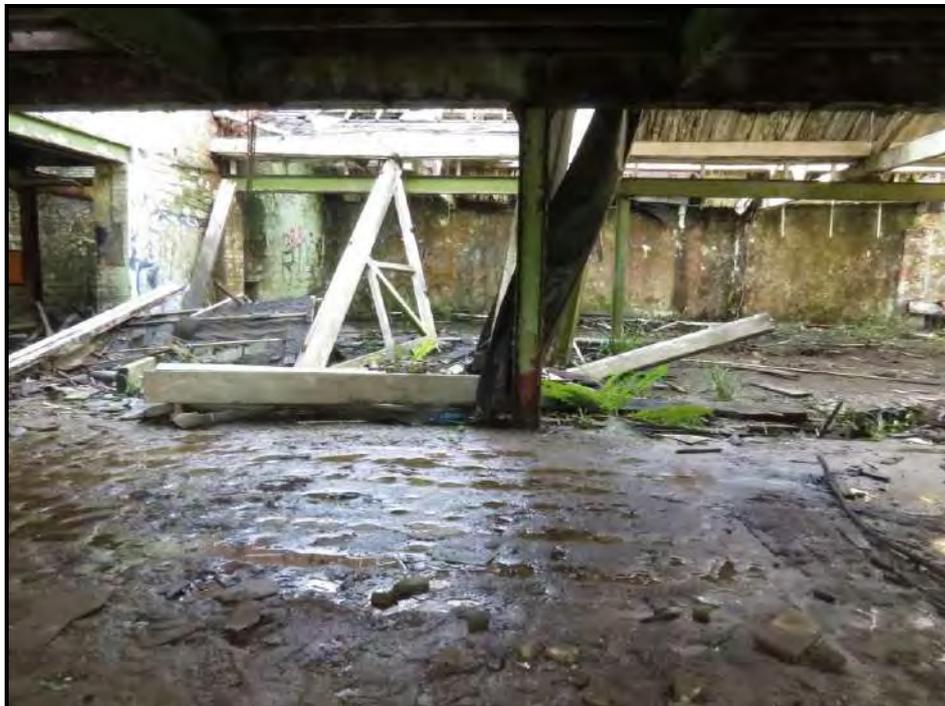
274 Unit 8 looking to cross wall

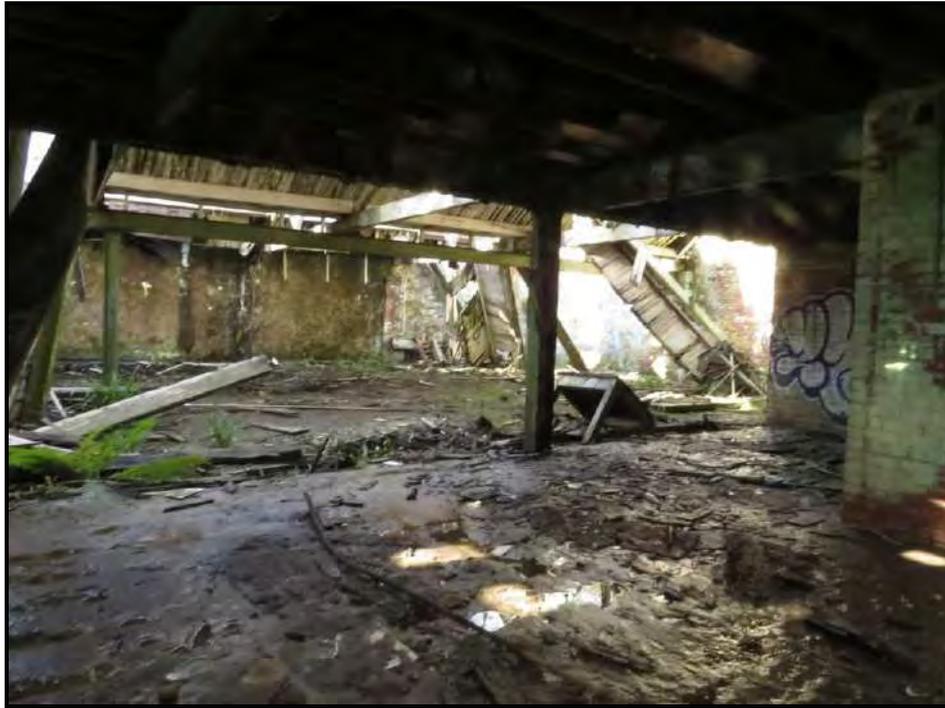
275 Unit 8 looking to cross wall

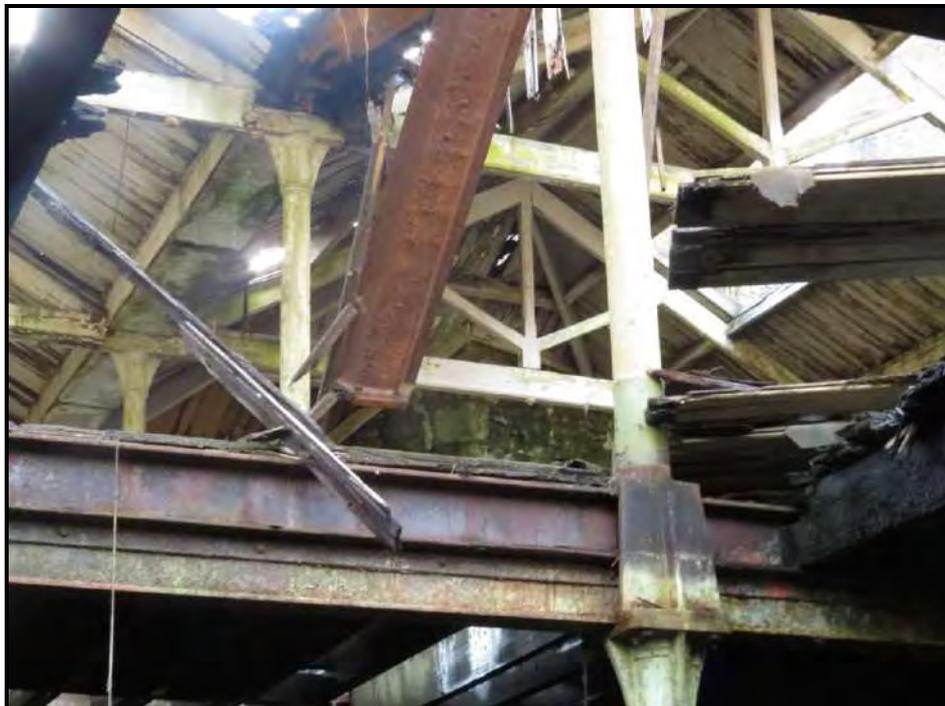
276 First floor and roof collapse above Units 6 - 7
